# FACILITY CONDITION ASSESSMENT

## TOWN OF WILTON – TOWN BUILDINGS

Wilton, Connecticut

Draft: February 2, 2024

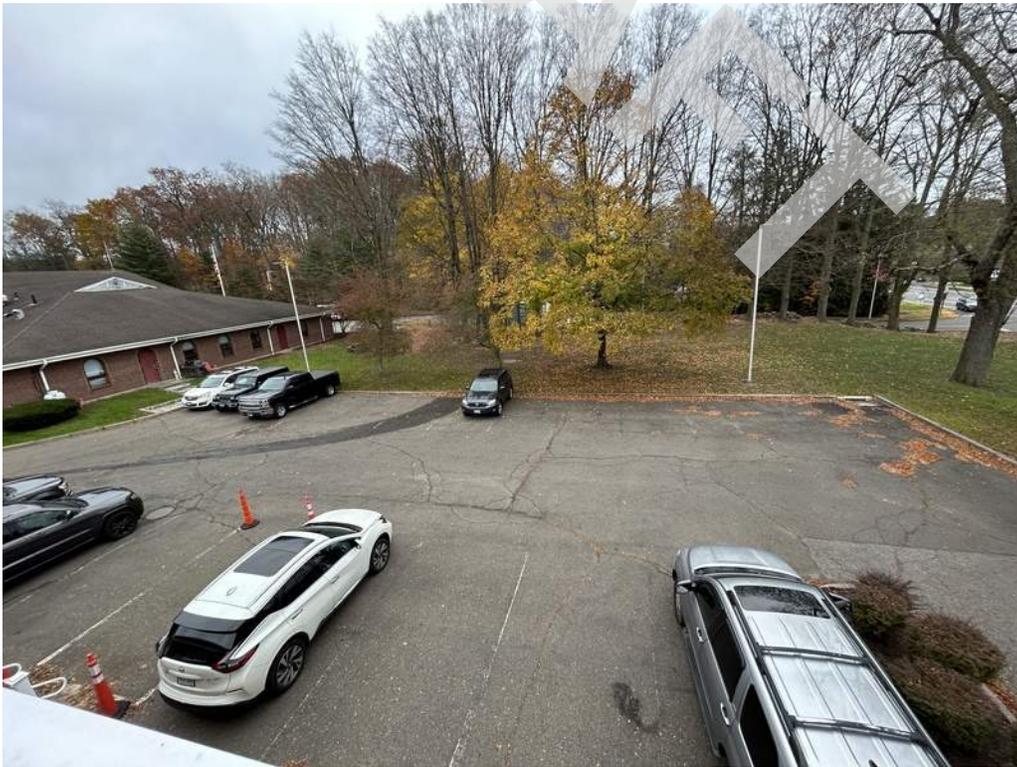
6 - Additional asphalt paved parking is provided on the south side of the building.

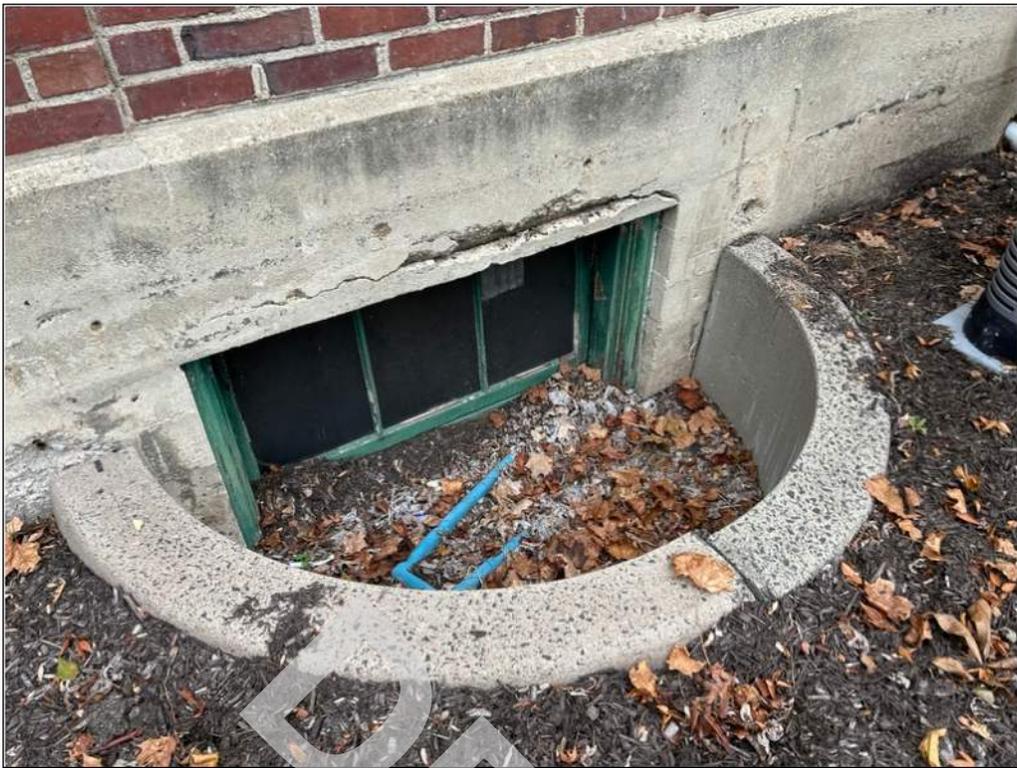
7 - Reinforced concrete foundation wall has spalled and has exposed steel reinforcement.

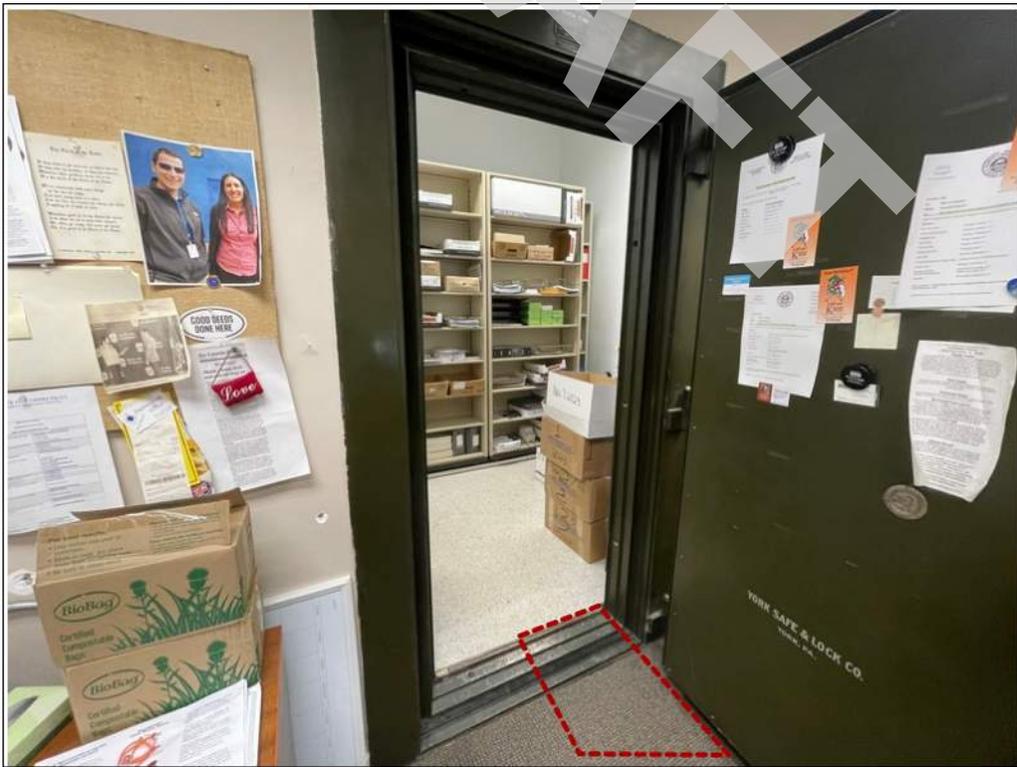
8 - Localized displacement noted near the safe door hinge.

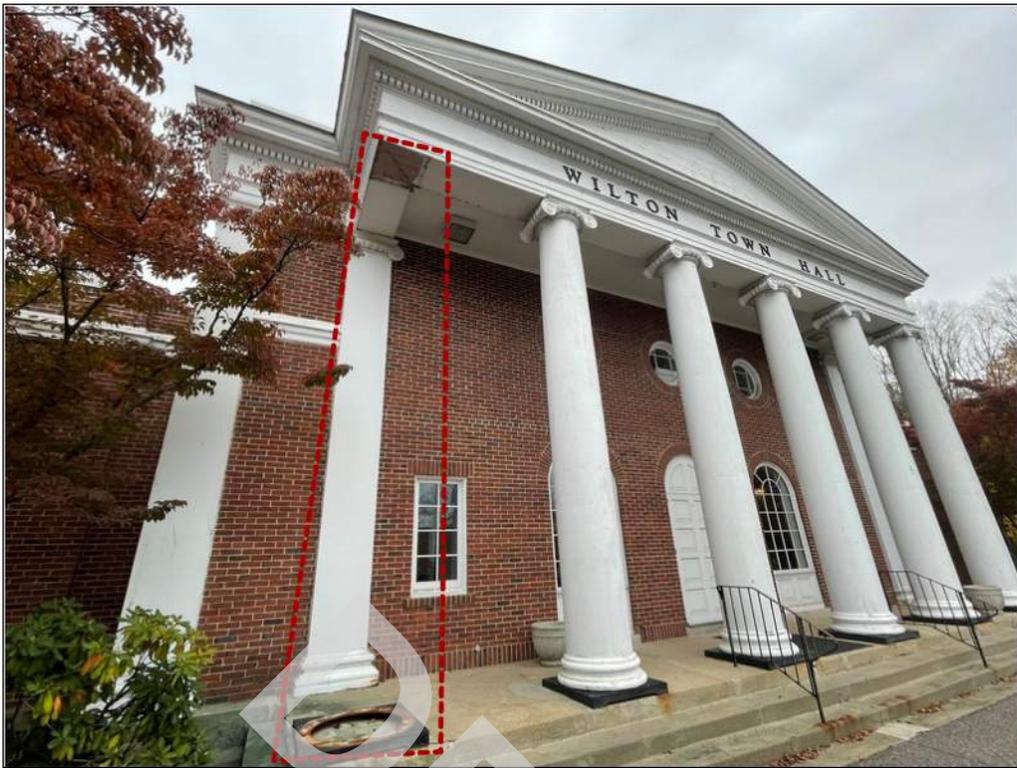
9 - Missing column along the front facade.

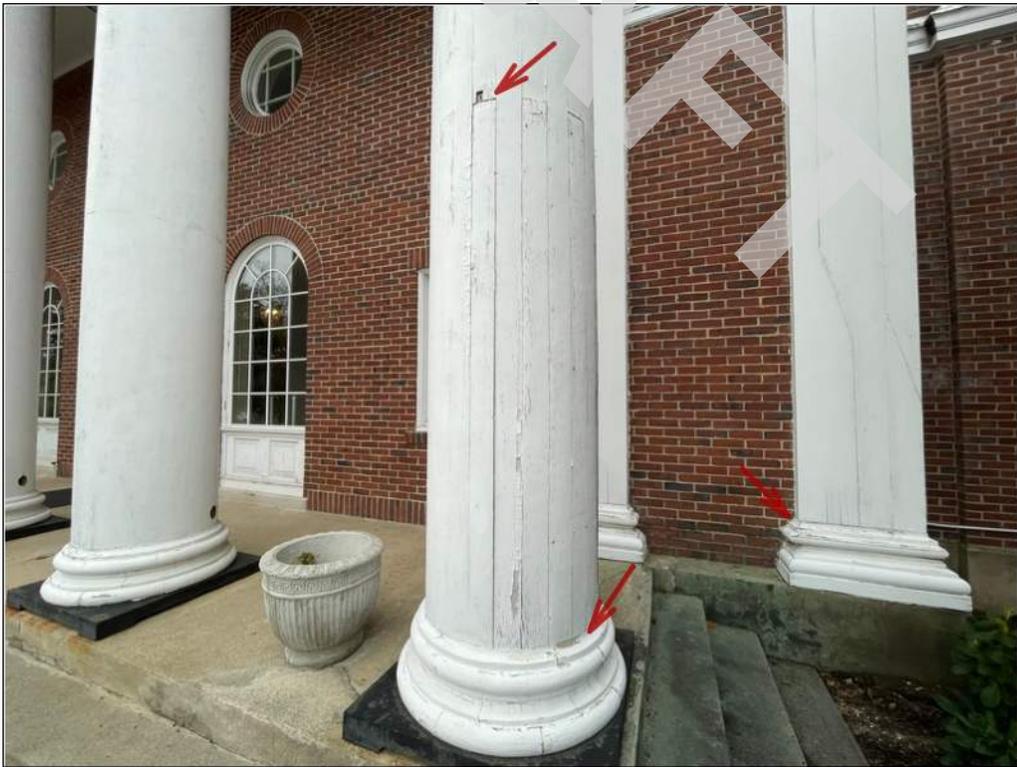
10 - Front facade wood column surface has localized damages and damaged finishes.

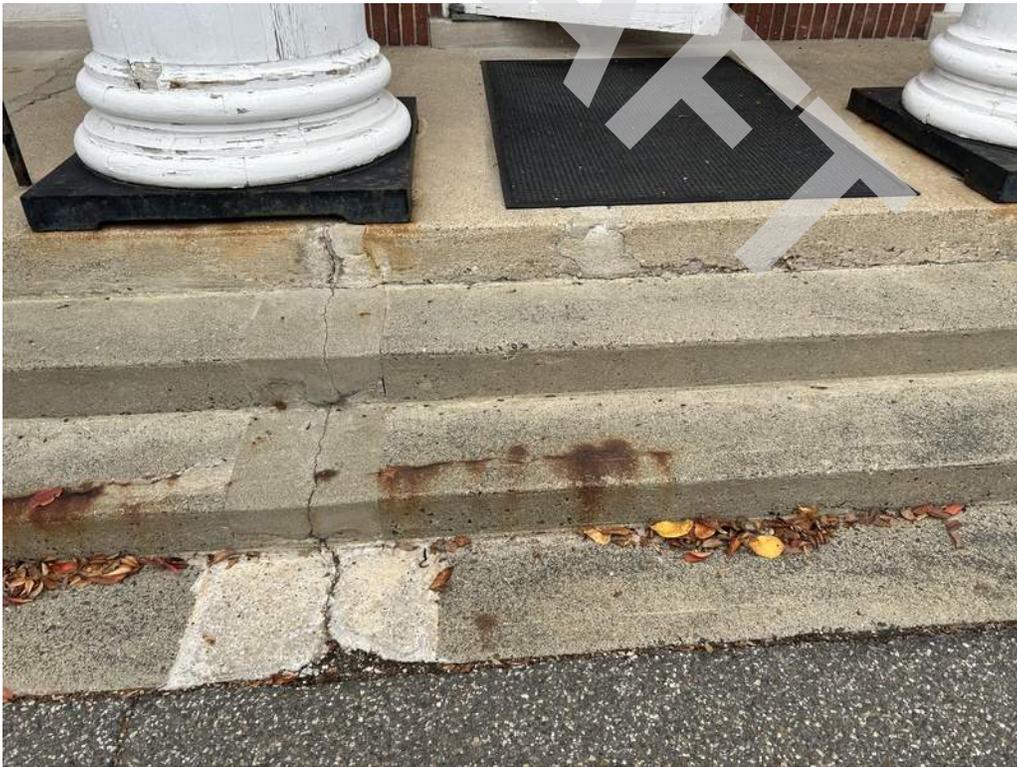
12 - Evidence of prior patching along with additional cracking and corrosion are present at the front concrete porch.

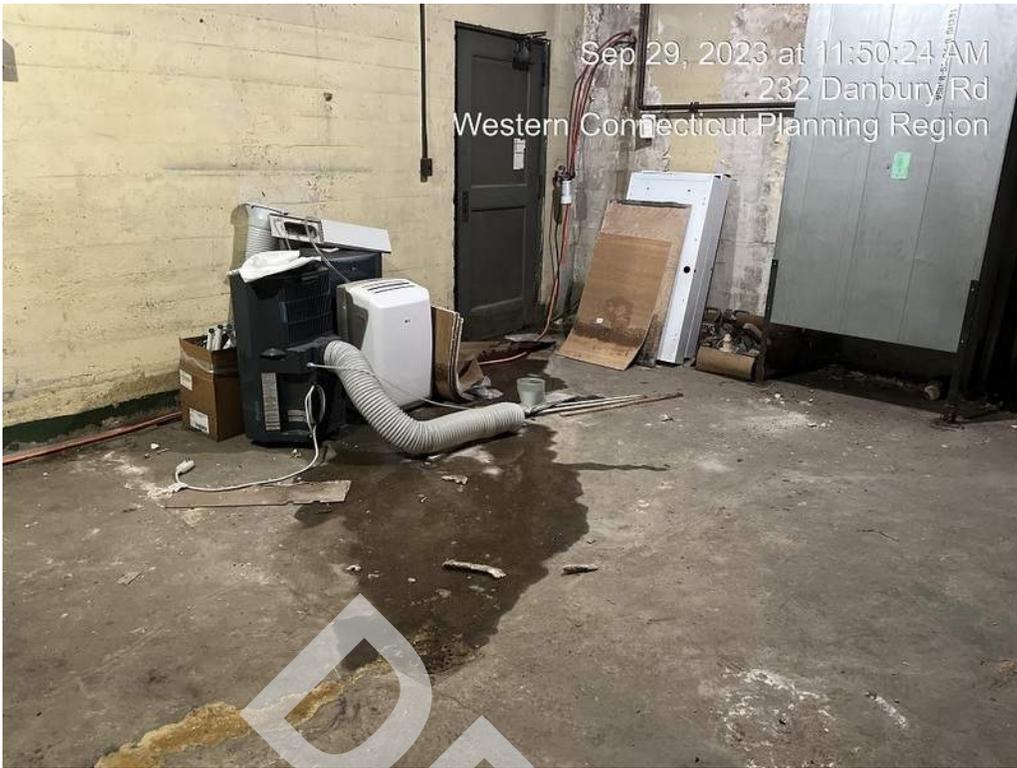
19 - Water intrusion at the boiler room.

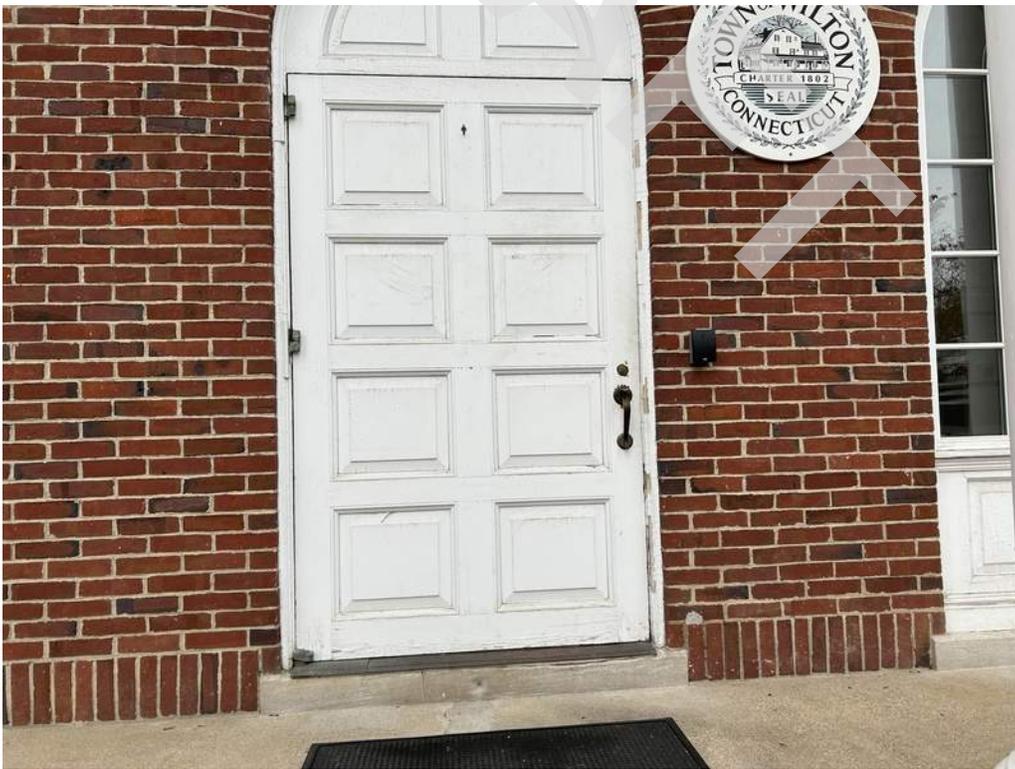
30 - Main entry wood door is in poor condition. Deficiencies include deteriorated door hardware and peeling finish surface.

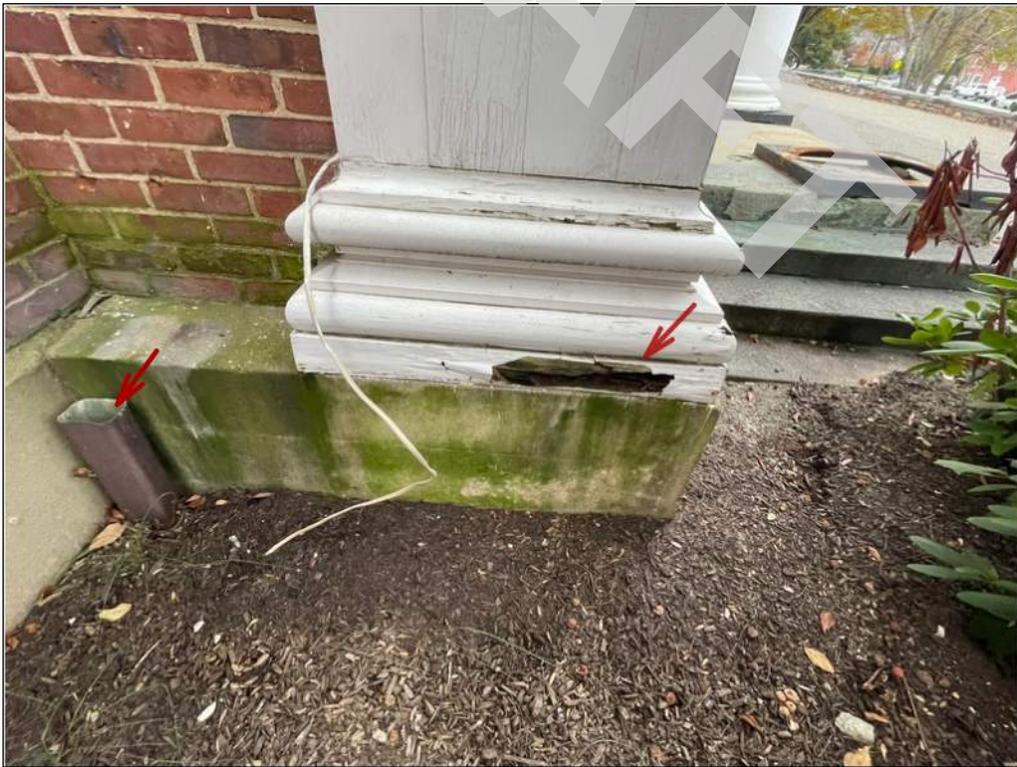
32 - Wood pilaster surfaces have rotted and have peeling finishes. Roof leader is missing.

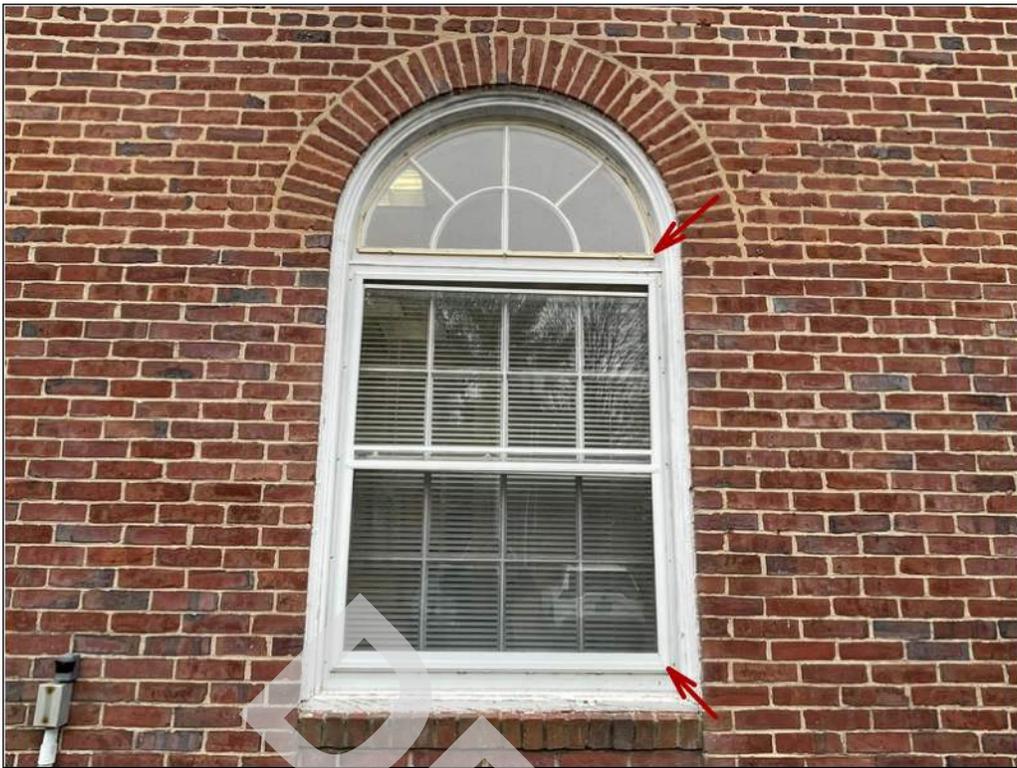
33 - Window assemblies consist of wood framed single pane units. Windows are provided with plastic coverings.

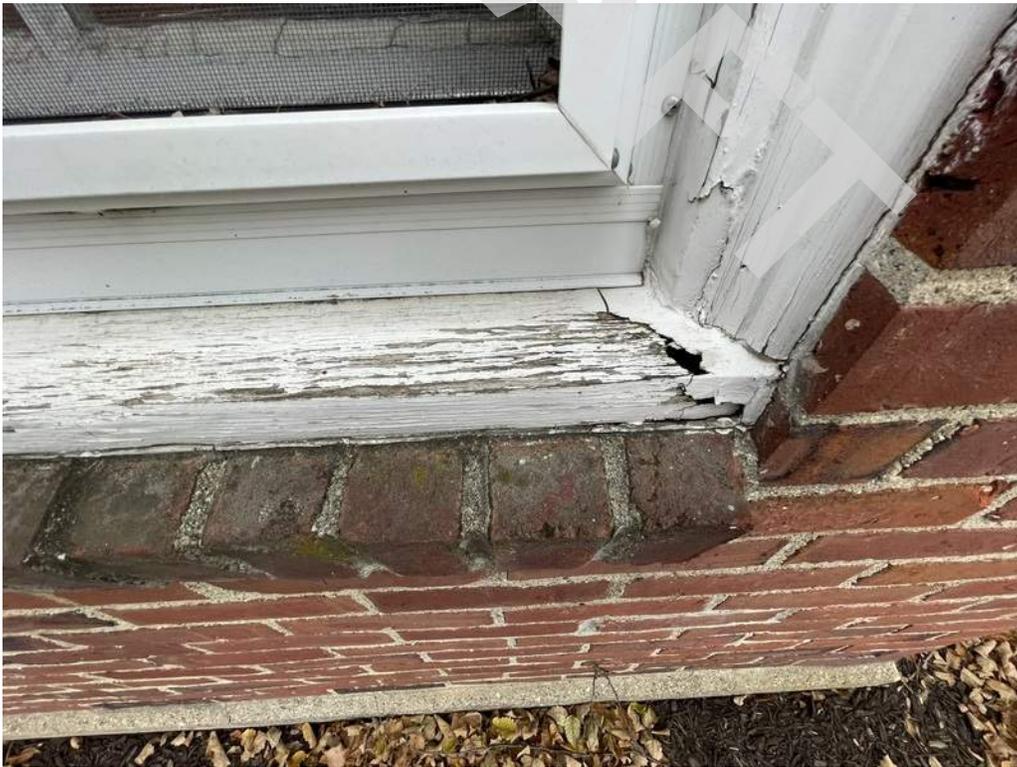
34 - Wood and brick sills are in poor condition. Wood is rotted and brick sill has organic growth, spalled brick units, and deteriorated mortar joints.

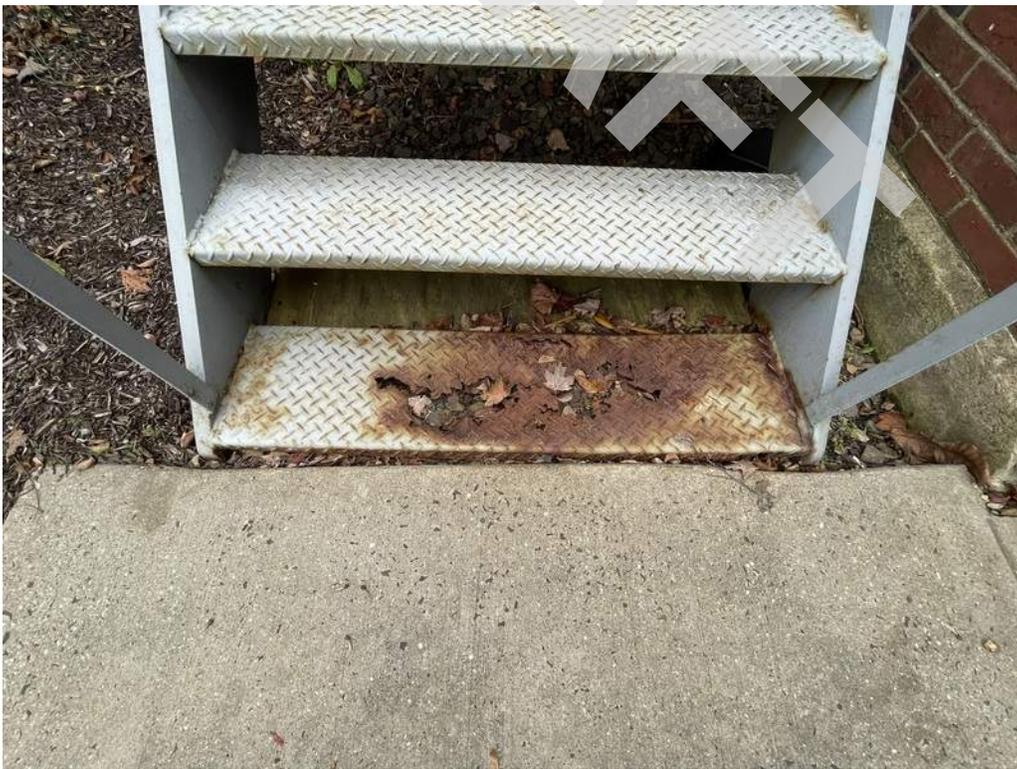
36 - Pitting corrosion at the lowest metal riser.

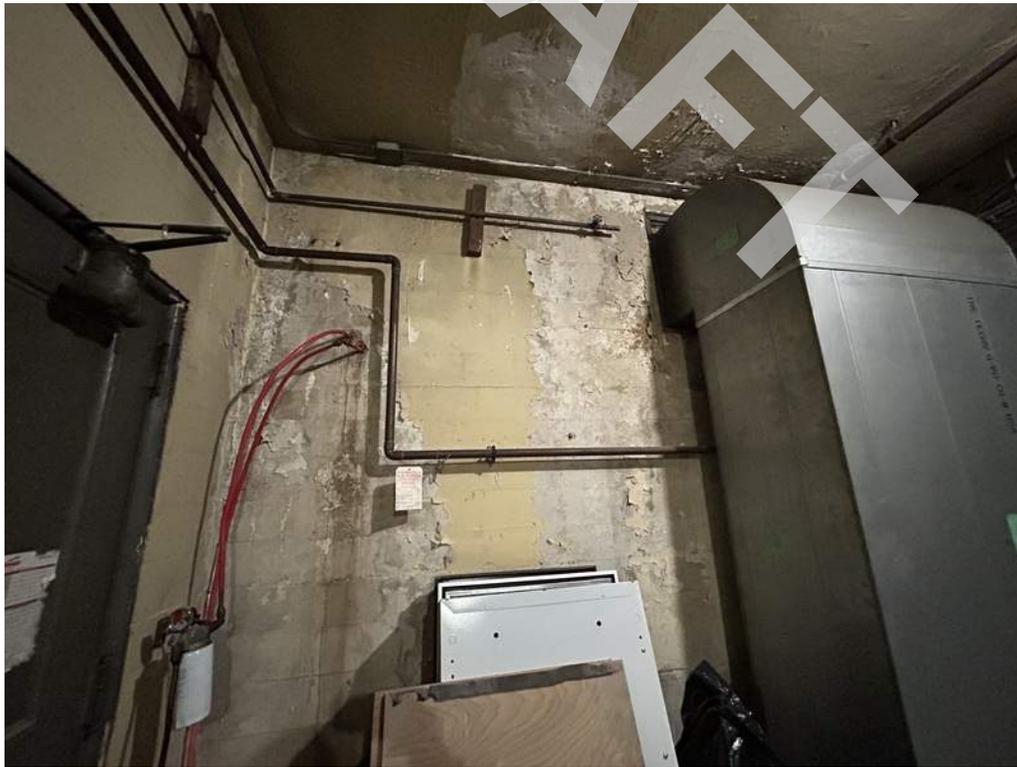
44 - Deteriorated paint and evidence of persistent water intrusion was observed at the boiler room in the basement level.

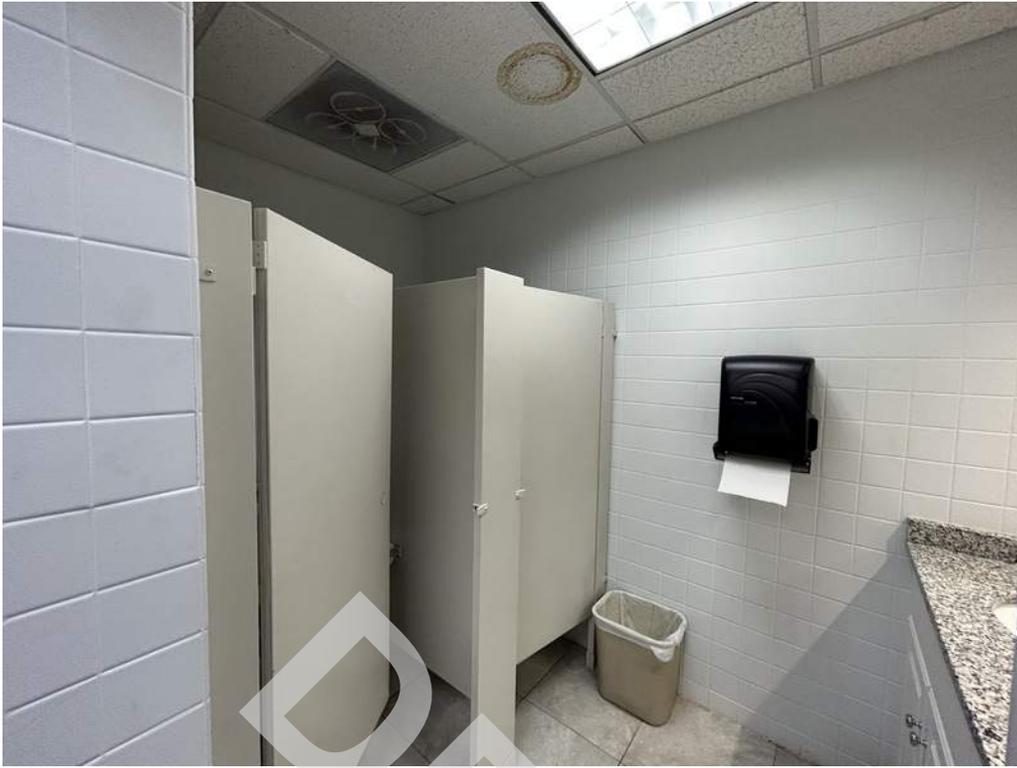
65 - An accessible stall is not provided at the multi-user restroom on the first floor.

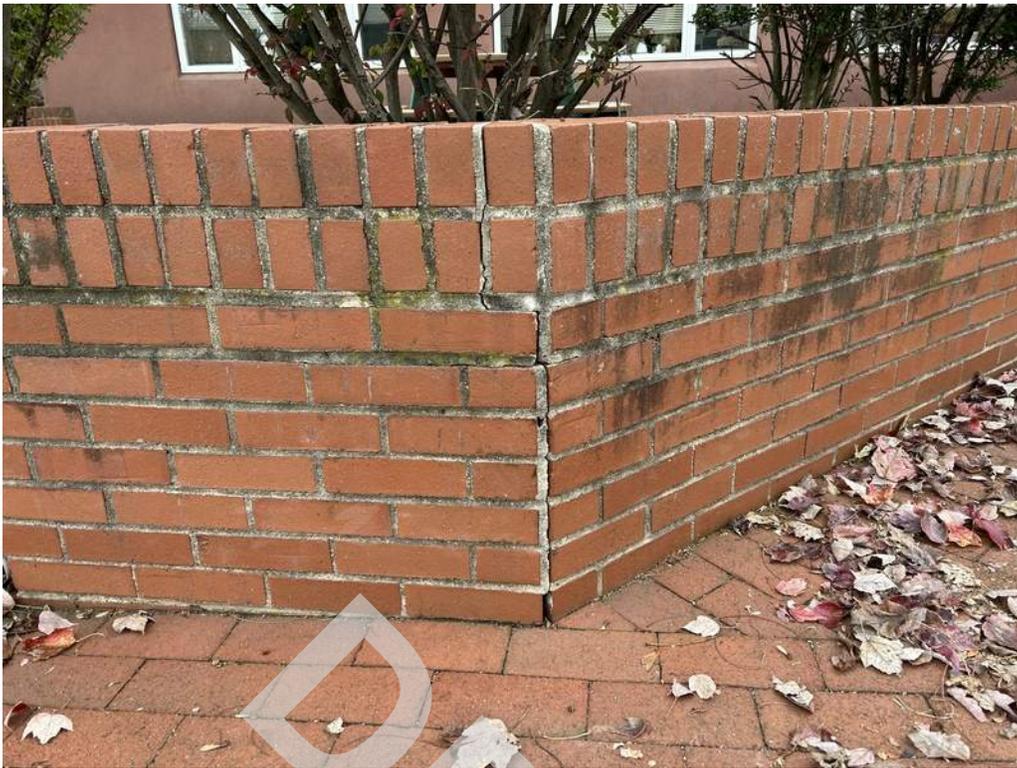
3 - Deteriorated mortar was observed at the brick garden wall, adjacent to the patio.

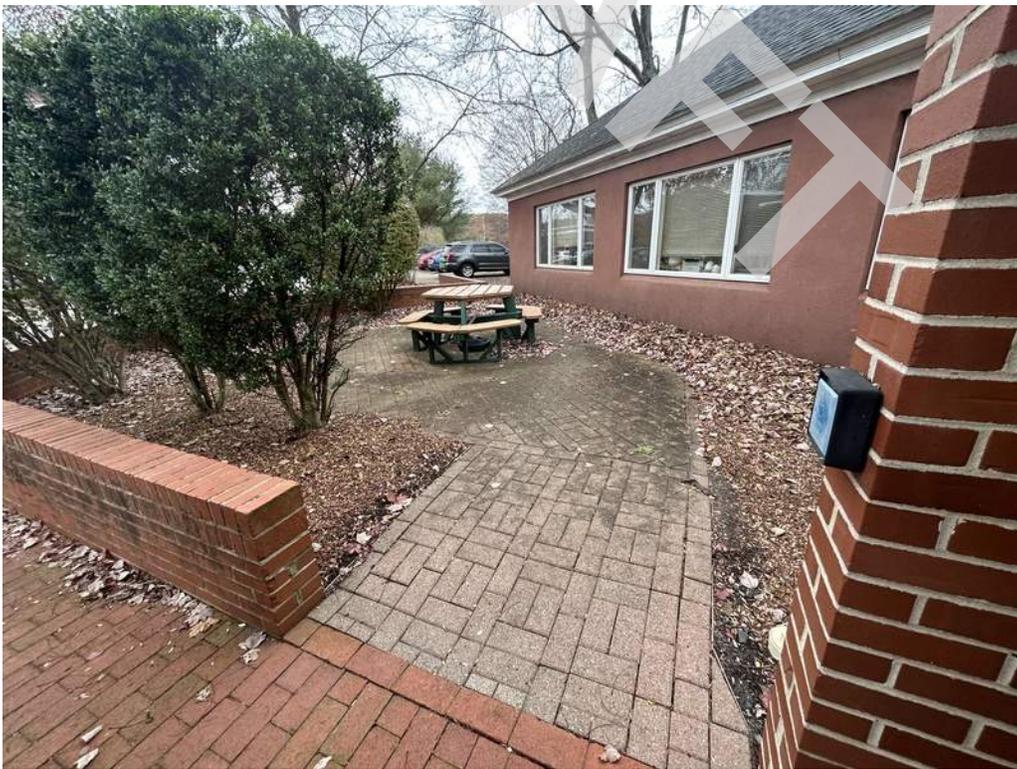
4 - A brick paved patio is provided at the front of the facility.

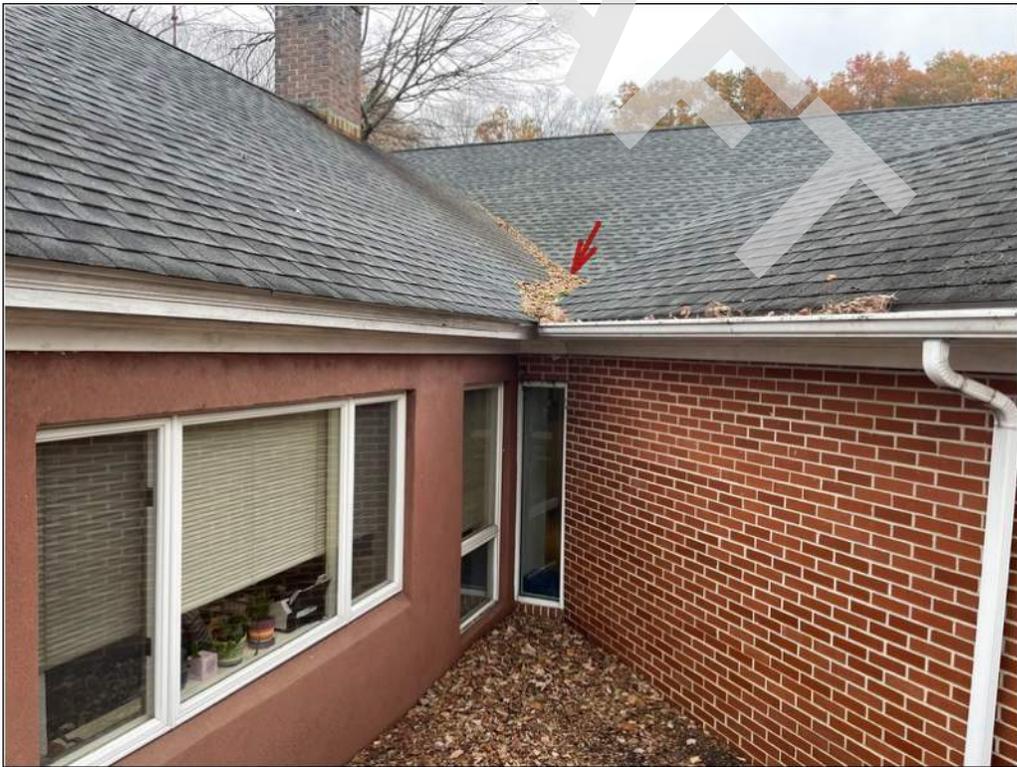
6 - Annex building roof consists of asphalt shingles. Interior areas below the roof valley had instances of water intrusion.

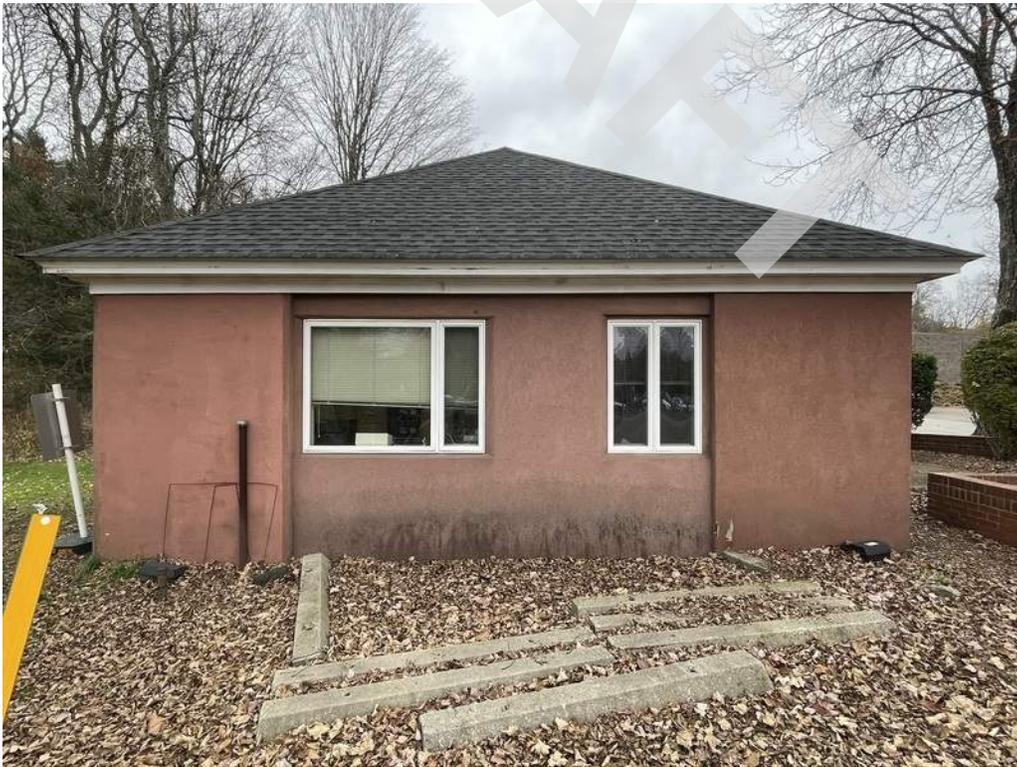
8 - Exterior surfaces along the façade have peeling paint finishes, debris accumulation, and organic growth stains.

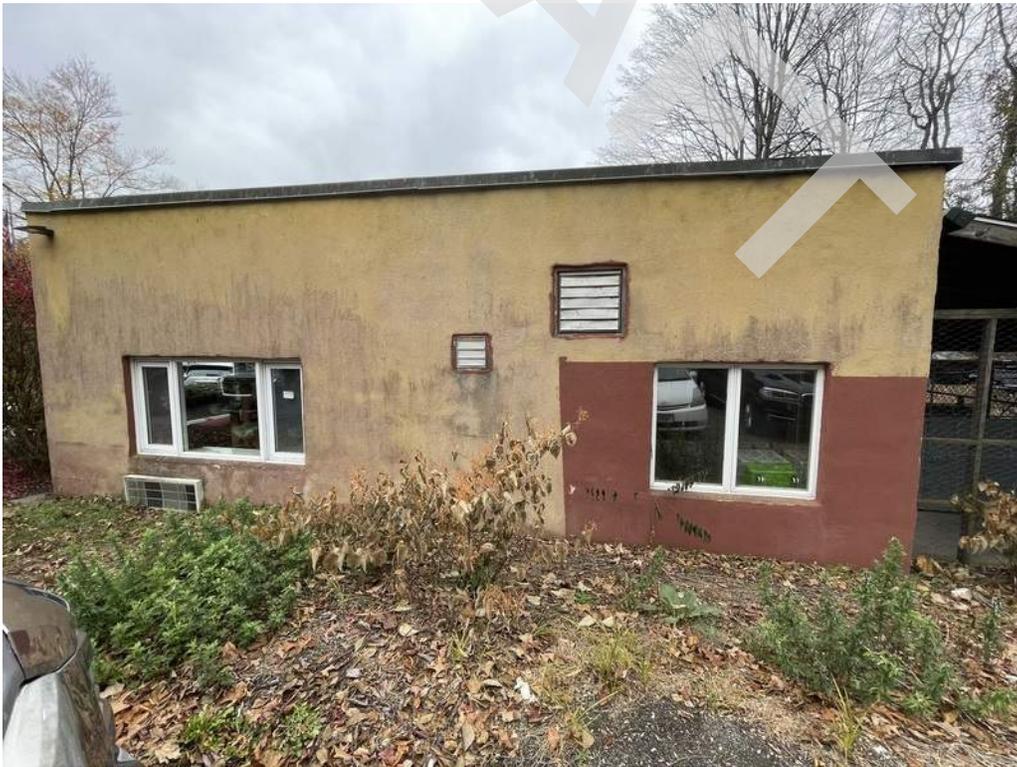
10 - Exterior wall finishes at the animal shelter stucco facade are in poor condition.

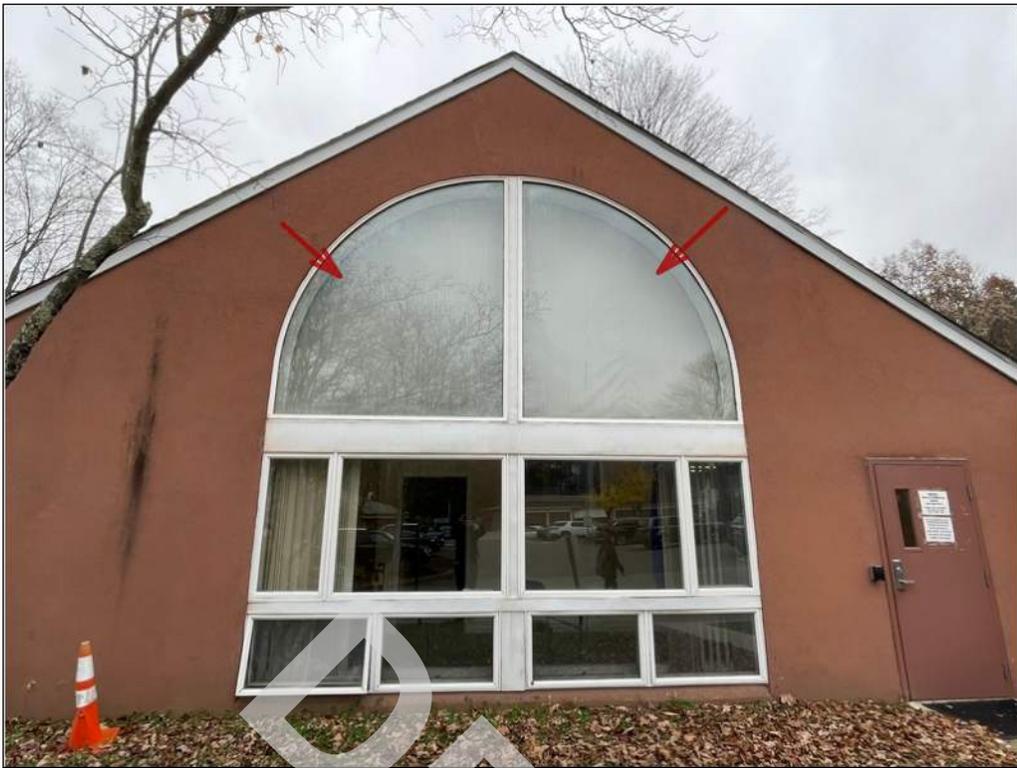
11 - Quarter circle window units along the south facade have failed.

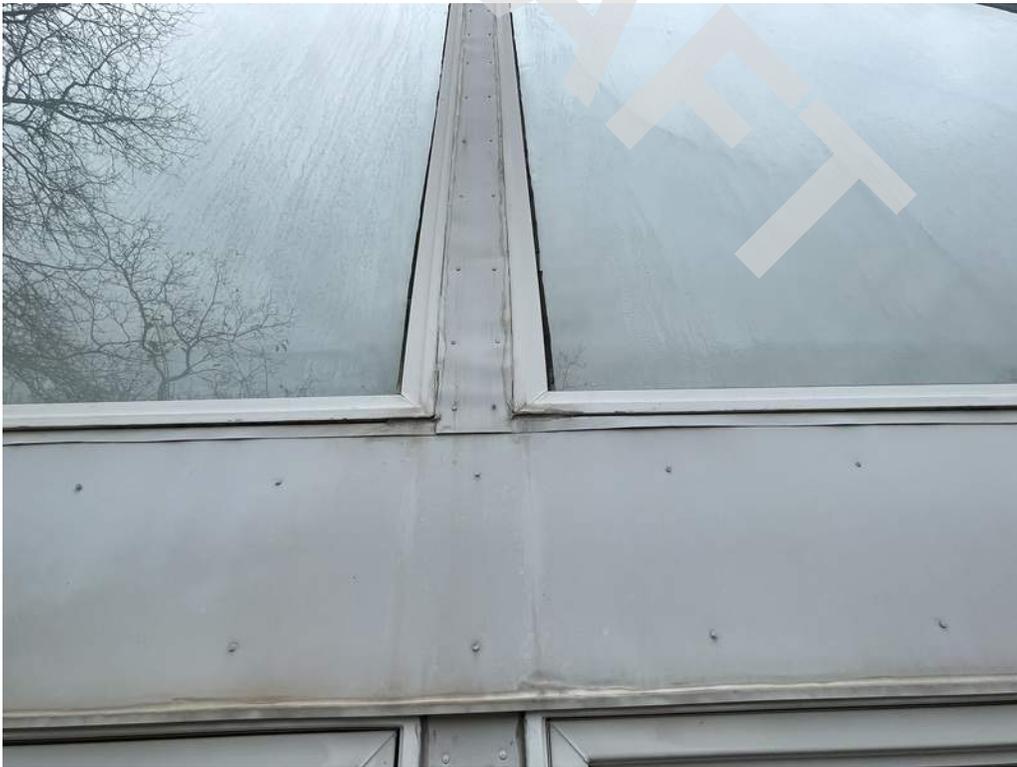
12 - Insulating glass units within the quarter round windows have failed and have internal condensation.

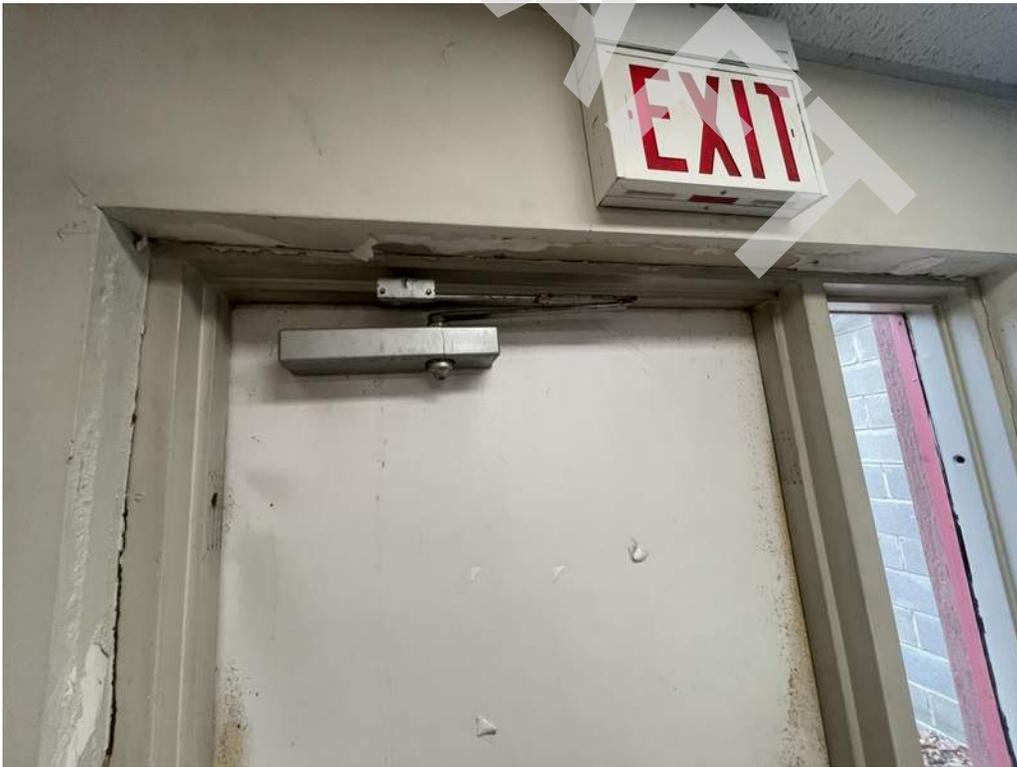
14 - Hollow metal egress door along the north facade is in poor condition.

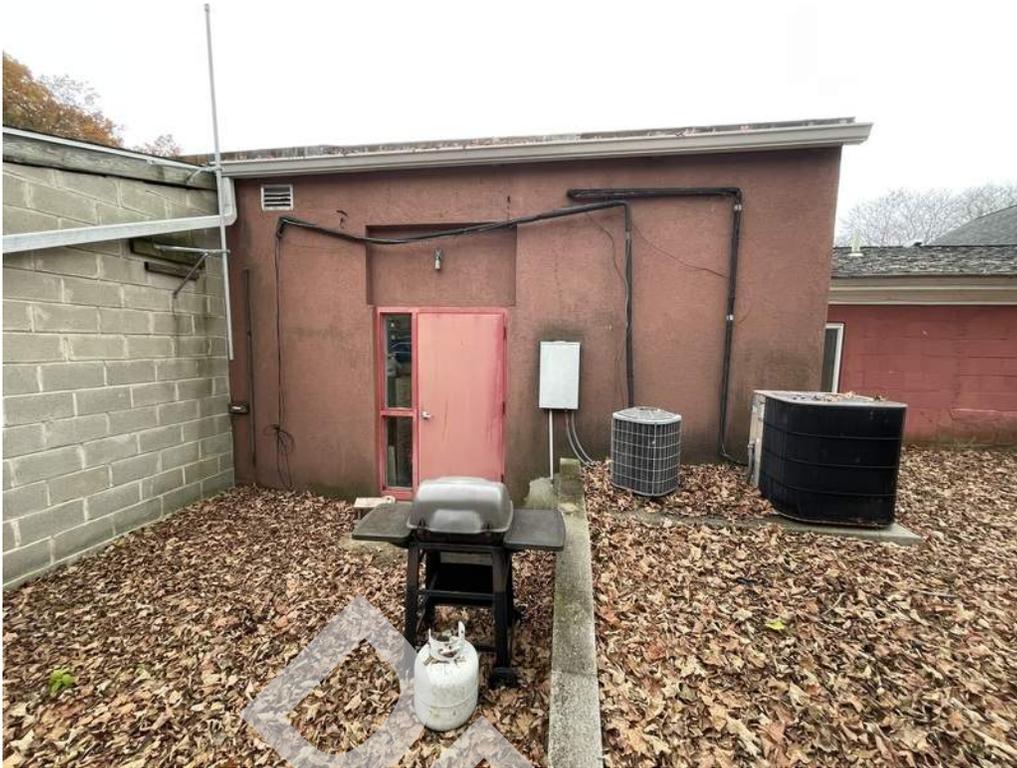
15 - Exterior surfaces along the north facade egress door are in poor condition.

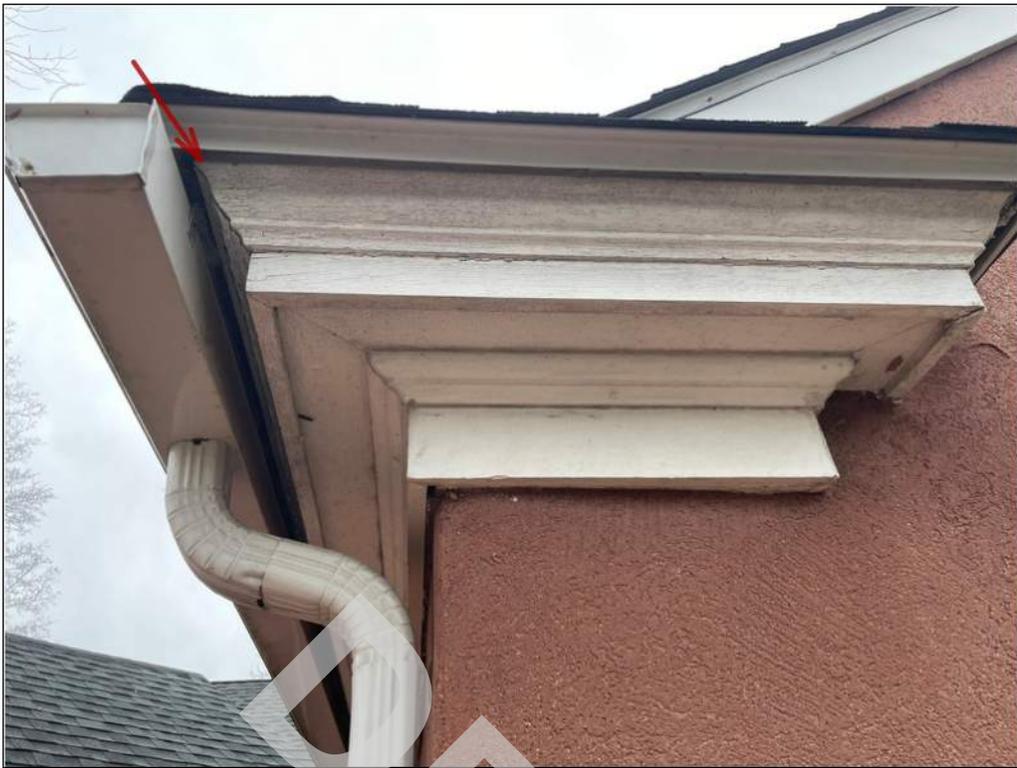
17 - Wood trim paint finishes are cracking.

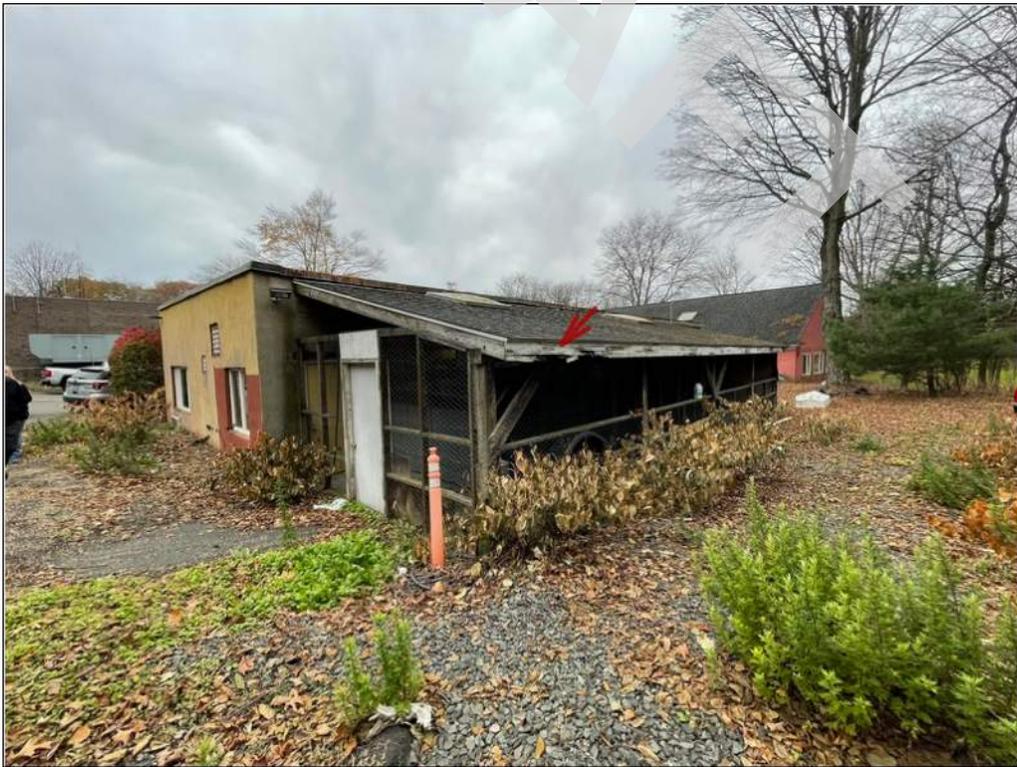
18 - Wood trim around the animal shelter kennel roof has rotted.

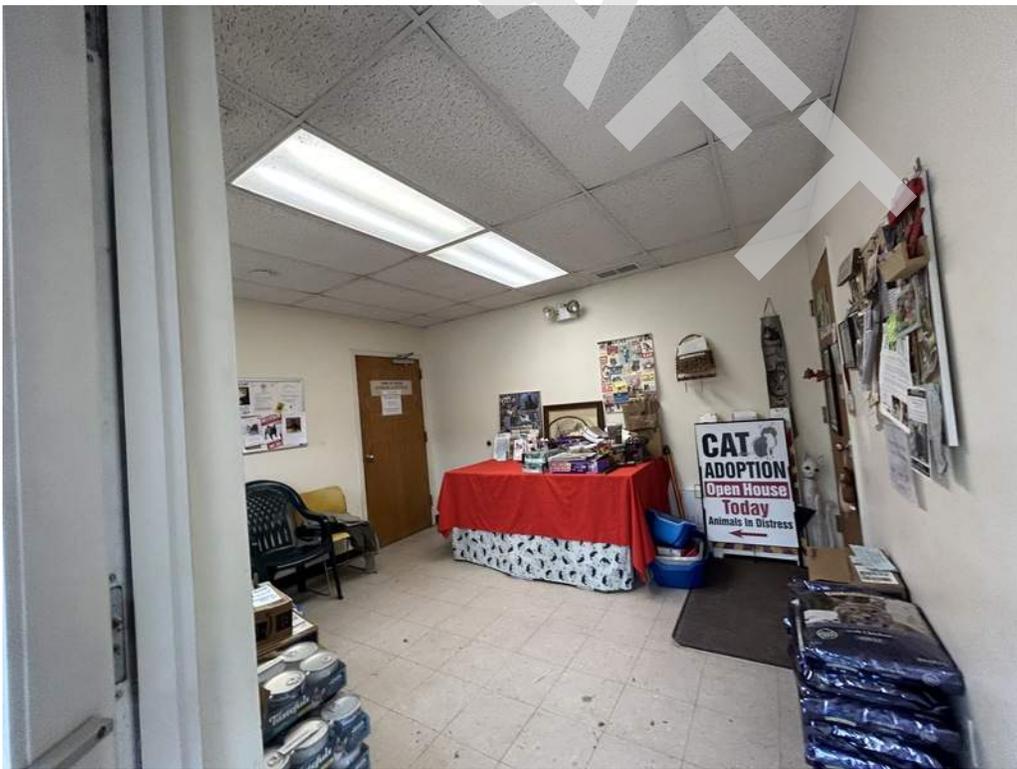
21 - Instances of paint peeling at isolated areas was observed at the facility.

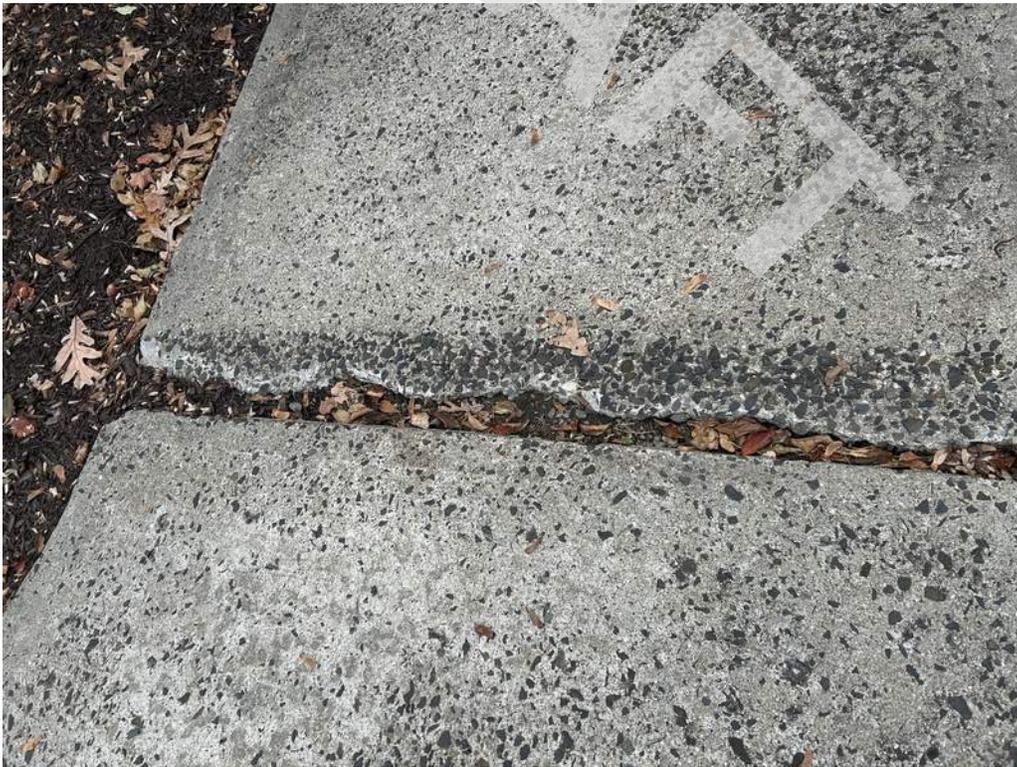
2 - Spalled concrete was observed at localized areas at sidewalks.

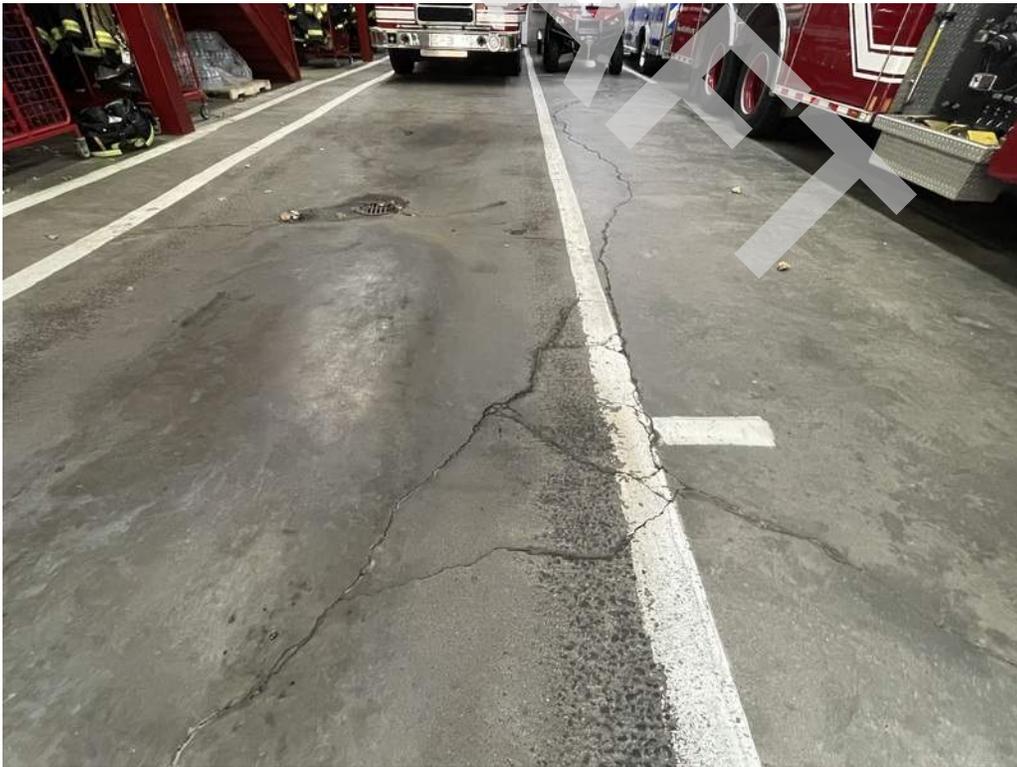
4 - The apparatus room slab on grade is uneven, has spalled, and has continuous cracks.

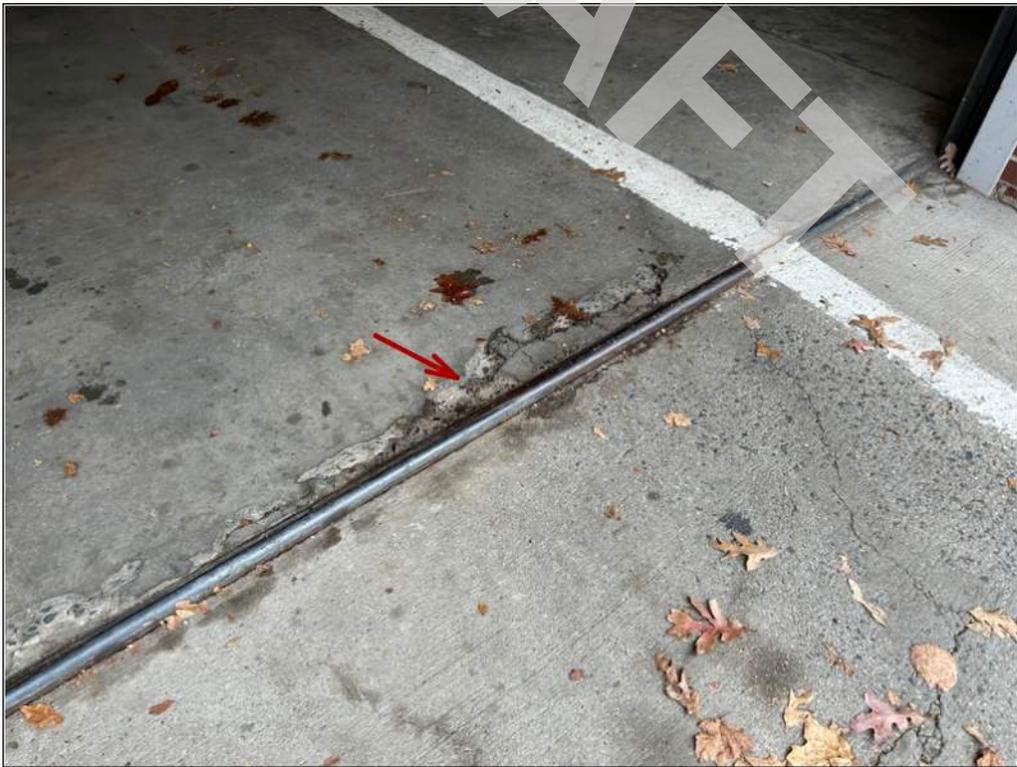
6 - Spalling along the base of an overhead door.
