# FACILITY CONDITION ASSESSMENT

## TOWN OF WILTON – TOWN BUILDINGS

Wilton, Connecticut

Draft: February 2, 2024

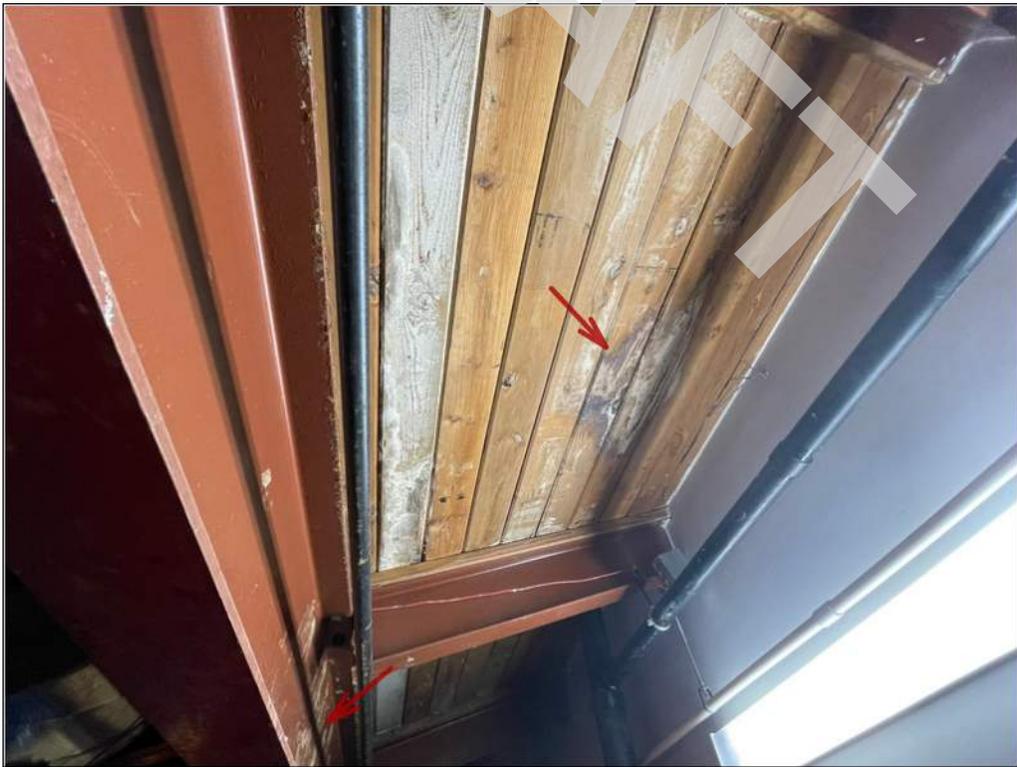
8 - Areas of noted and reported water intrusion at the mezzanine ceiling.

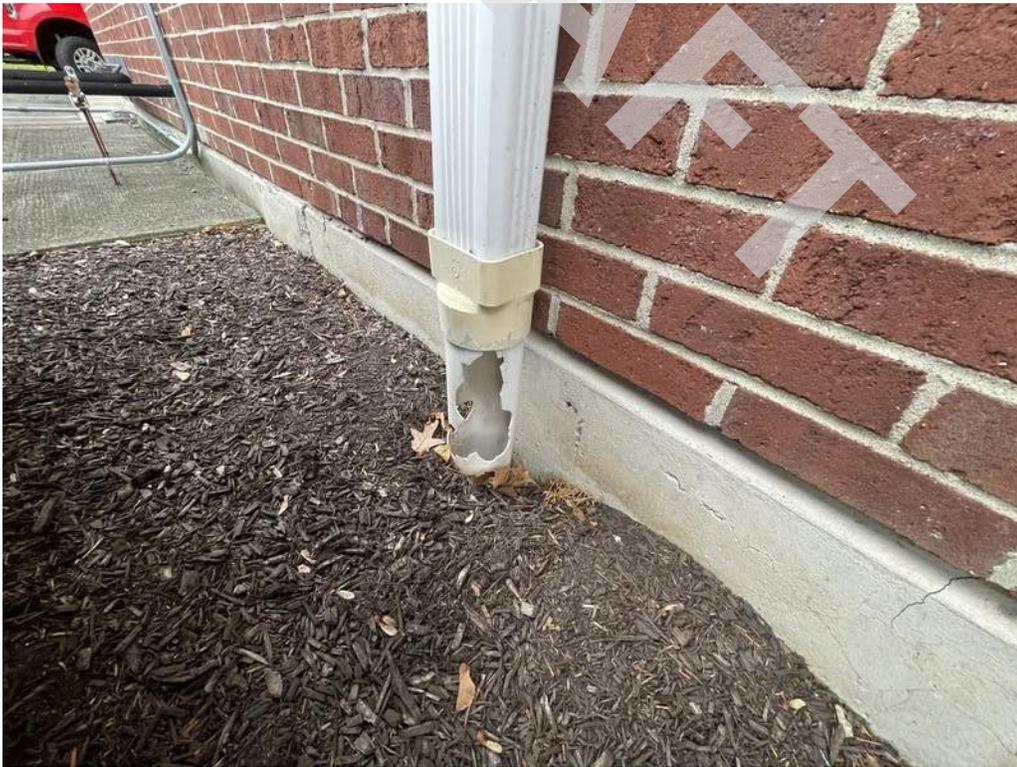
10 - Instances of the roof leader connection to the building's stormwater system are broken.

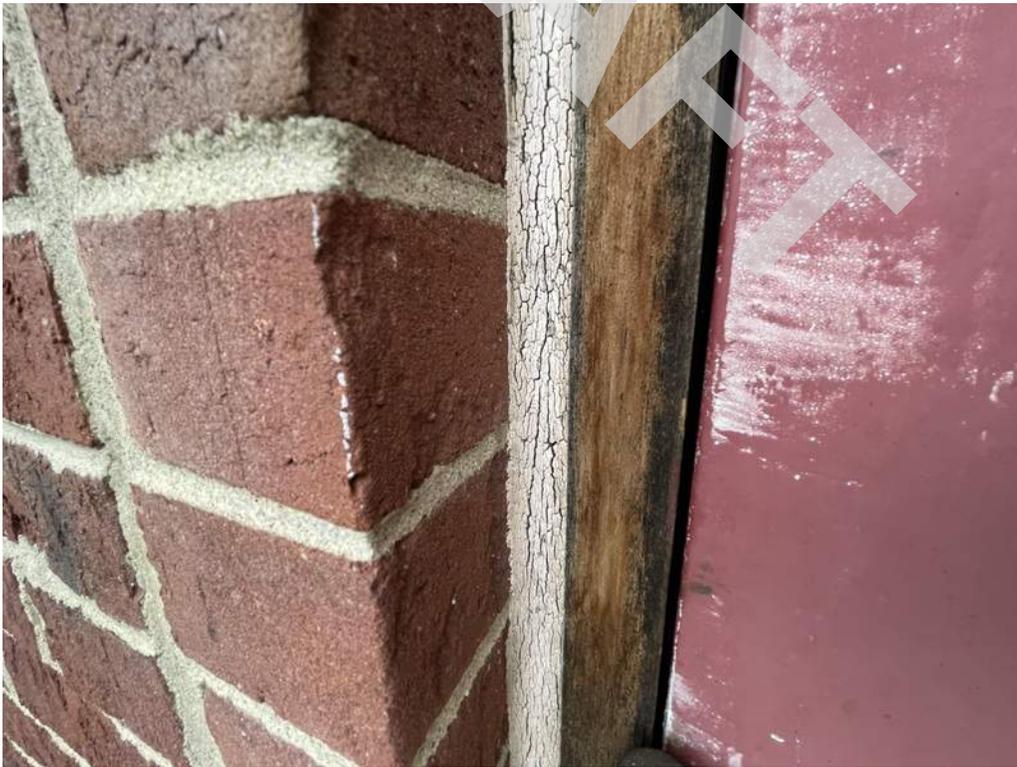
12 - Perimeter joint sealant has failed.

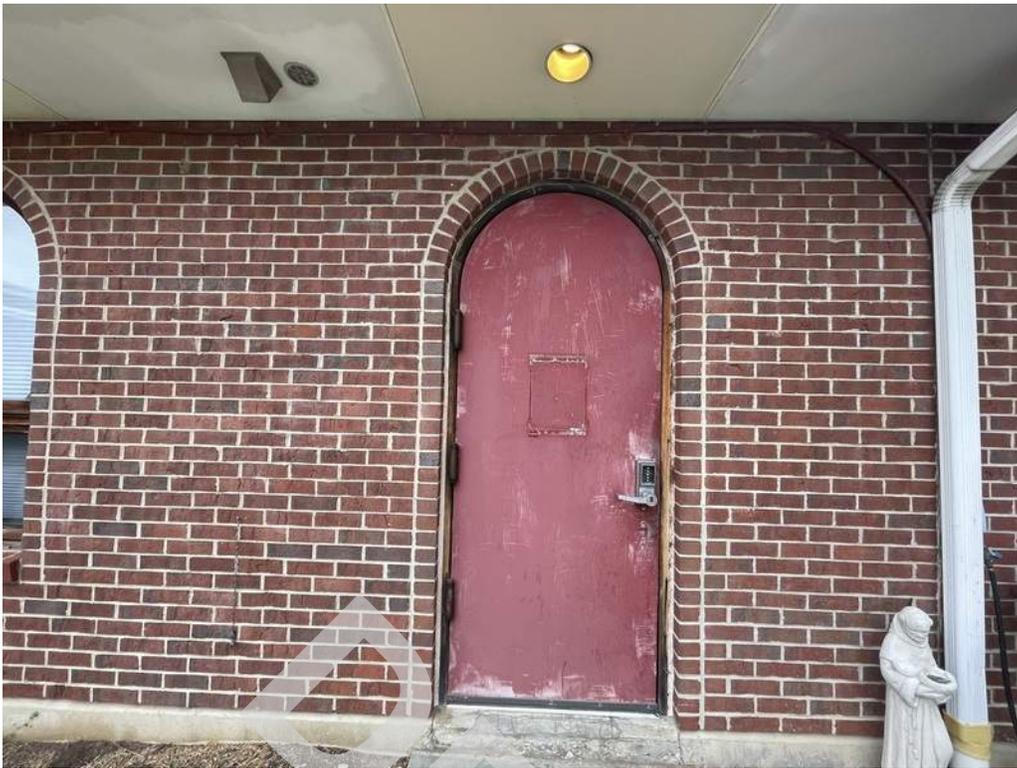
13 - Hollow metal door surface and finishes are in poor condition.

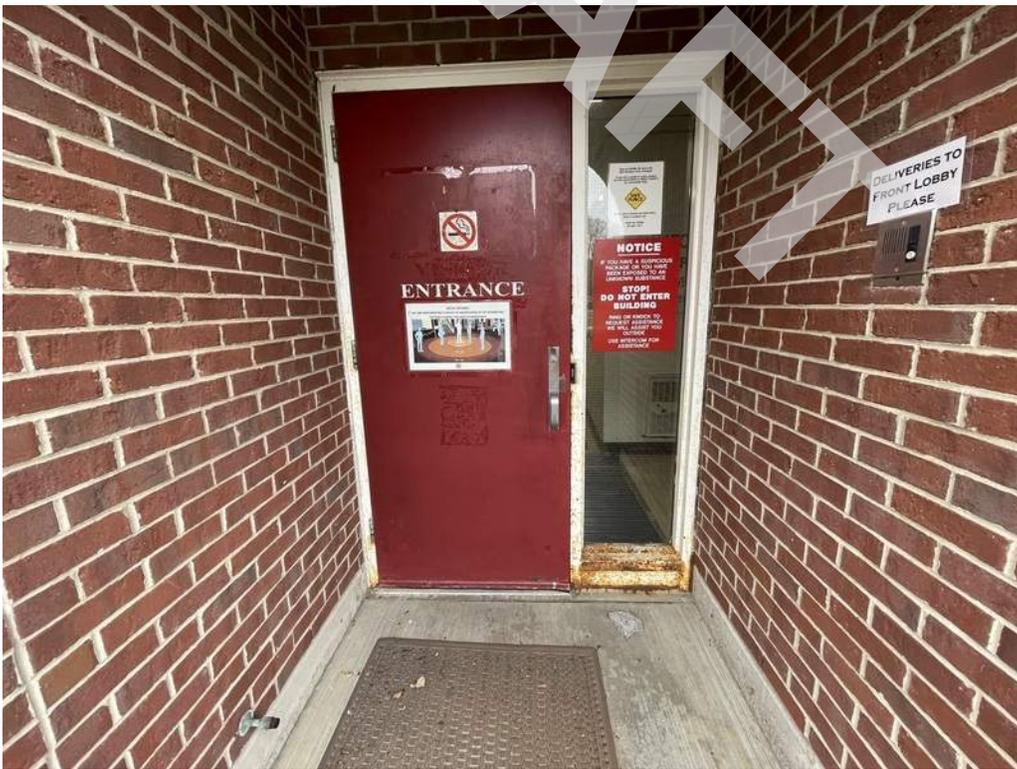
14 - Side light framing has corroded along the bottom. Hollow metal door surfaces are in fair condition.

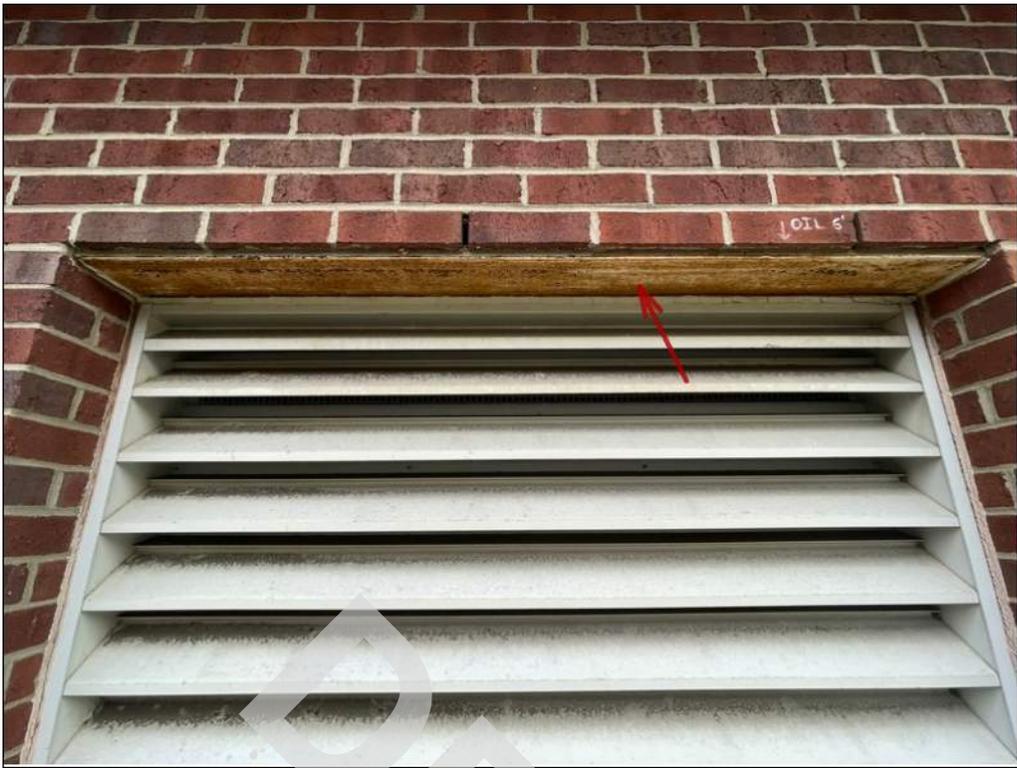
15 - Metal surface of the lintel at the louver opening has corroded.

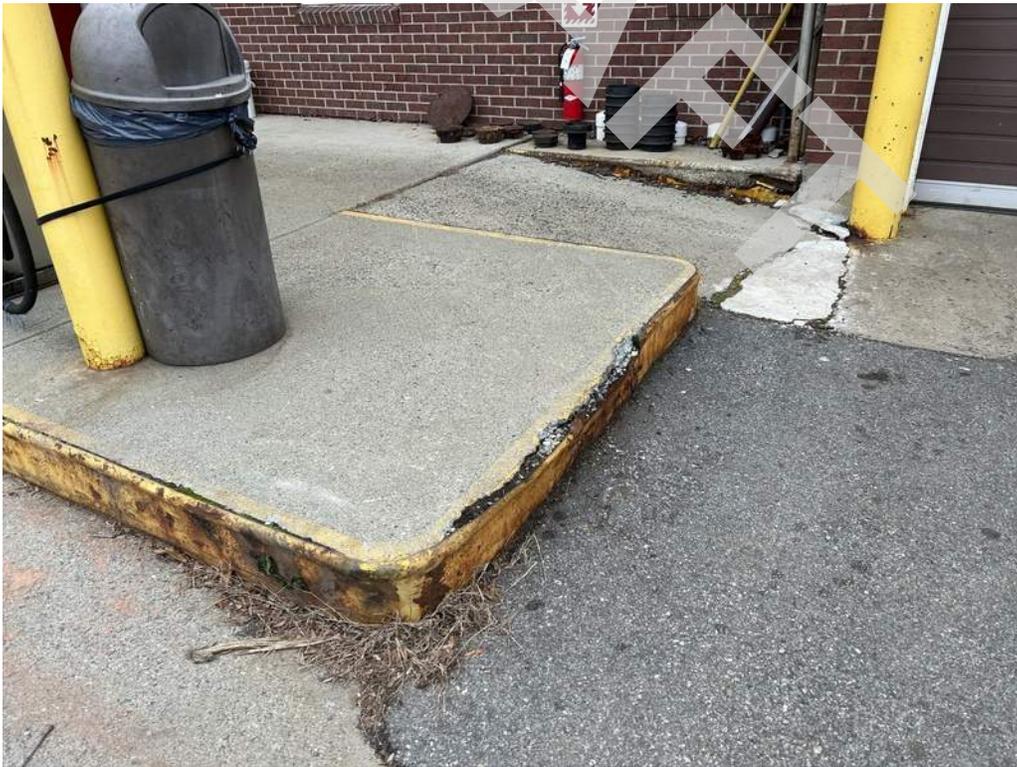
4 - Walkways exhibit concrete spalling and deterioration.

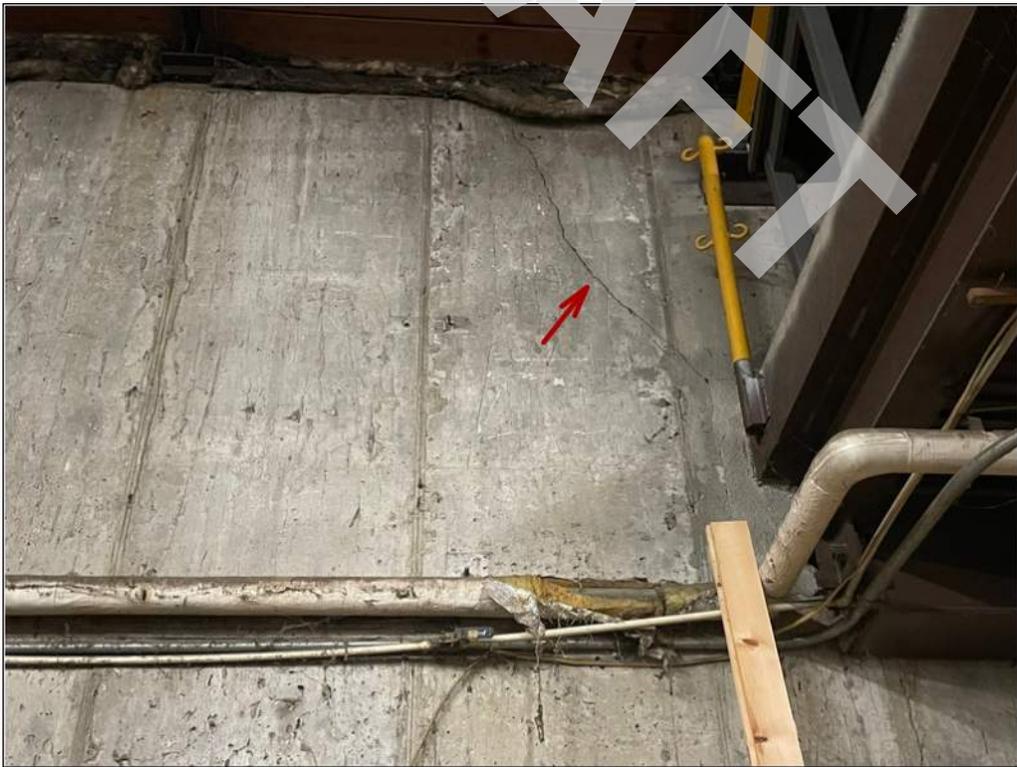
6 - Localized areas of the reinforced concrete wall have cracked.

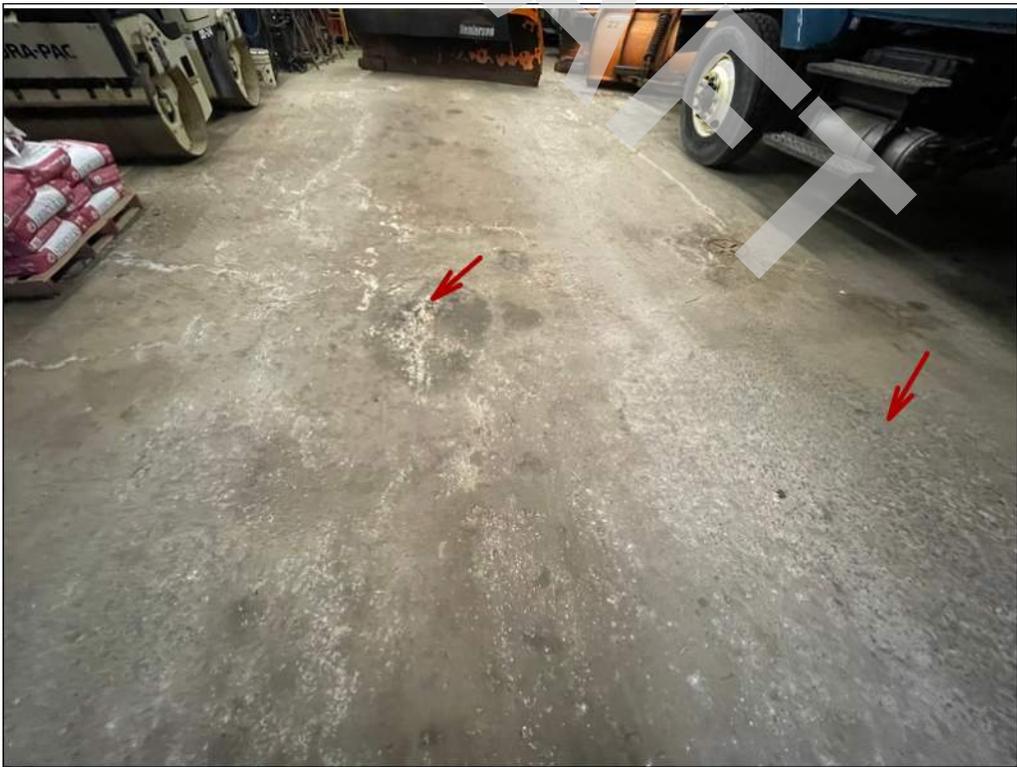
8 - Localized spalling and cracking has occurred along the concrete slab-on-grade.

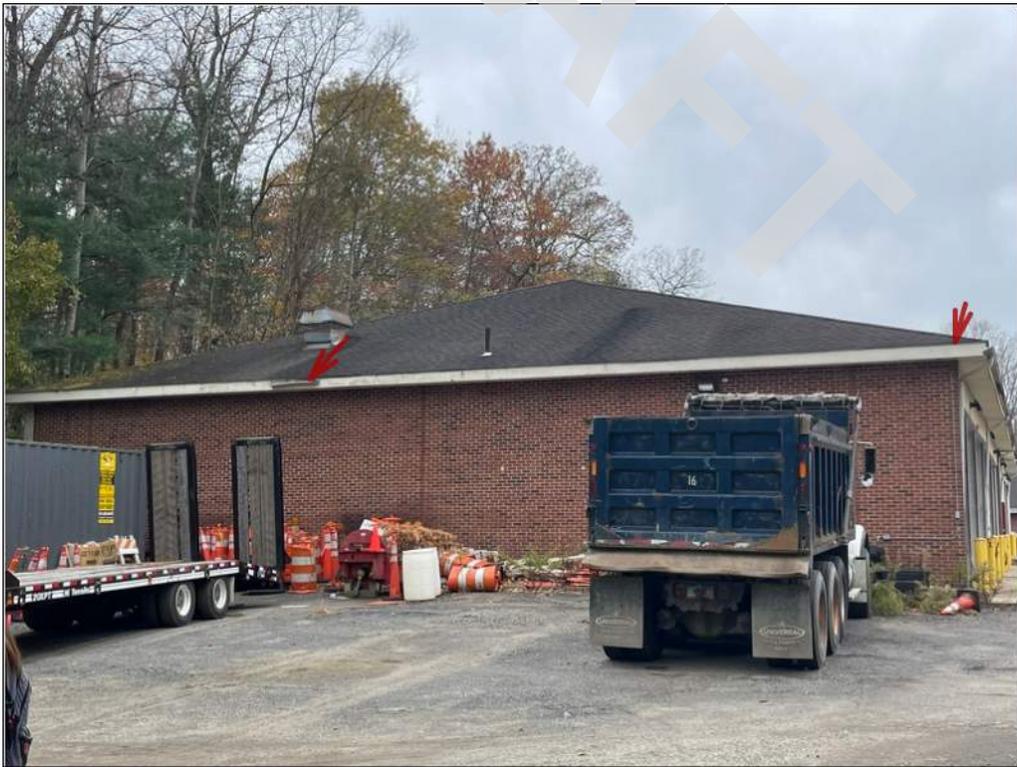
10 - Roof gutter is missing and fascia has damages along the east facade. Roof deficiencies include organic growth and stained asphalt shingles.

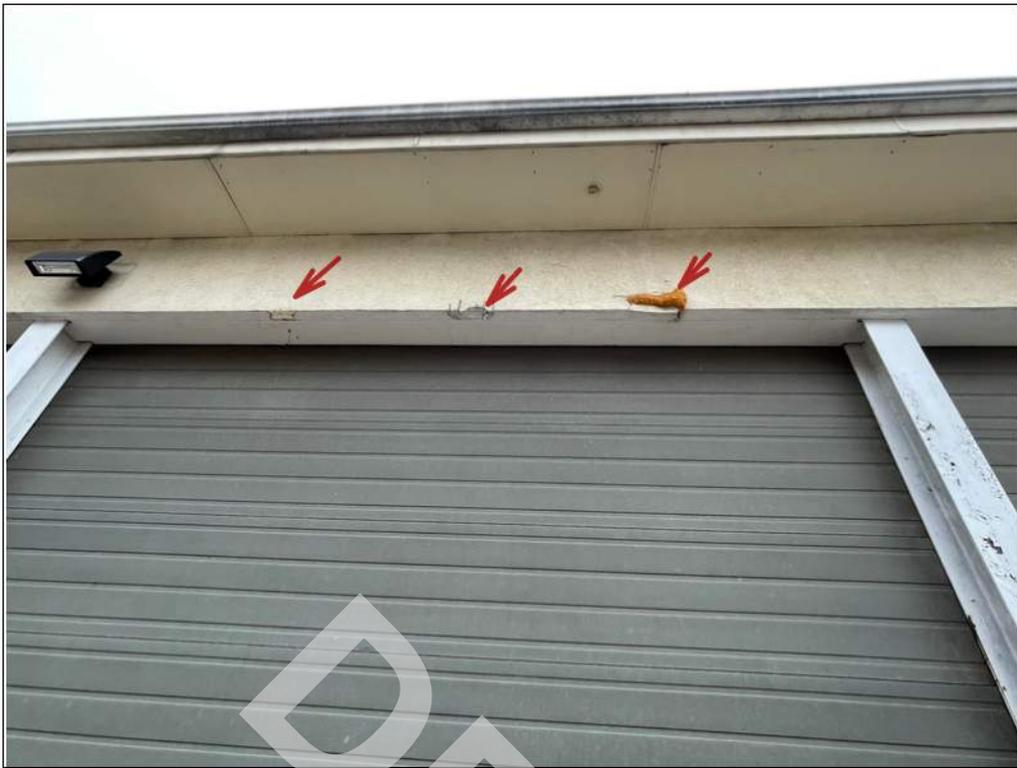
15 - Areas of the EIFS (exterior insulation finishing system) have been damaged.

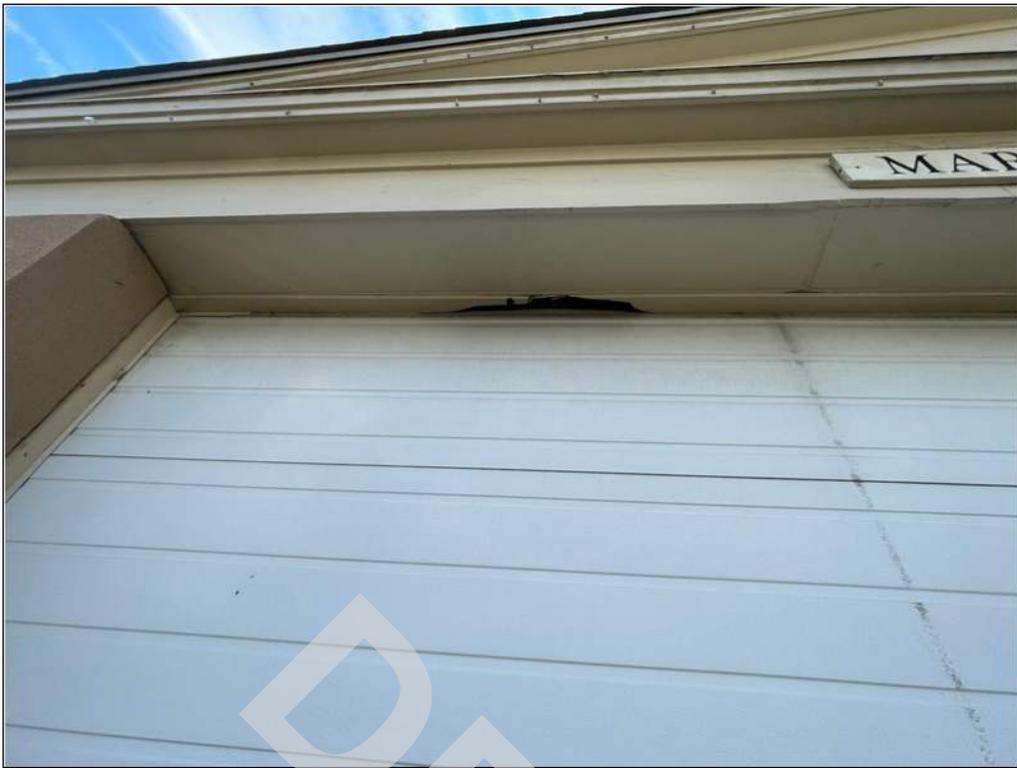
11 - Trim portions along the apparatus room door have broken.

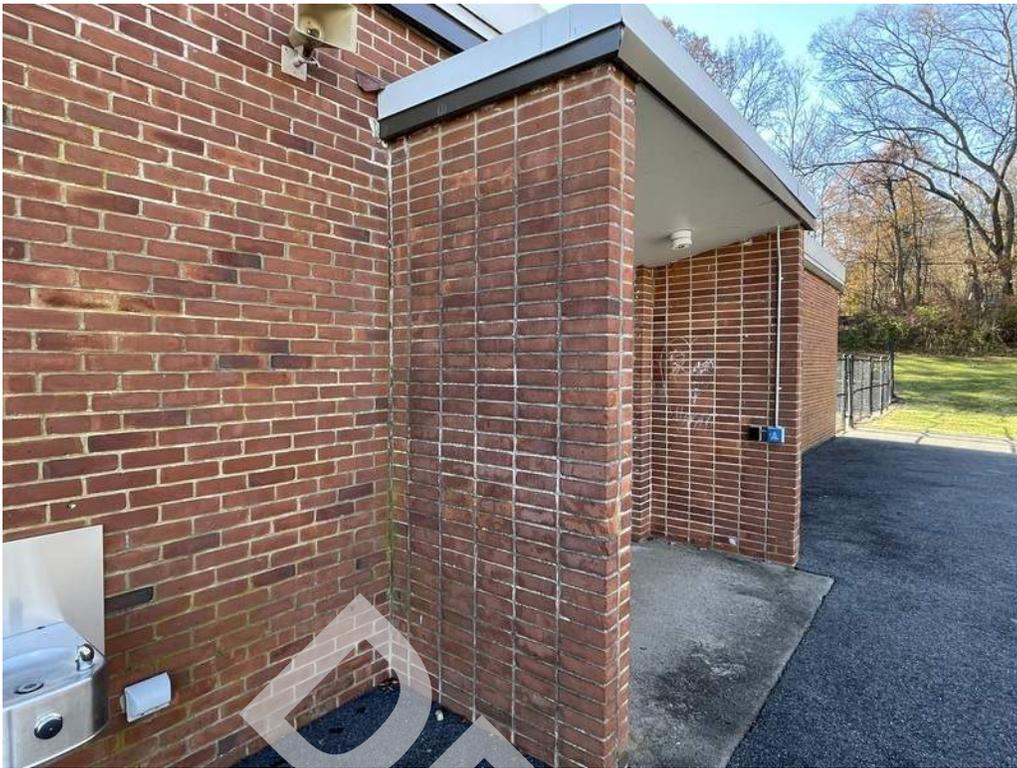
13 - Areas of the brick masonry unit wall have organic growth and deterioration at the mortar joints.

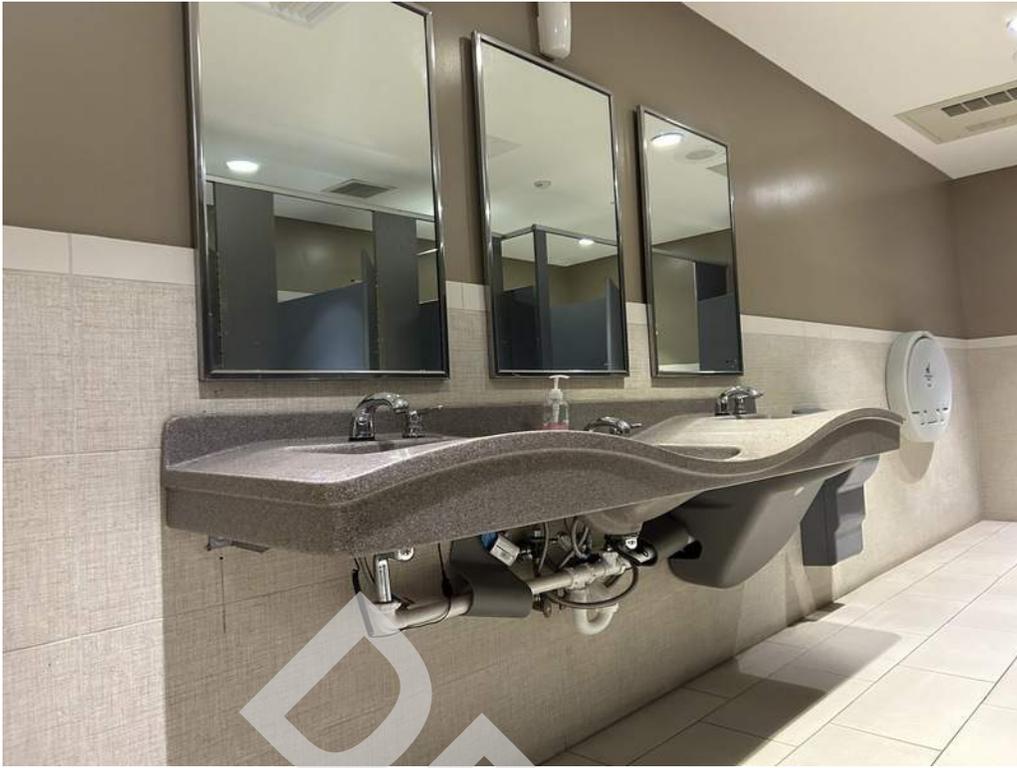
39 - Scald guard protection is not provided under the sinks.

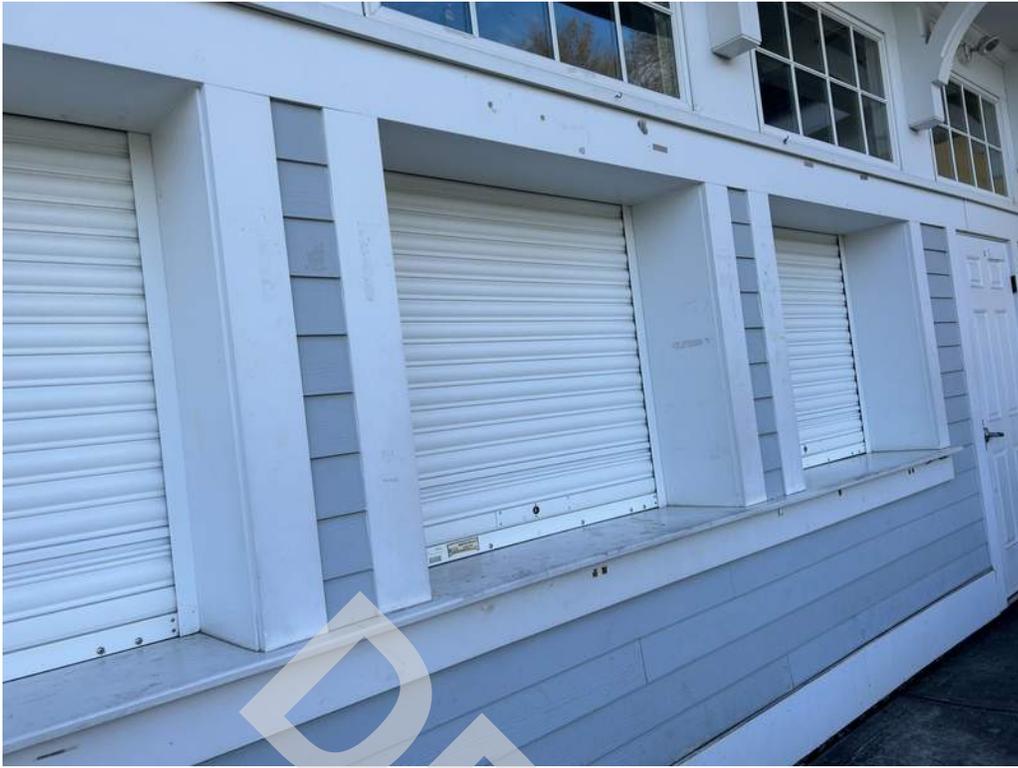
11 - A lowered counter area is not provided at the concession stand.

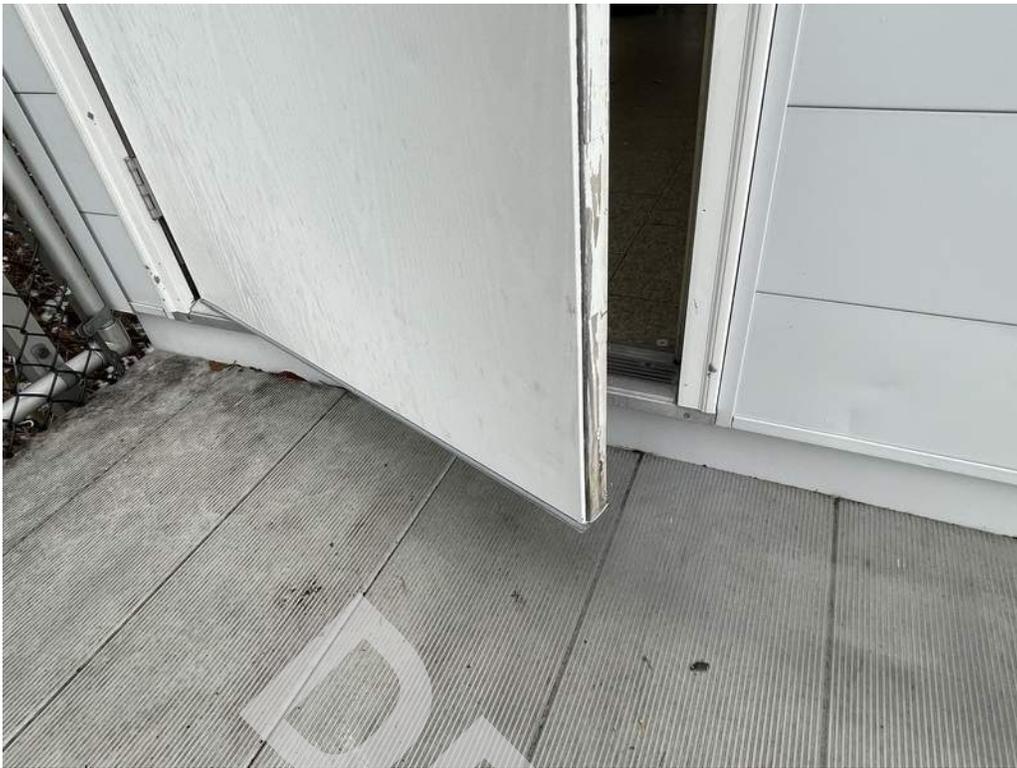
17 - Press box wood door surfaces are deteriorating.
