# FACILITY CONDITION ASSESSMENT

## TOWN OF WILTON – TOWN BUILDINGS

Wilton, Connecticut

Draft: February 2, 2024

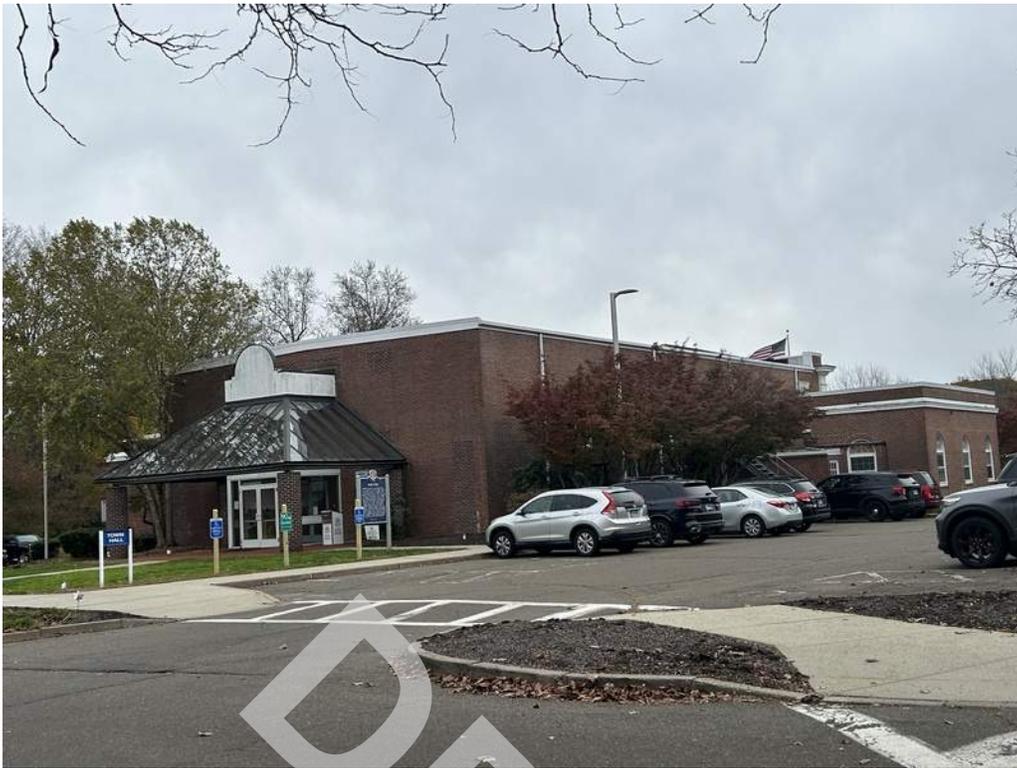
1 - Overview of the building.

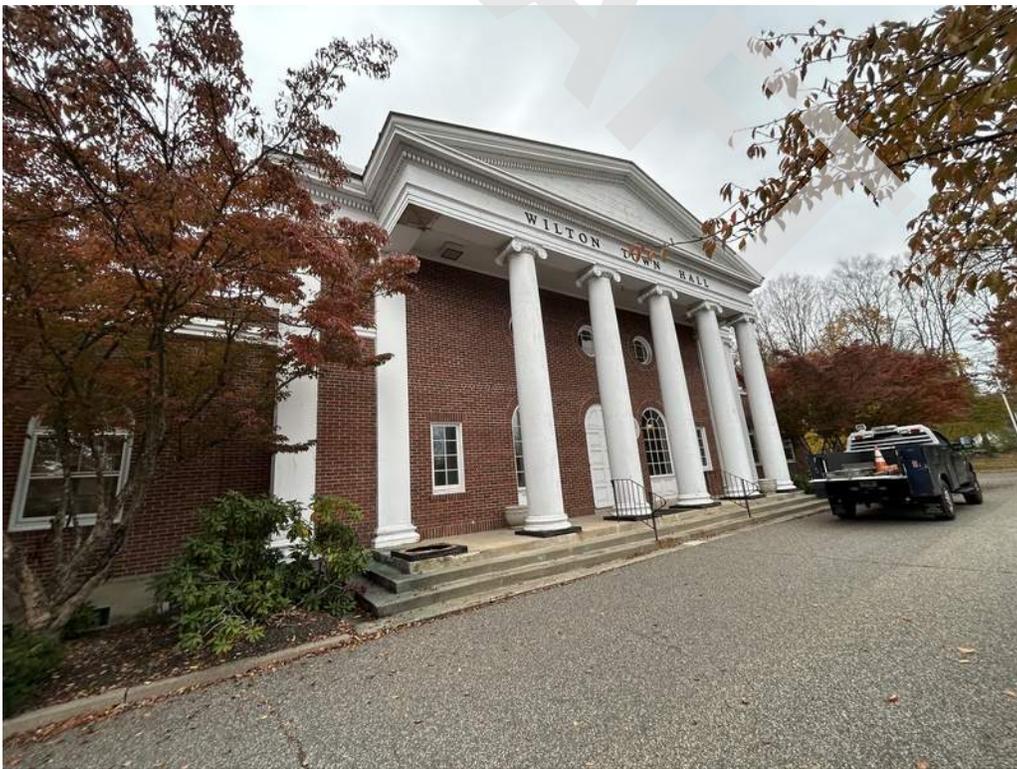
2 - Main entrance into the building is provided on the west side.

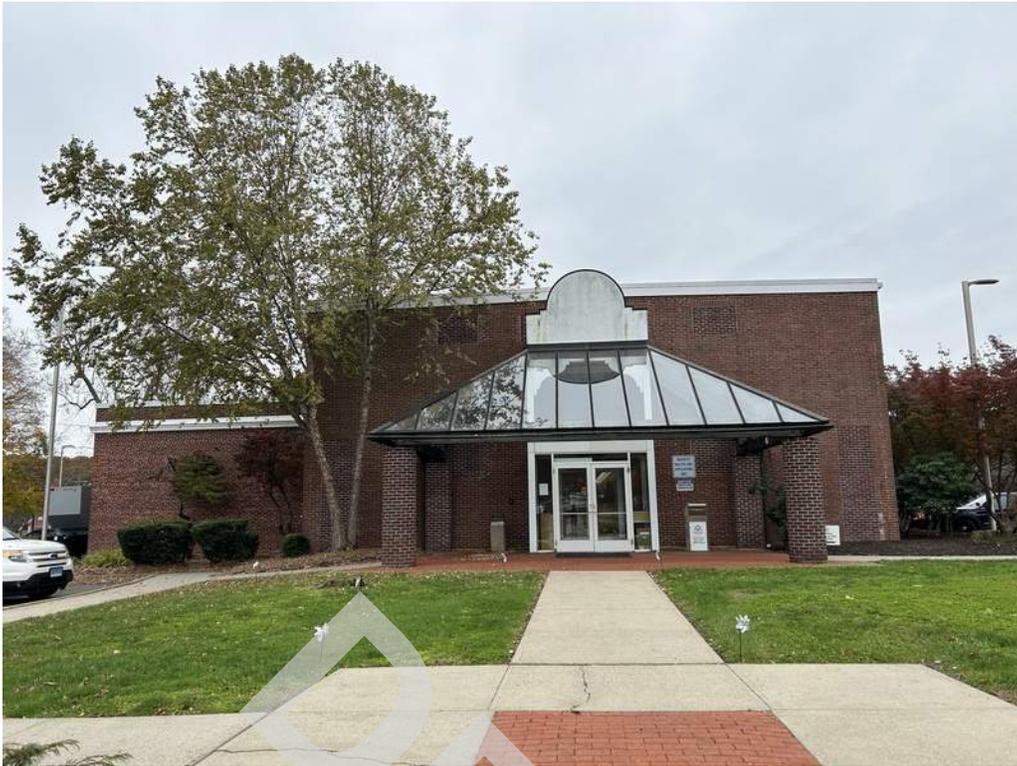
3 - A secondary entrance into the building is provided on the east side. Sidewalks consist of a combination of cast-in-place concrete and bricks.

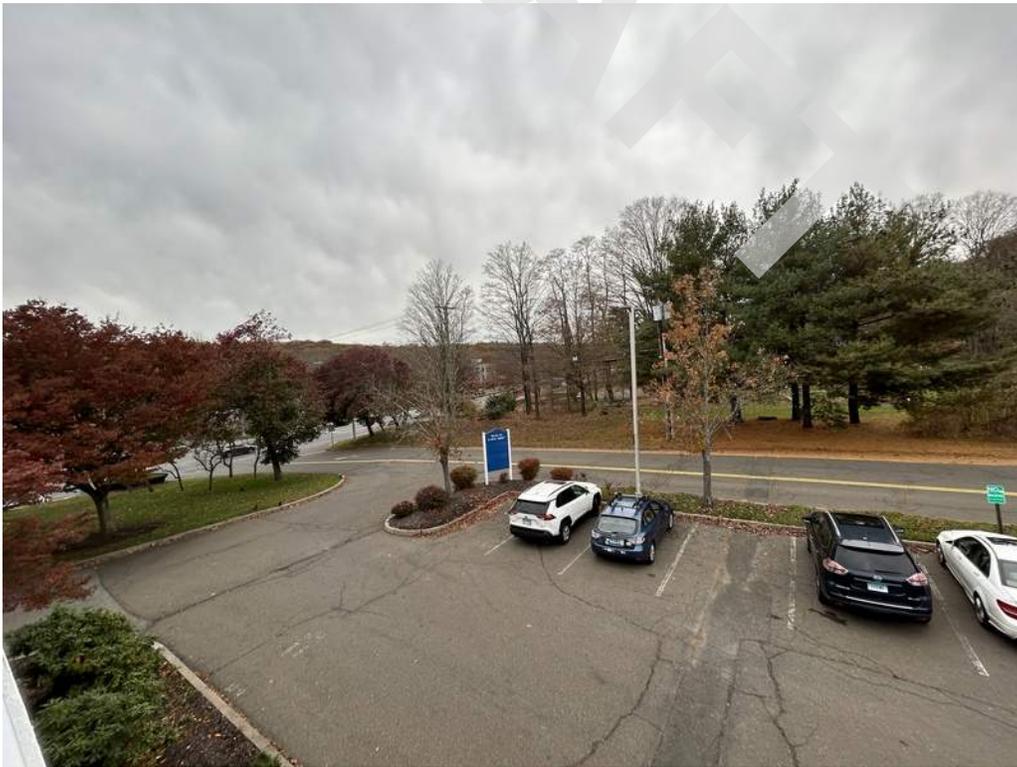
4 - Main vehicular access to the site is provided via a two-way curb cut off Danbury Road. Wayfinding signage is provided along the main drive lane. Site improvements consist of asphalt paved drive lanes and parking areas and landscaping.

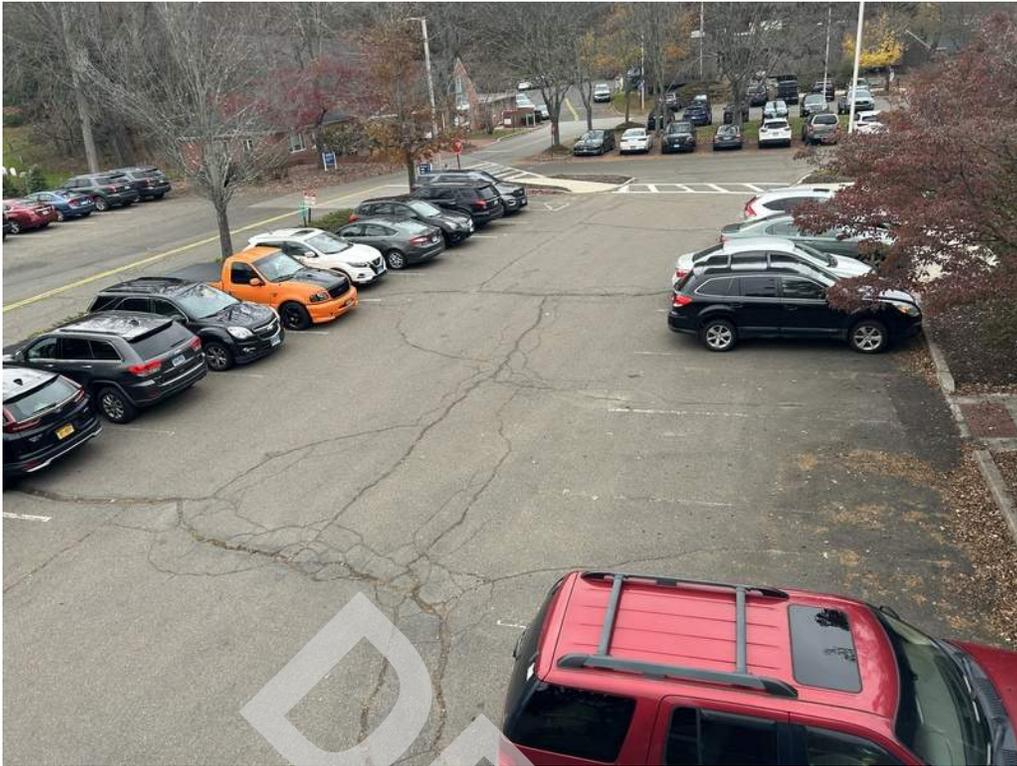
5 - Parking is provided along the north side of the building. Faded striping and alligator and longitudinal cracking was observed throughout the paved parking areas and drive lanes.

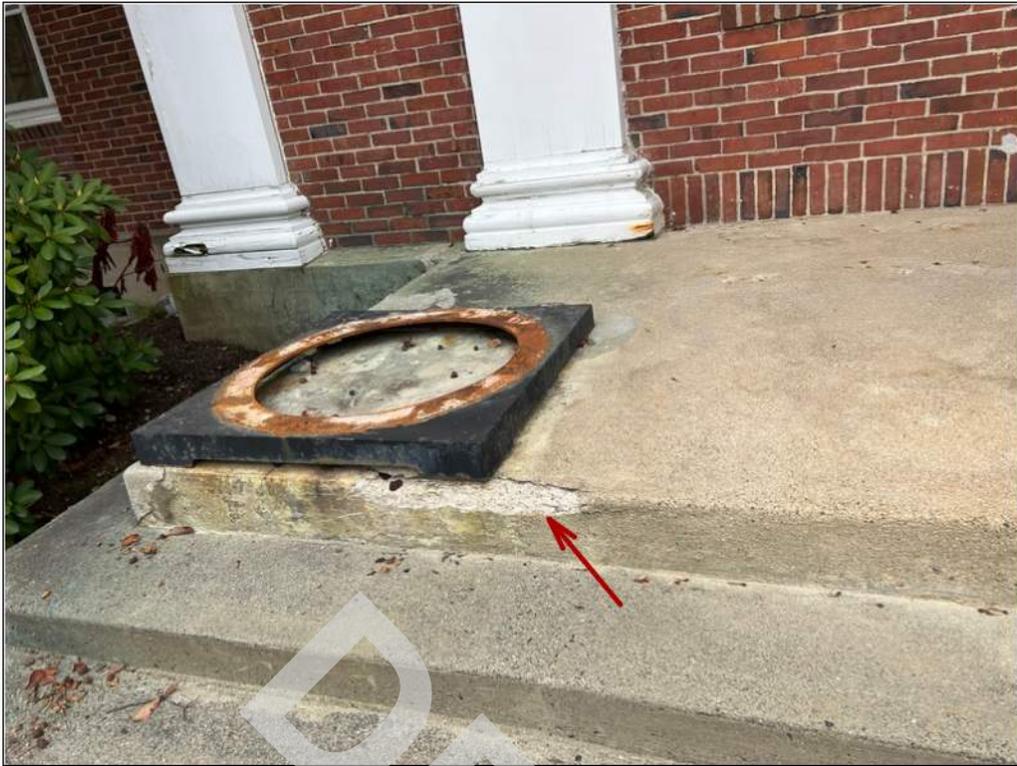
11 - Reinforced concrete at the main entrance plinth has spalled.

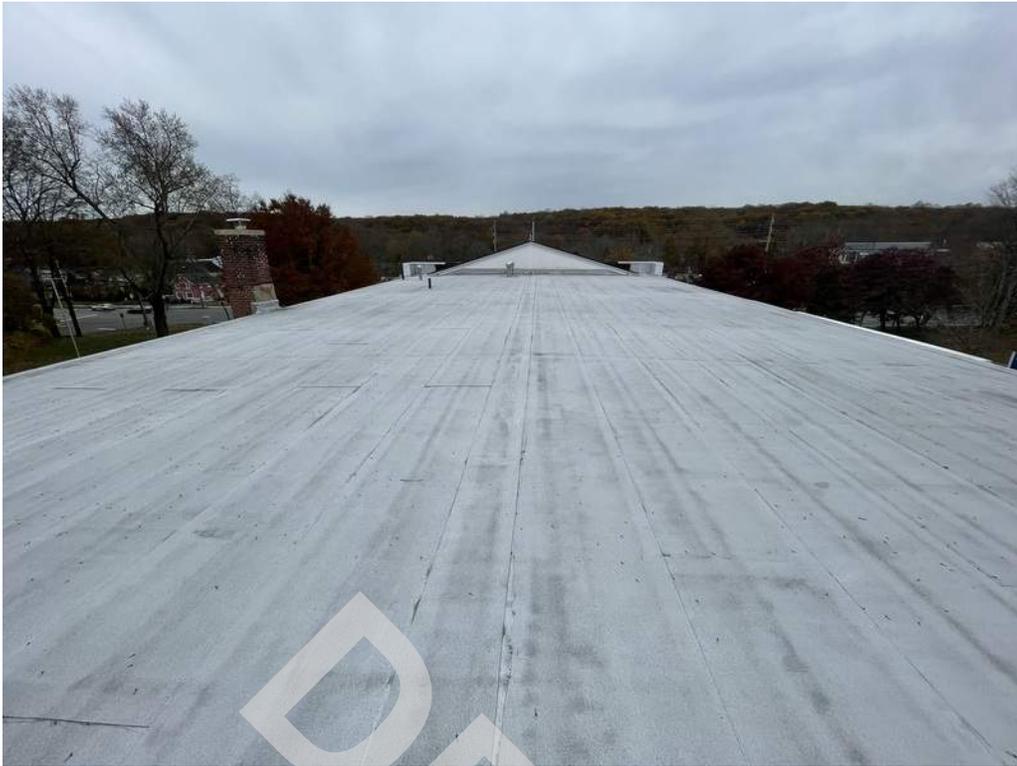
13 - Main roof consist of a modified bitumen roofing system.

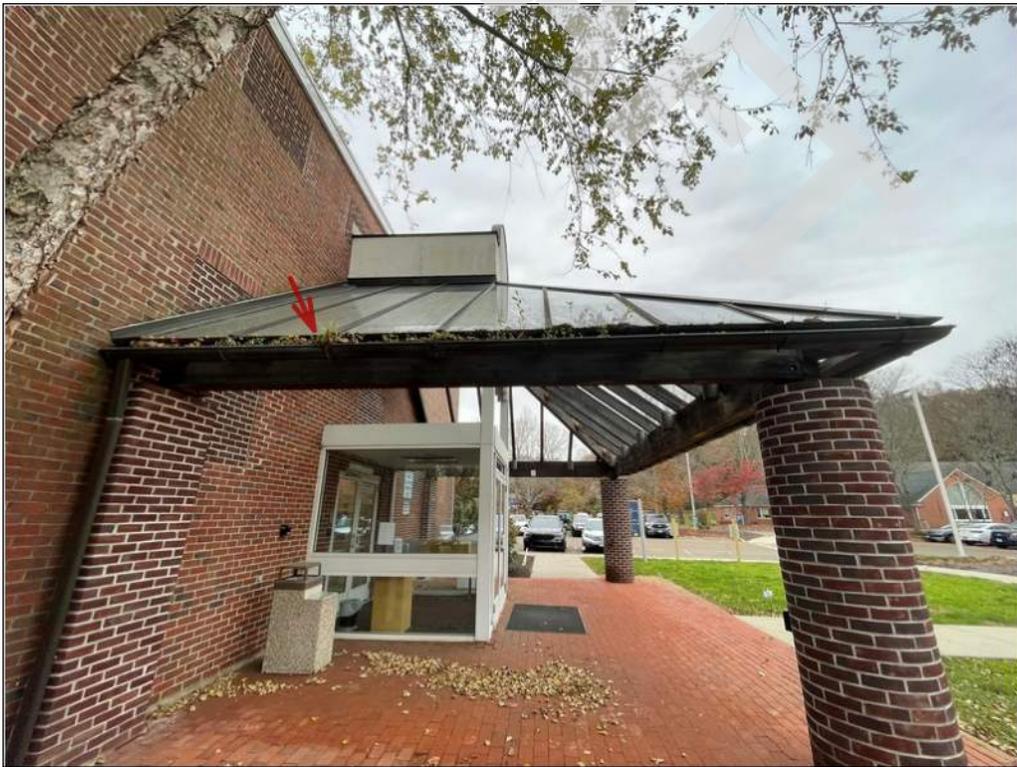
14 - Vegetation and debris accumulation at the roof gutters.

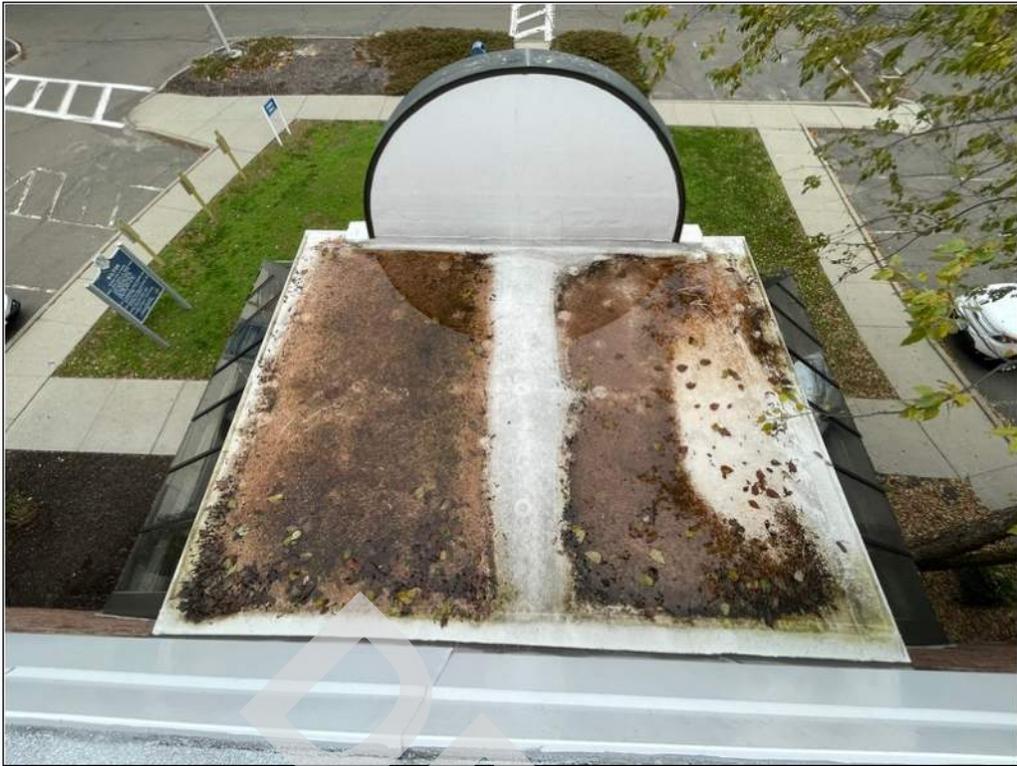
15 - Debris accumulation and water ponding at the low roof over the secondary building entrance.

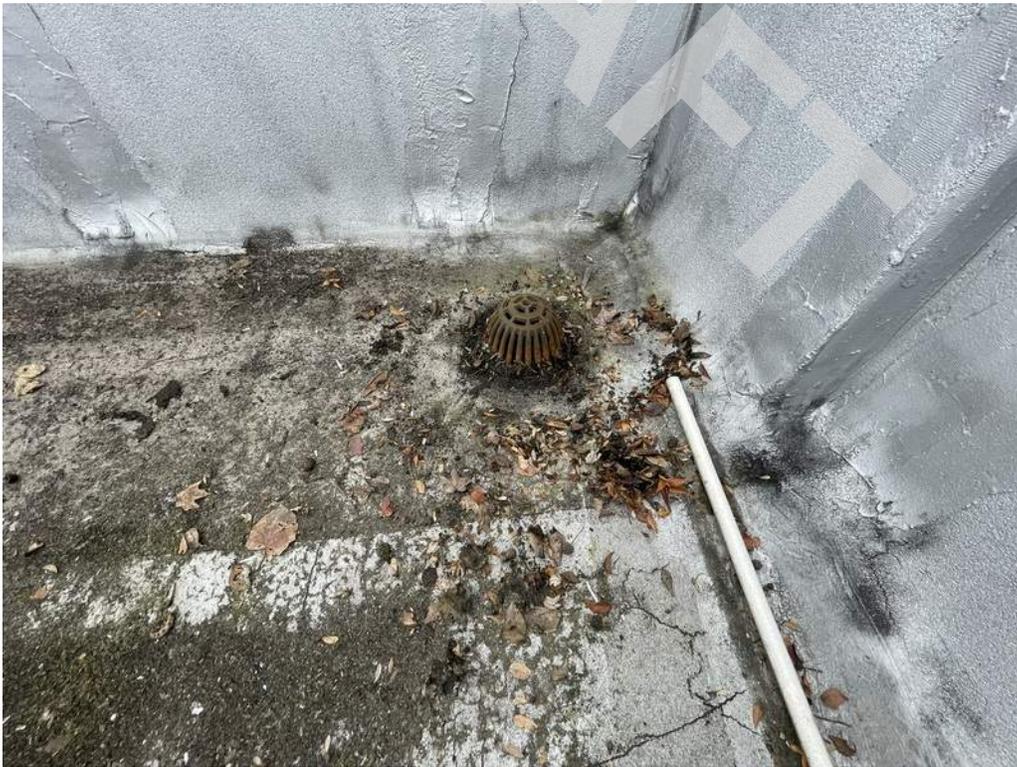
16 - Debris accumulation and organic growth around the lower roof.

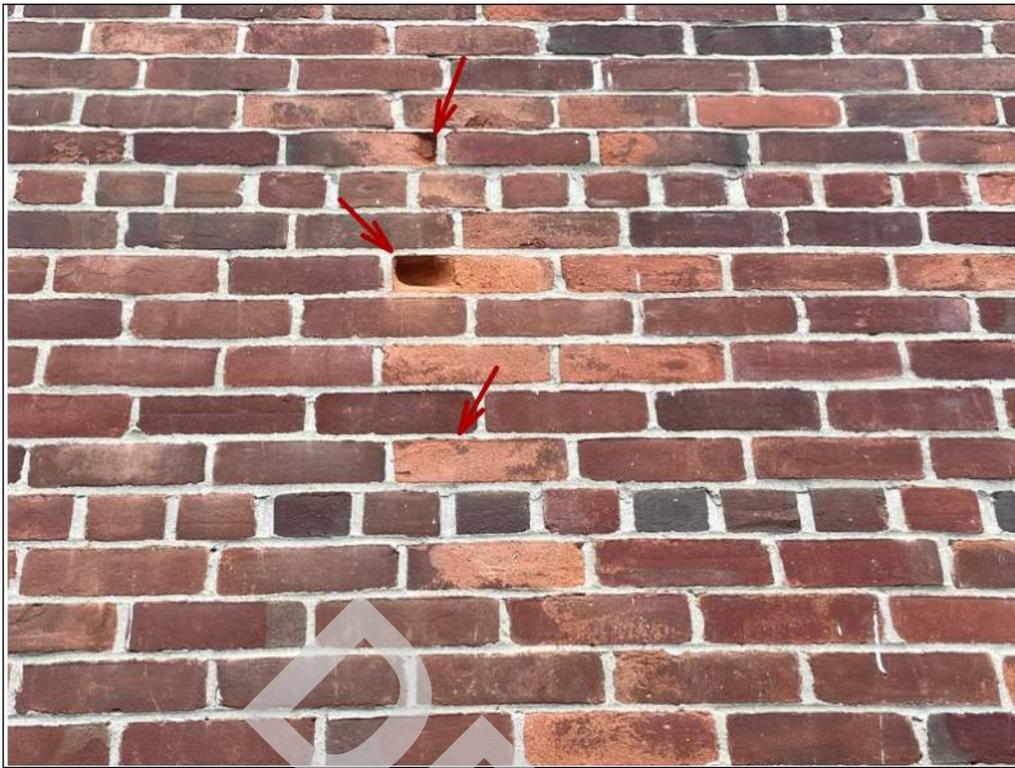
17 - Localized areas of the brick masonry unit facade have spalled units.

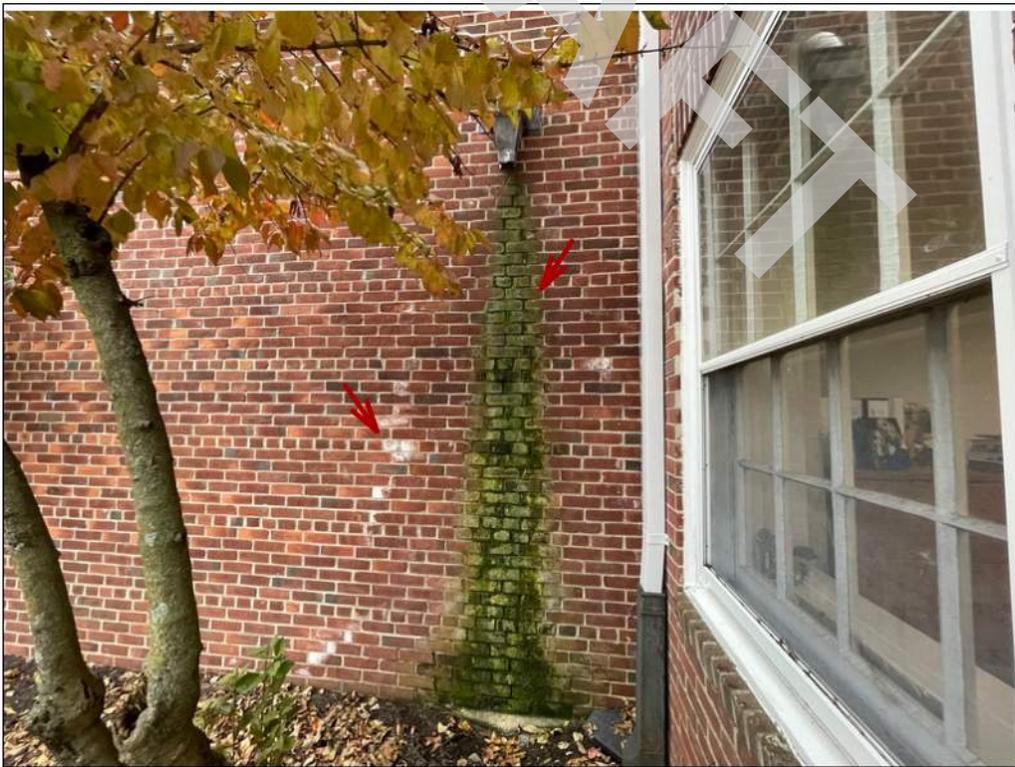
18 - Areas of the brick masonry facade have efflorescence and organic growth. Roof leader is missing.

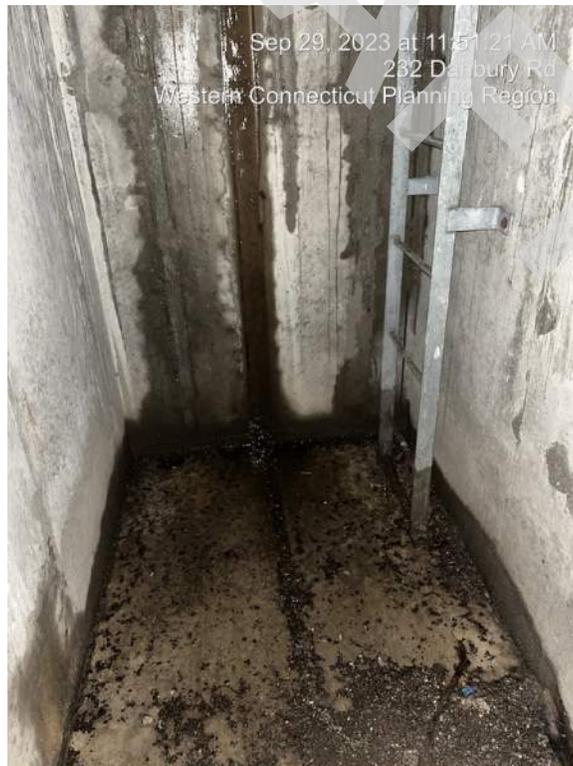
20 - Water intrusion at the bottom of the hatchway.

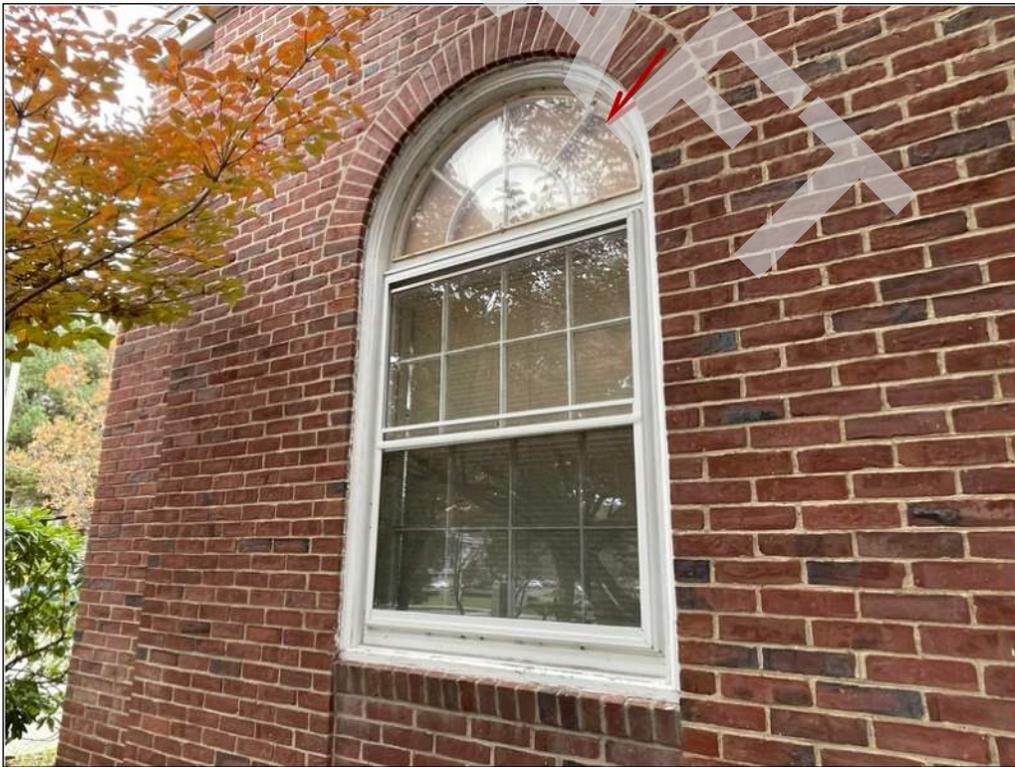
22 - Most of the window units have been covered with a plastic screen on the exterior.

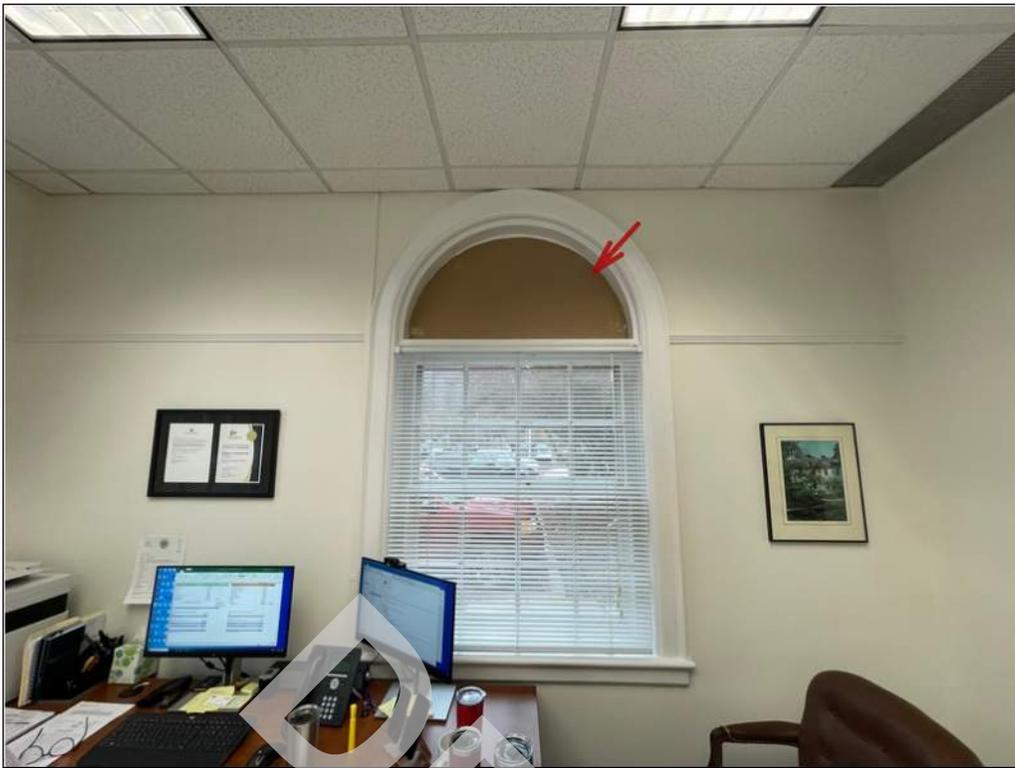
23 - A portion of the window units have been covered with cardboard.

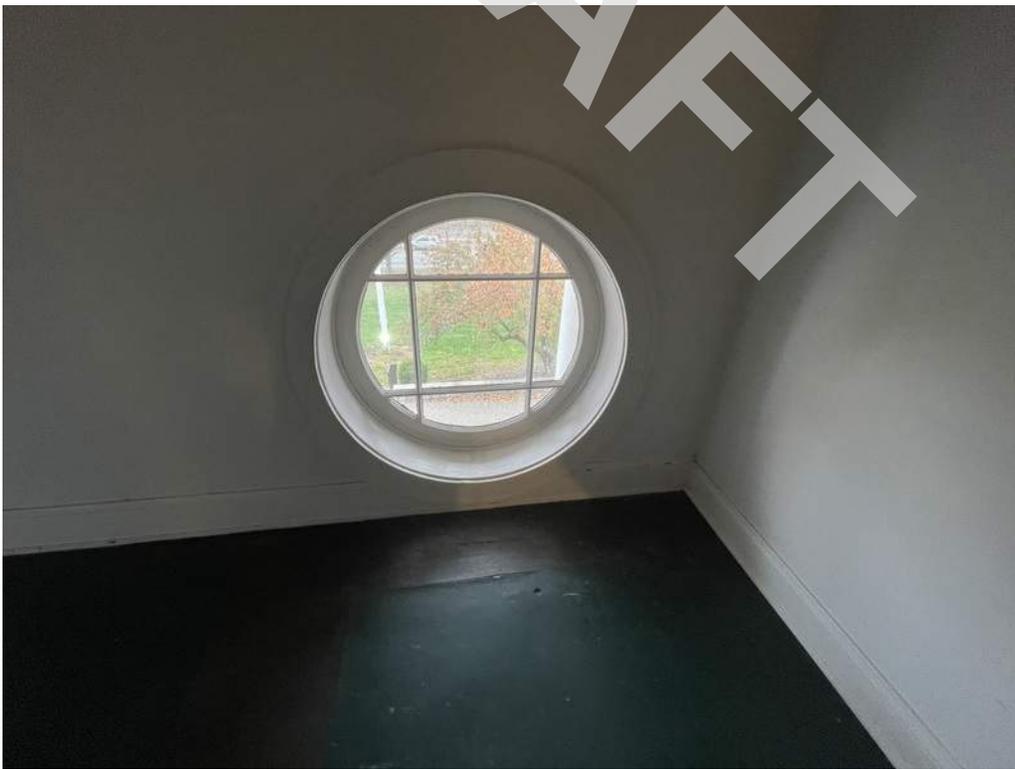
24 - Round windows along the front facade do not appear to include safety glazing.

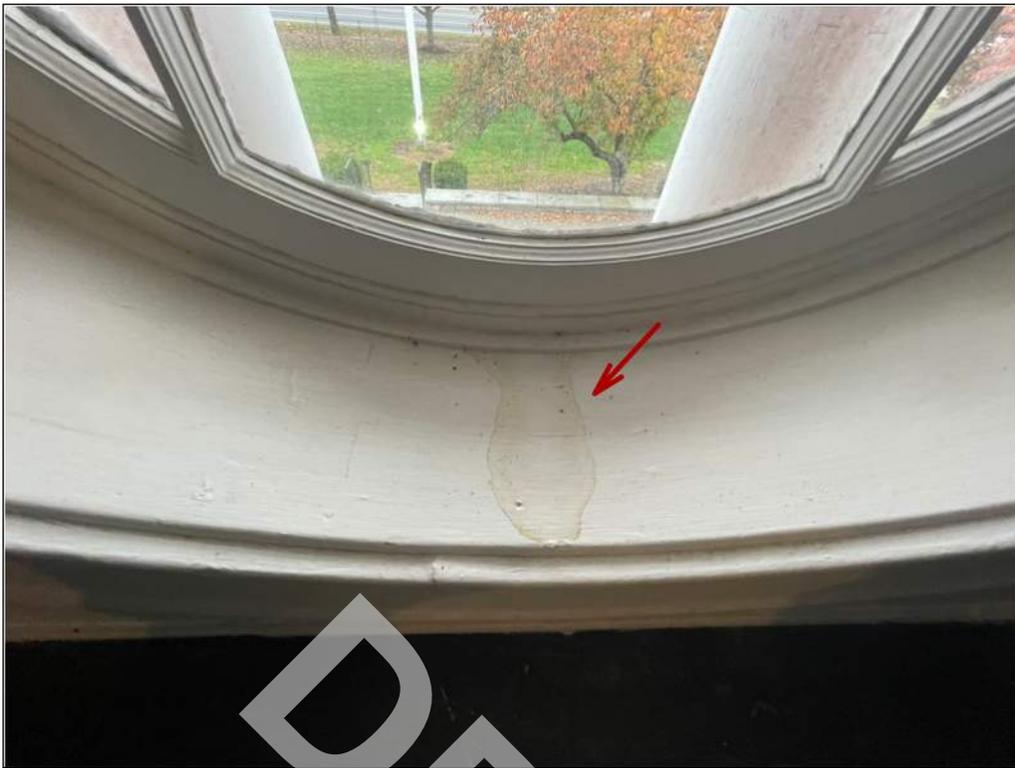
25 - Signs of water intrusion through the round windows along the main facade. Windows are single pane glass units with no safety glazing.

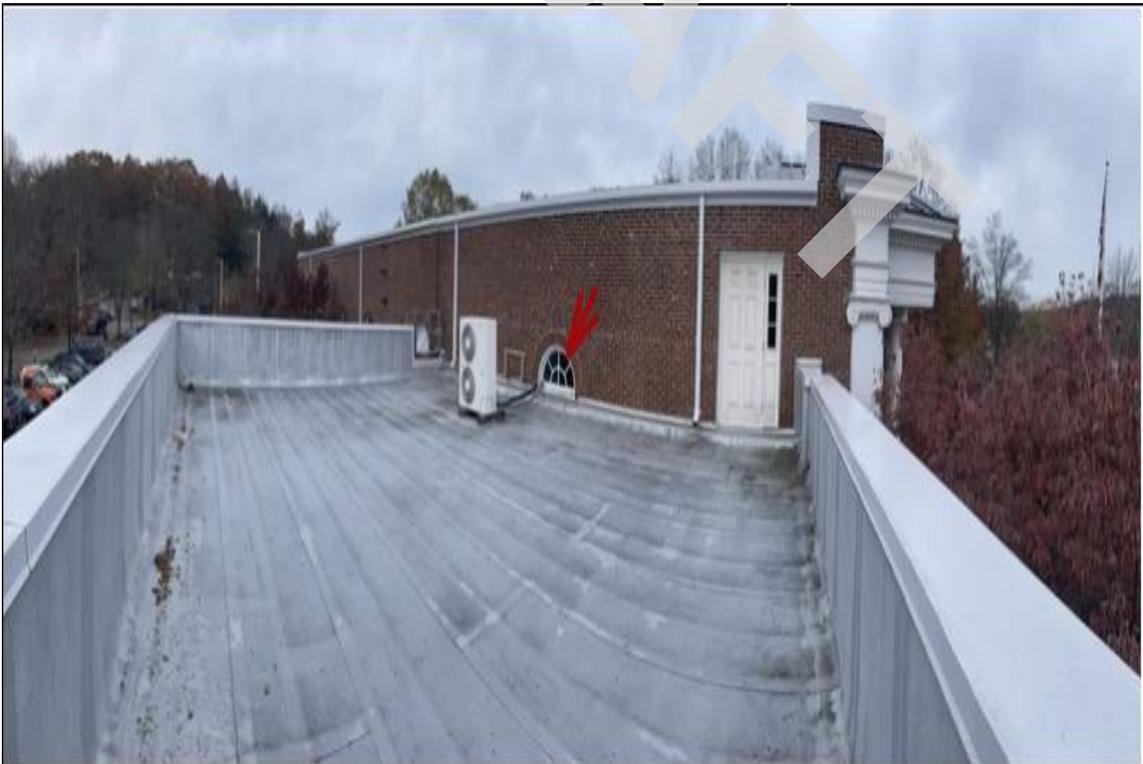
26 - The window along the north facade does not provide light or views to a usable space.

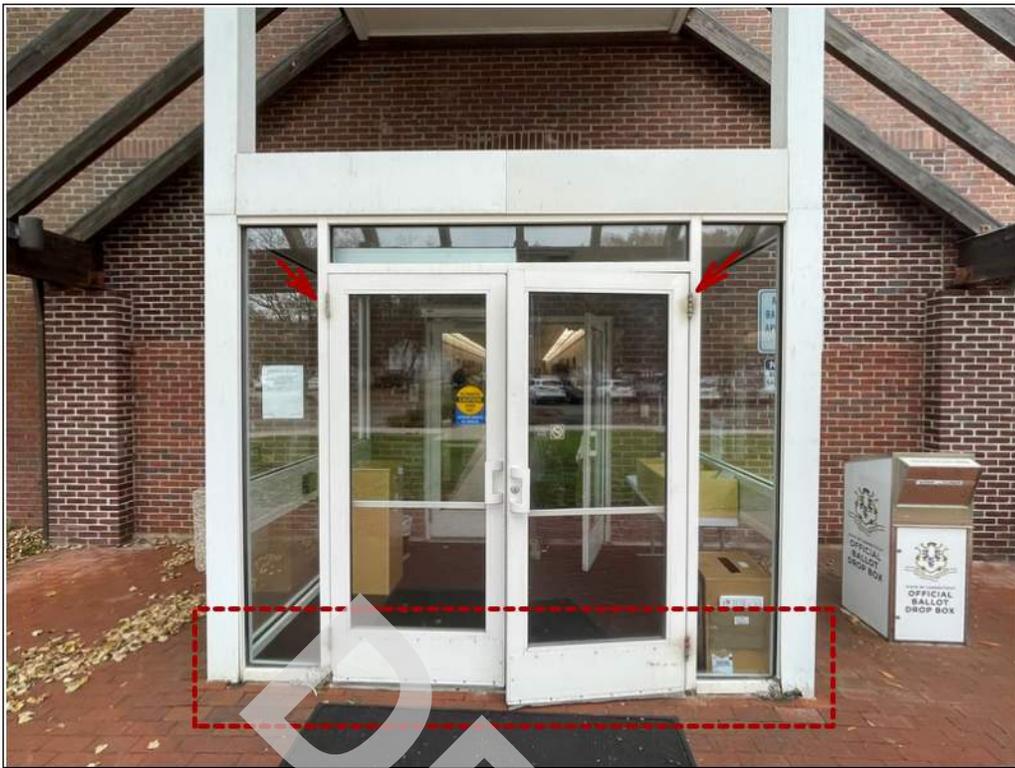
27 - The rear entrance storefront system has deteriorated. Damages include corrosion at the hinges and storefront framing along the base.

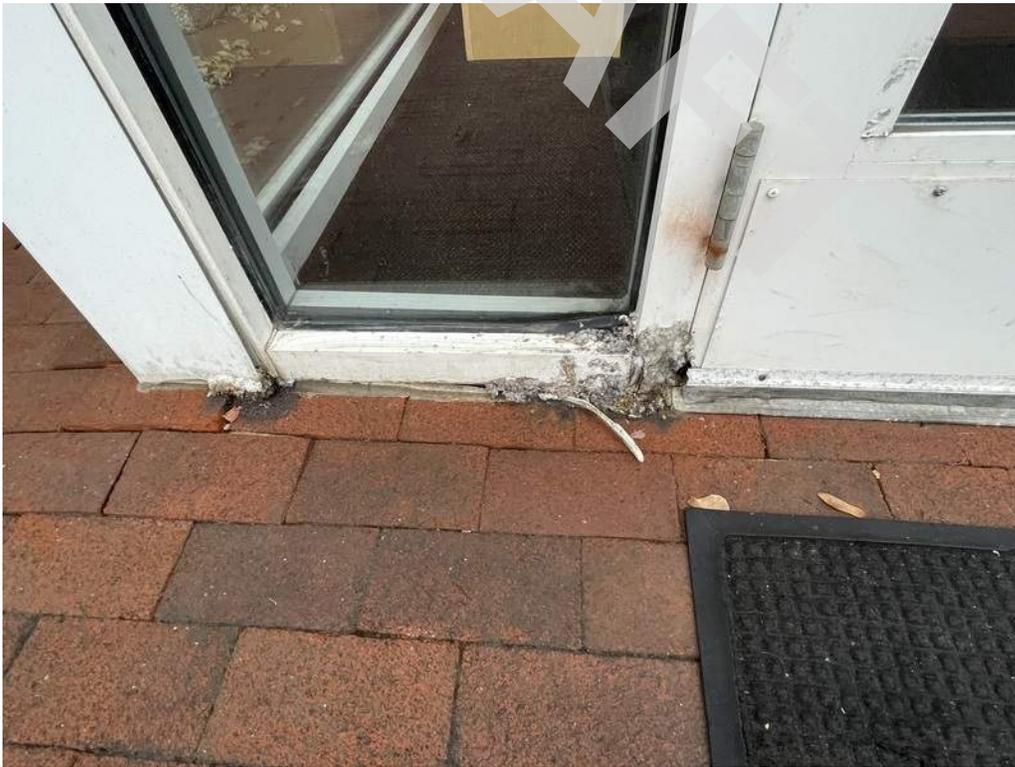
28 - Close up view of the corroded storefront framing components.

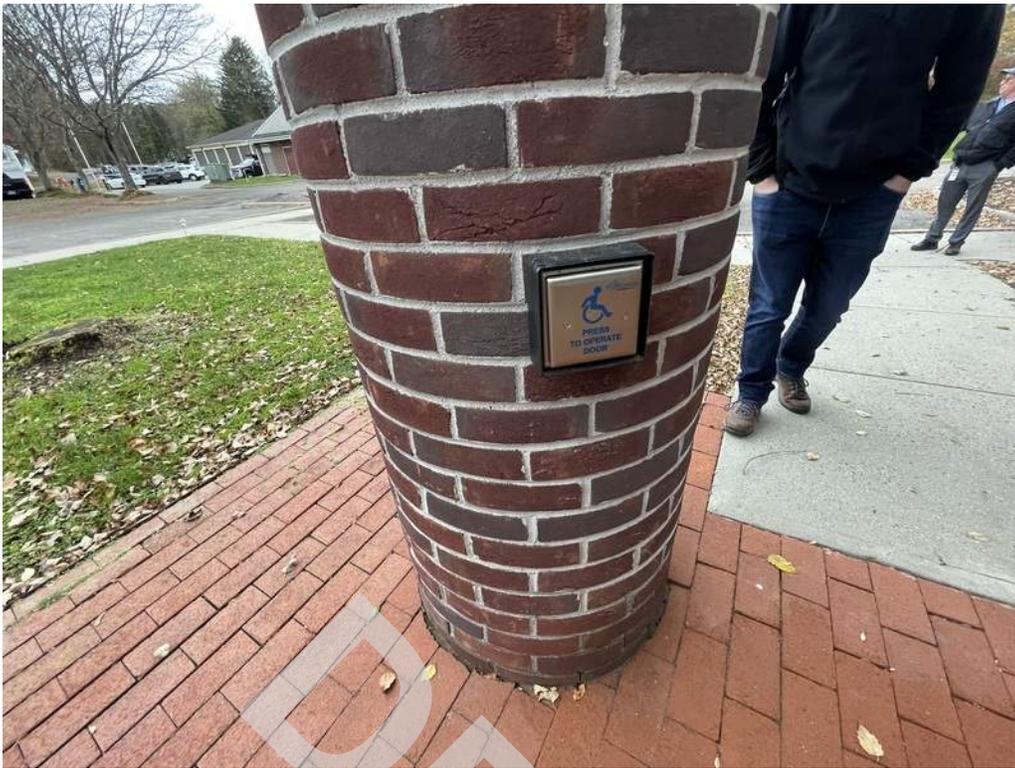
29 - Operated door push plate is located approximately 12' away from the door.

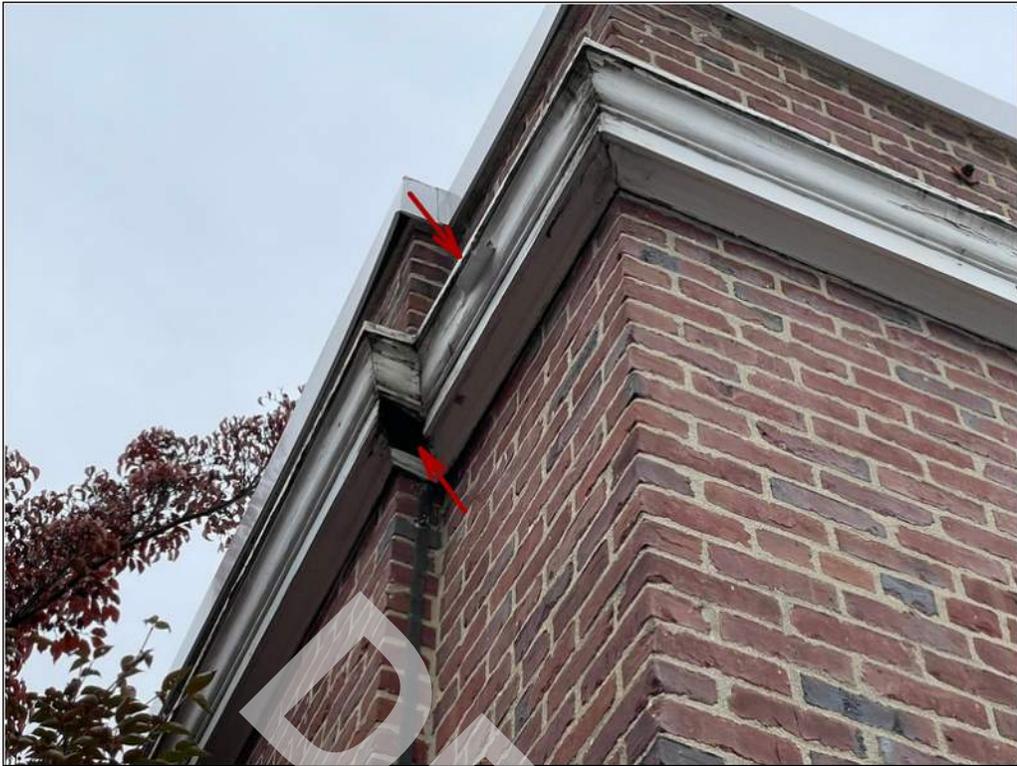
31 - Decorative wood trim cornices have rotted and have peeling finishes.

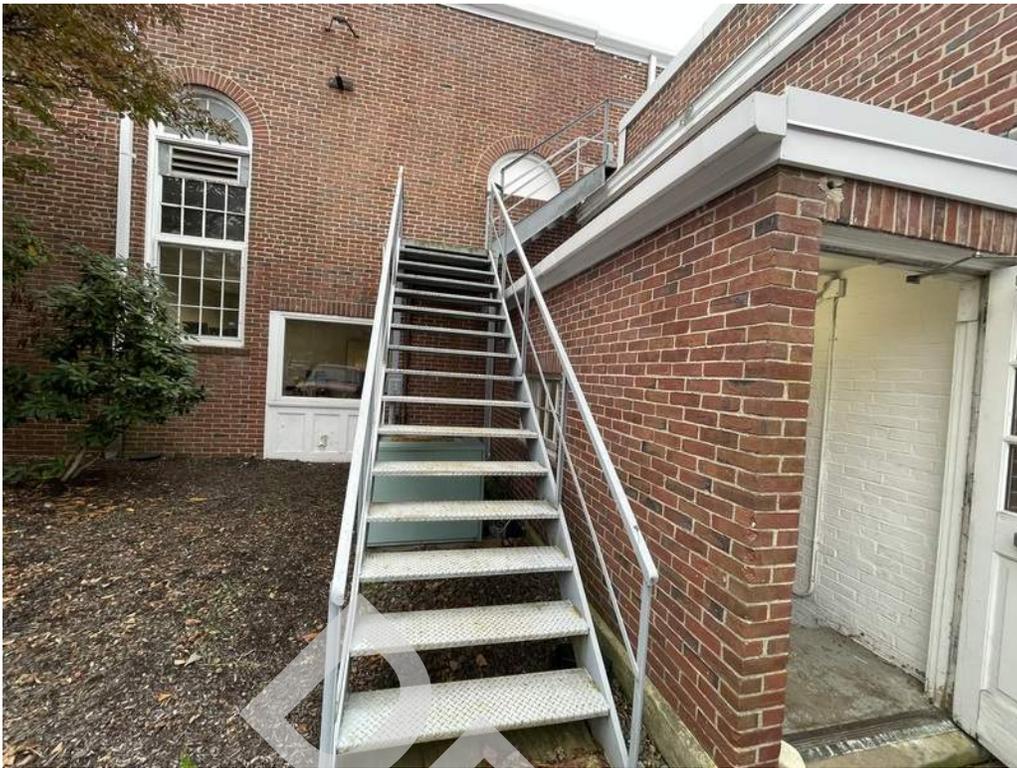
35 - Metal egress stair from the roof.

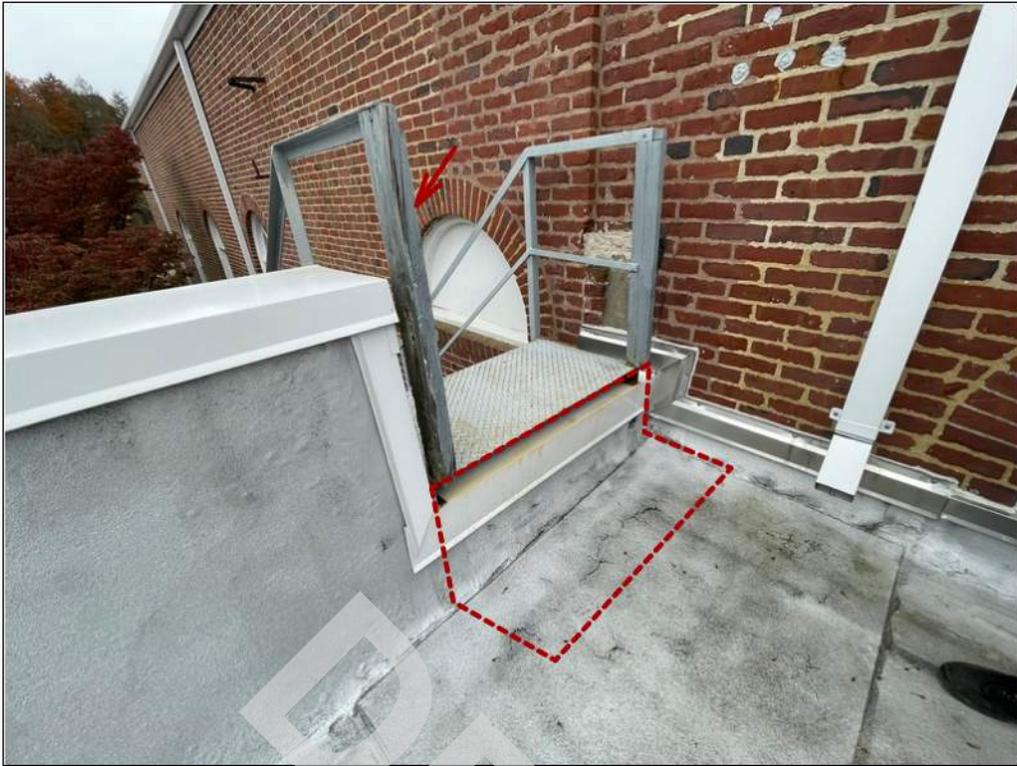
37 - Height of the riser in the path of egress is above the code requirement. Previously repaired handrail support.

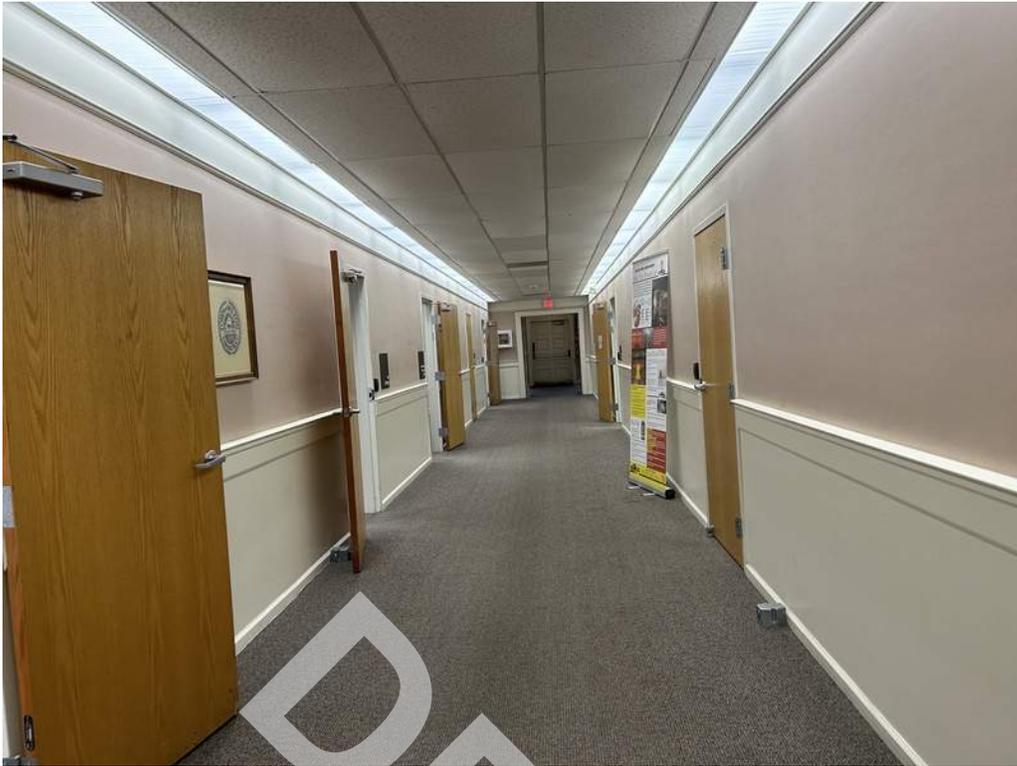
39 - Interior finishes at the corridors on the first floor typically consist of painted gypsum wall boards, suspended grid ceilings with acoustic tiles, and carpet floors.

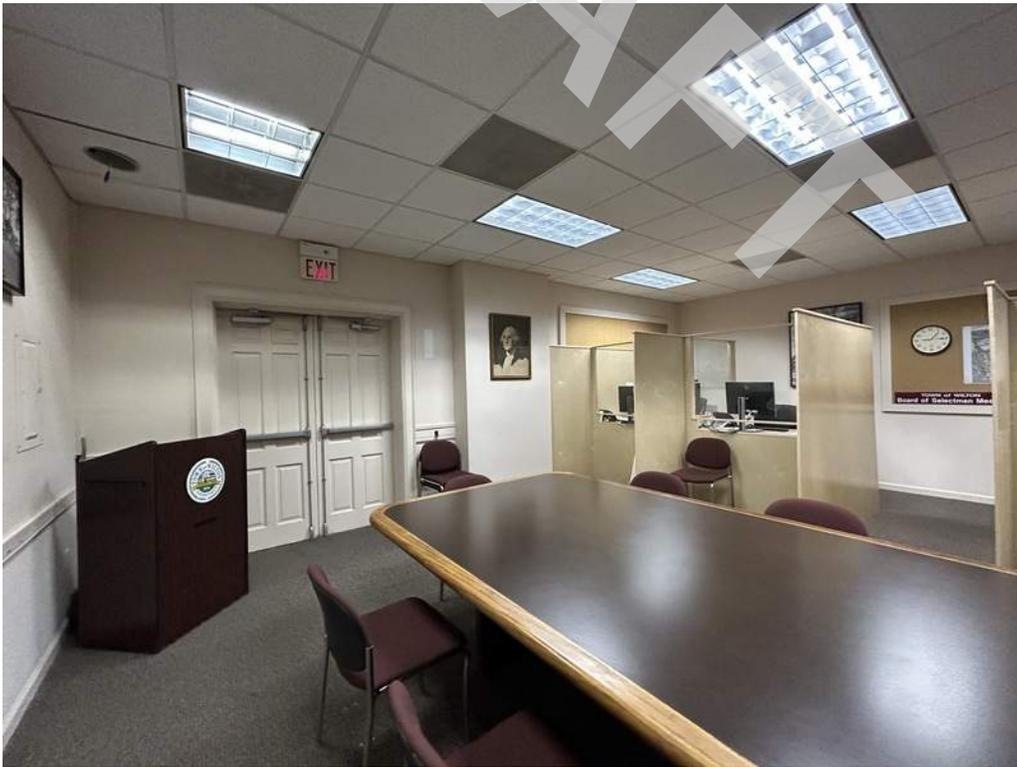
40 - Conference rooms generally consist of painted gypsum wall boards, suspended grid ceilings with acoustic tiles, and carpet floors.

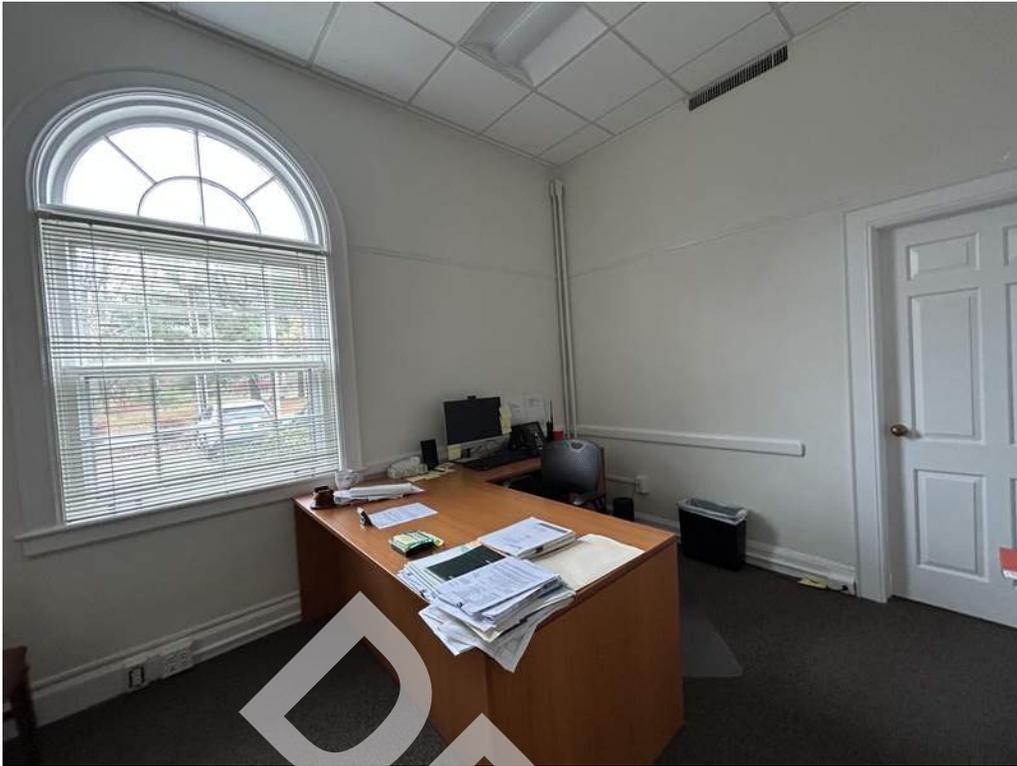
41 - Interior office finishes consist of painted gypsum wall board, suspended grid ceilings with acoustic tiles, and carpet floors.

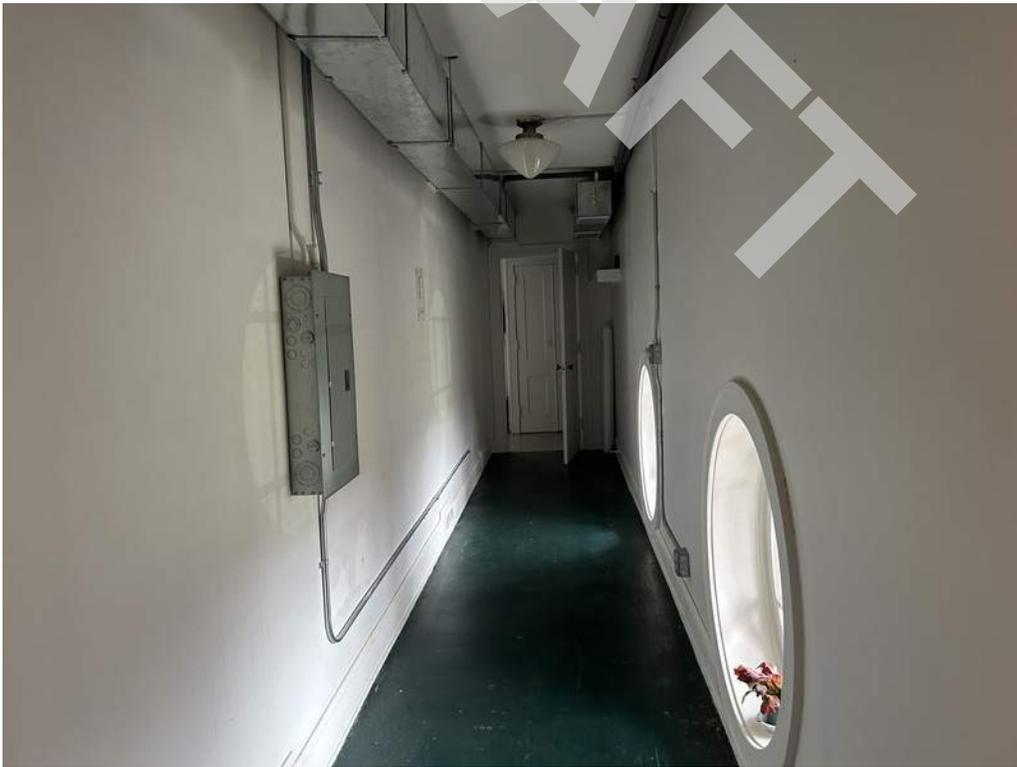
42 - Interior finishes at the second floor corridor consist of painted gypsum wall and ceiling boards and vinyl flooring.

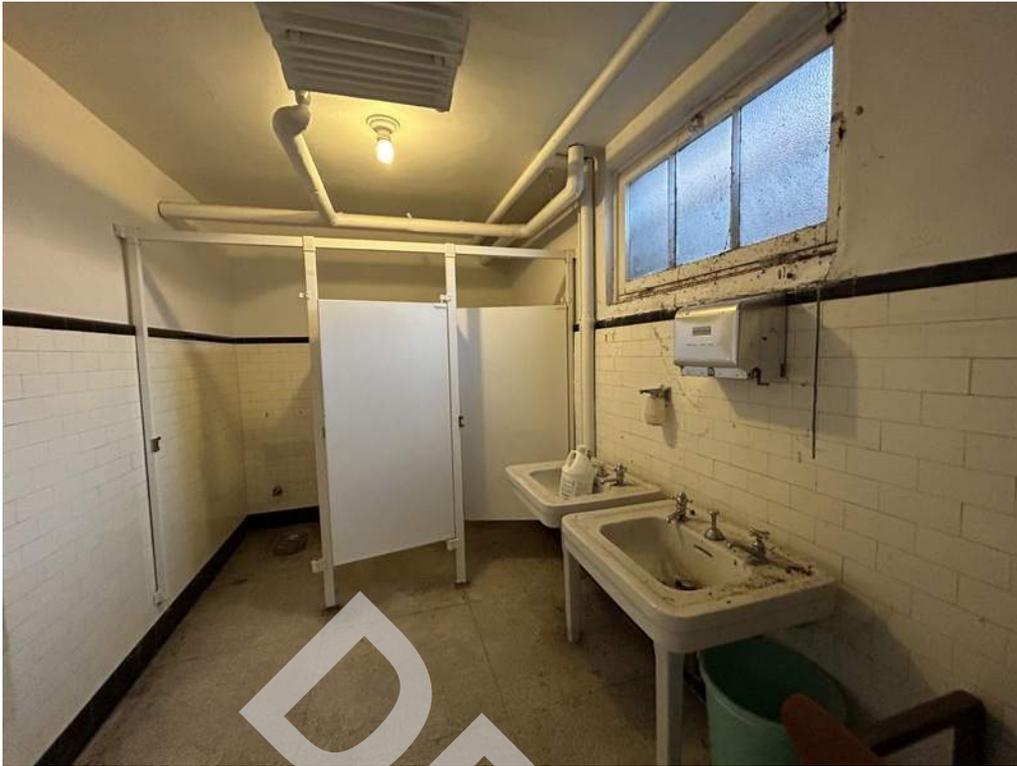
45 - Basement restrooms are out of service.
