# FACILITY CONDITION ASSESSMENT

## TOWN OF WILTON – TOWN BUILDINGS

Wilton, Connecticut

Draft: February 2, 2024

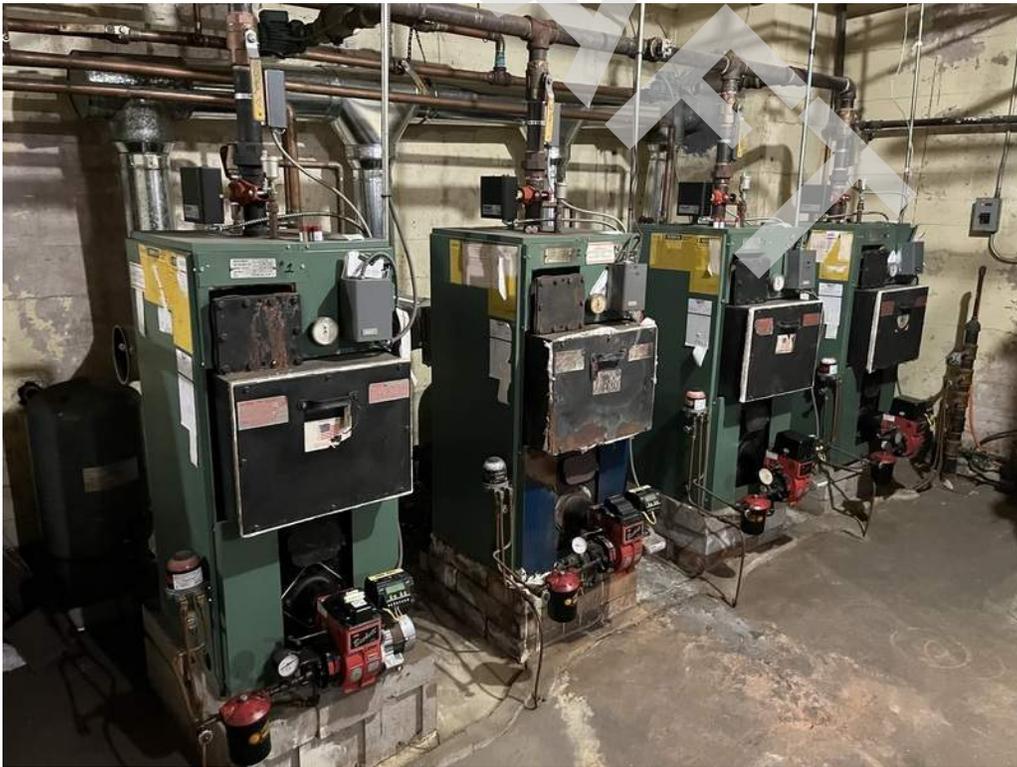
46 - Four propane fired boilers located in the basement provide heating hot water throughout the building. All four are currently operational. Insulation is not provided on the associated piping.

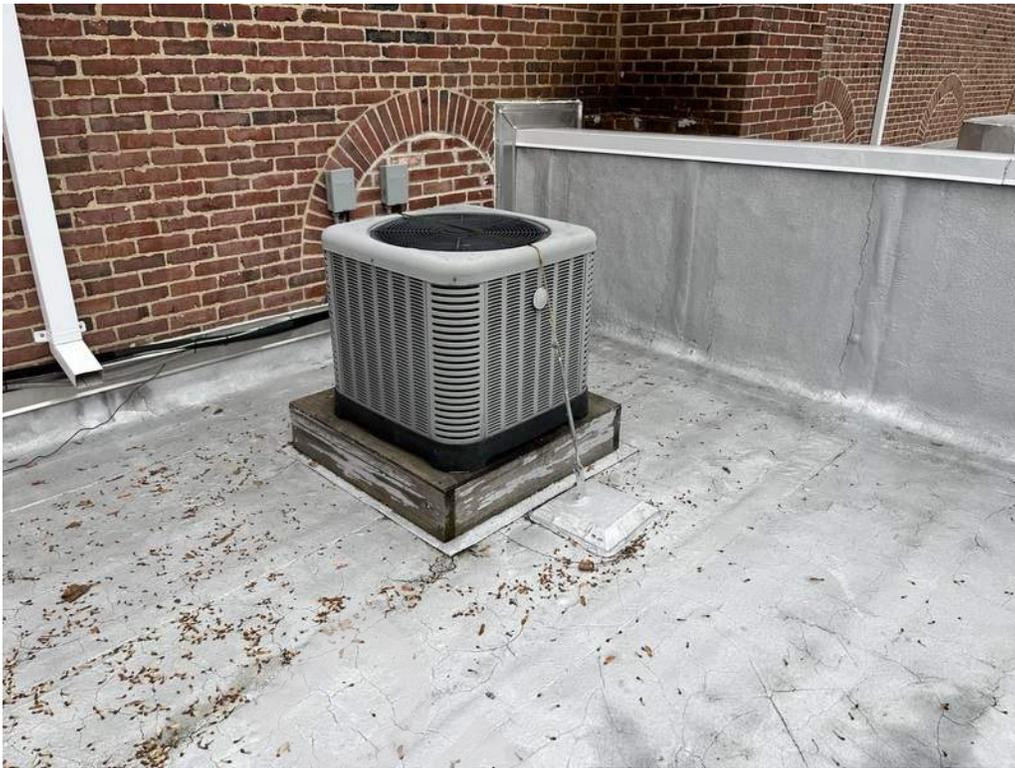
47 - Split system air conditioning units are located on the roof and provide cooling to the office areas of the building.

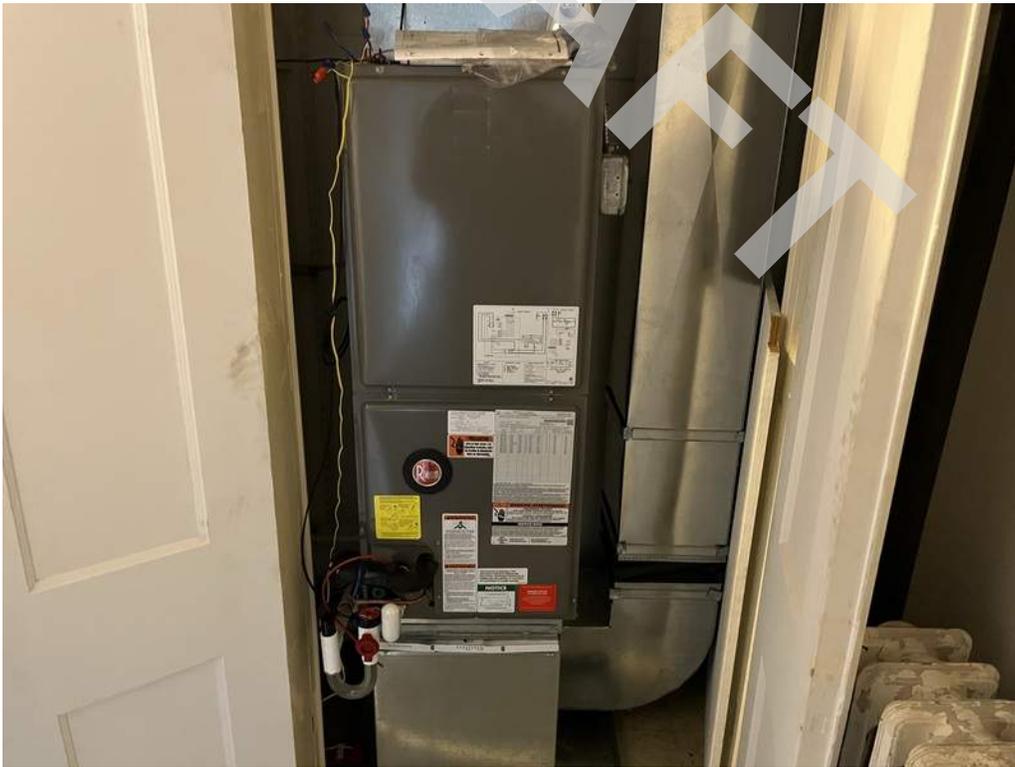
48 - Split system indoor air handling units with auxiliary electric heaters are located within the building and provide air conditioning through ductwork throughout the building.

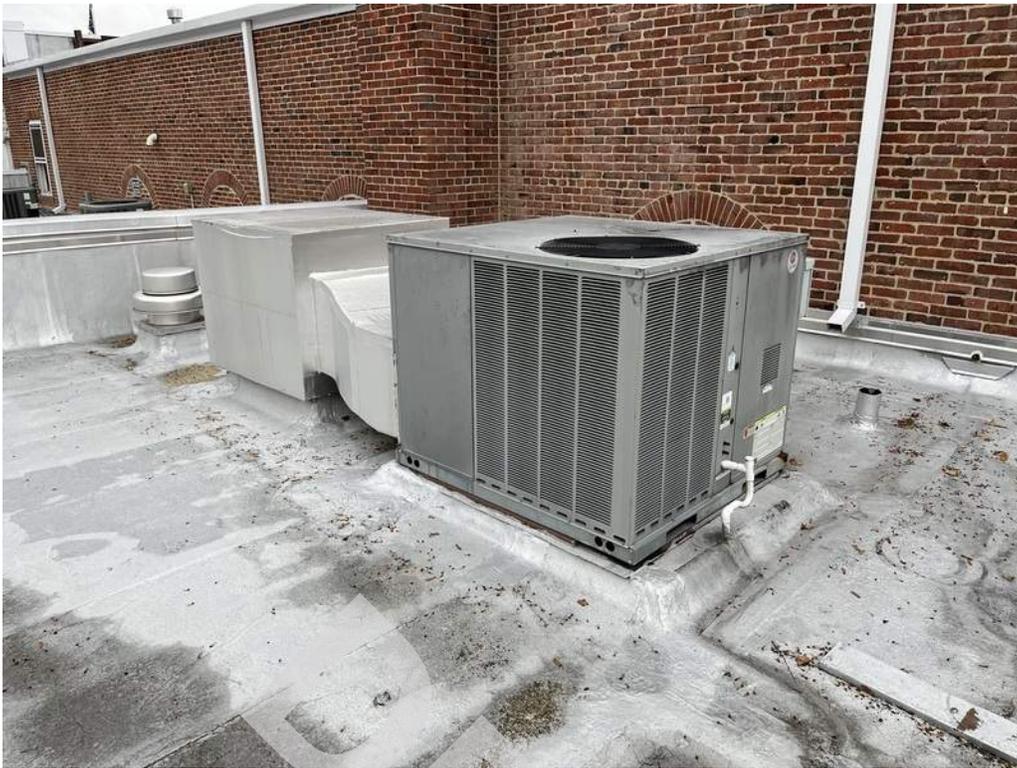
49 - A rooftop packaged unit provides cooling to the vault room on the first floor.

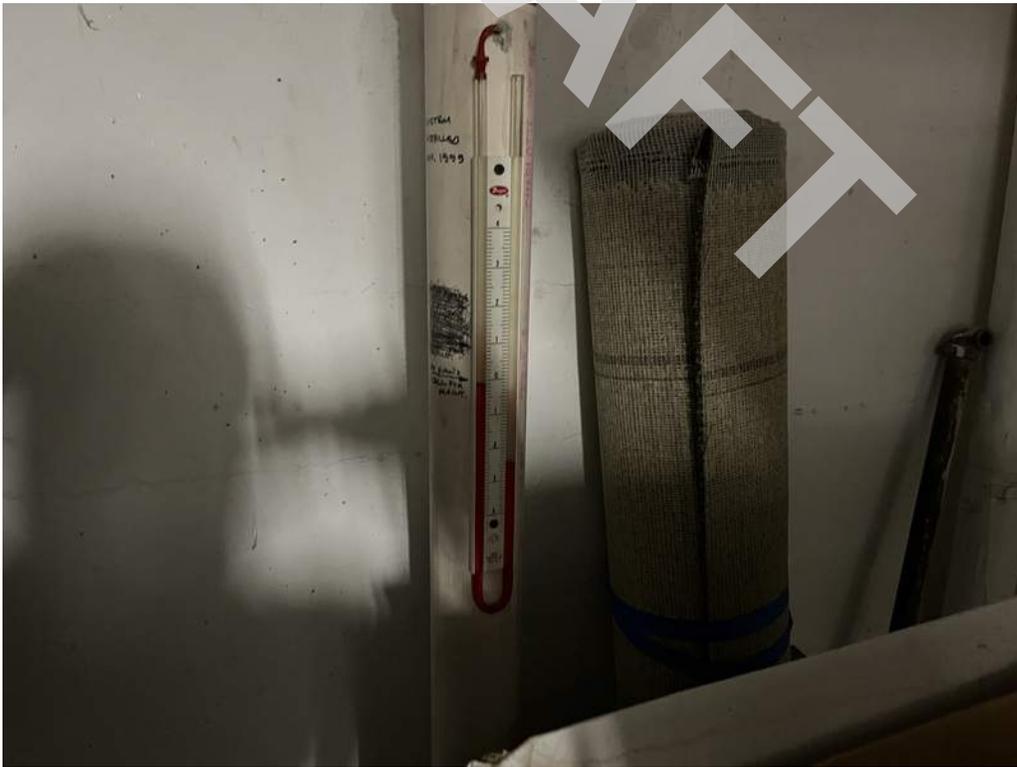
50 - A radon mitigation system is provided within the building.

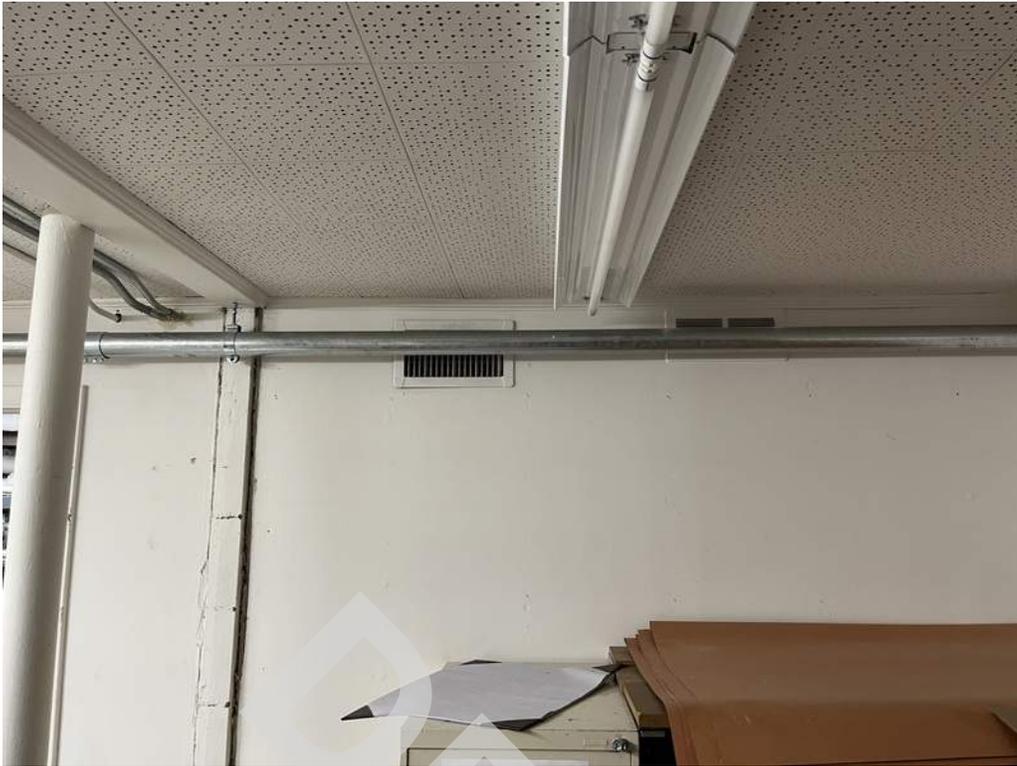
51 - A conduit in the basement is currently partially blocking two wall mounted grilles.

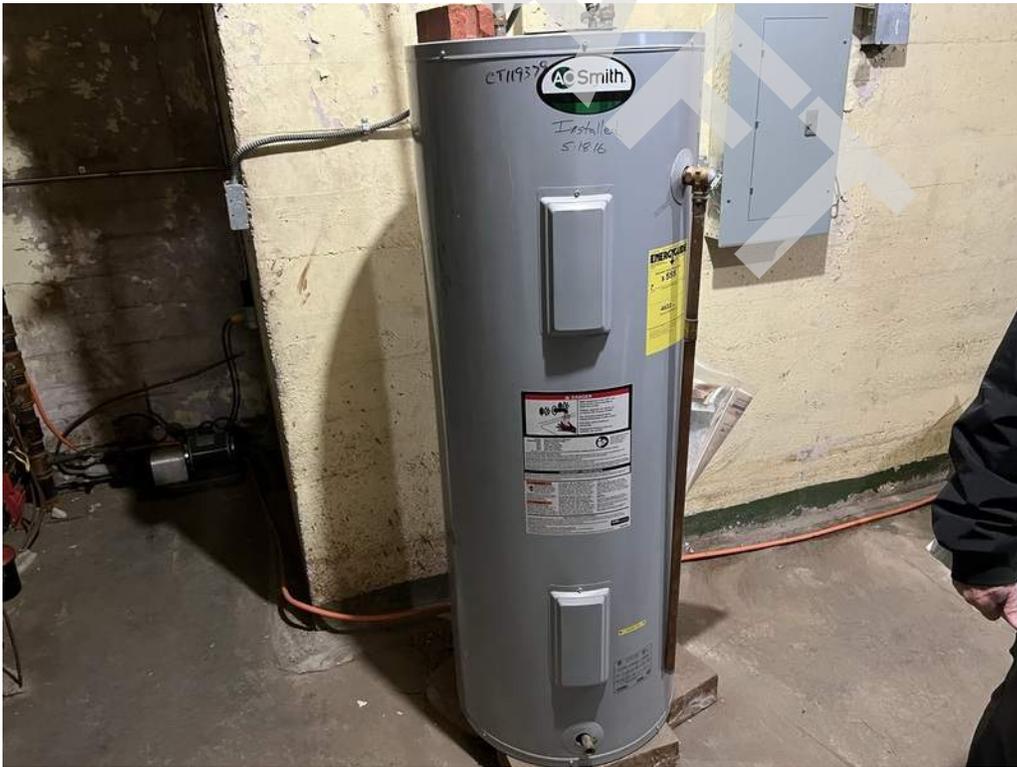
52 - An electric storage-type water heater is located in the basement and provides hot water throughout the building.

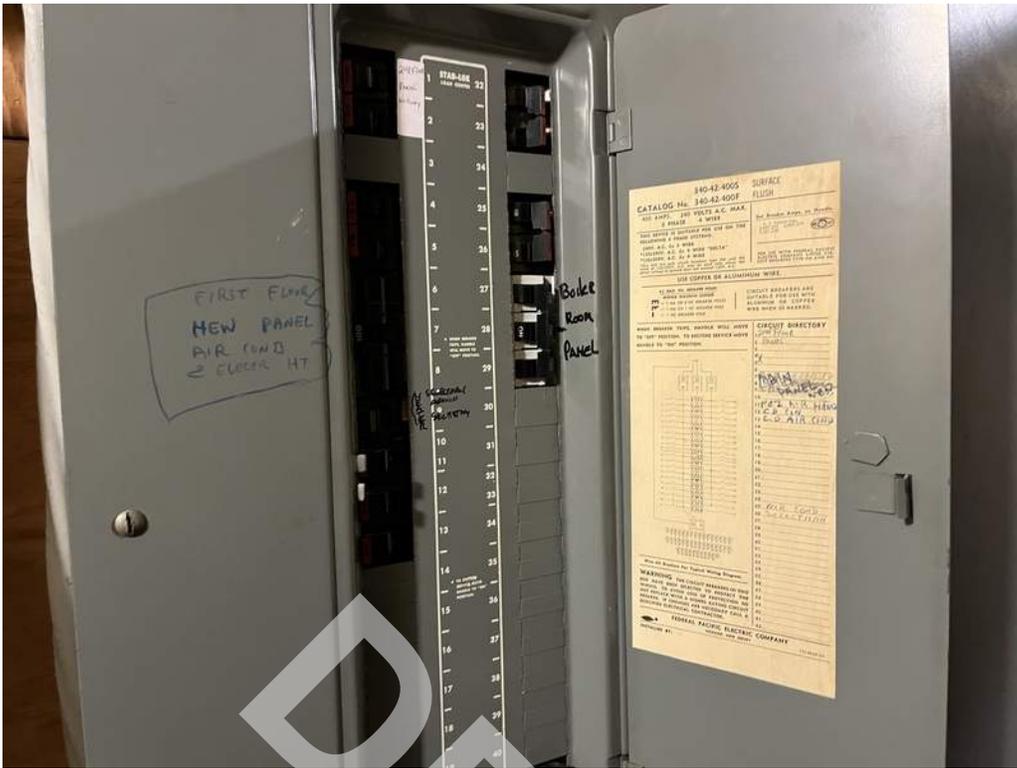
53 - Two electric panels located in the electric service room are Stab-Lok model Federal Pacific panels.

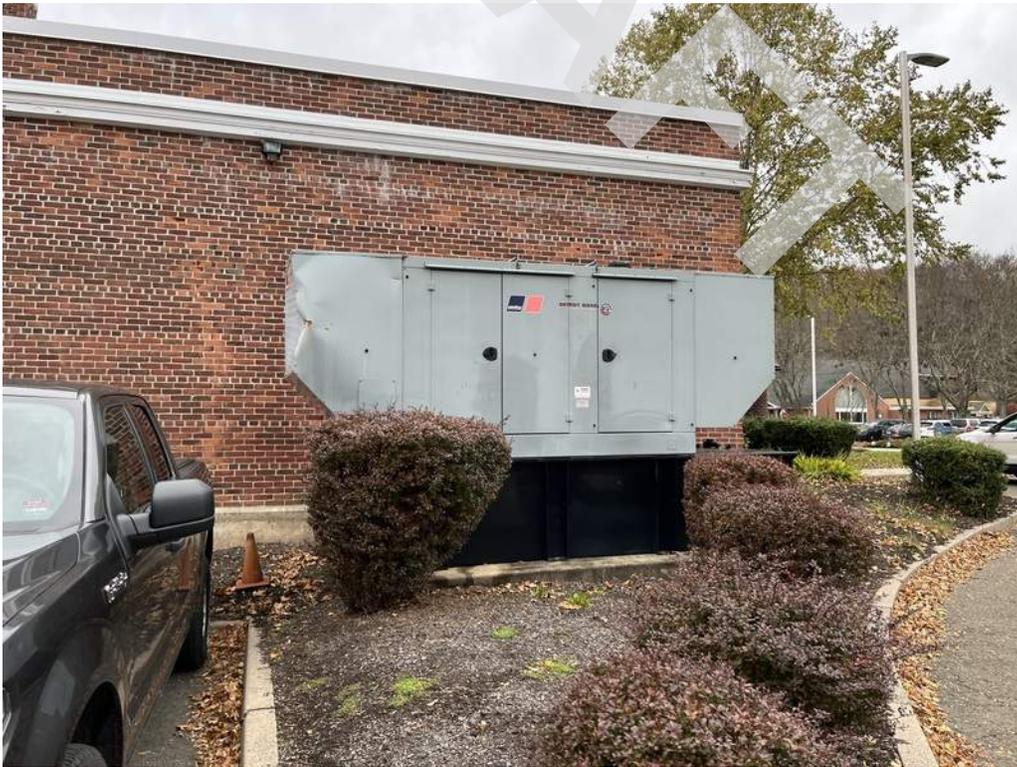
54 - A diesel-fired emergency generator located on the exterior of the building provides emergency power to the Town Hall and Annex buildings.

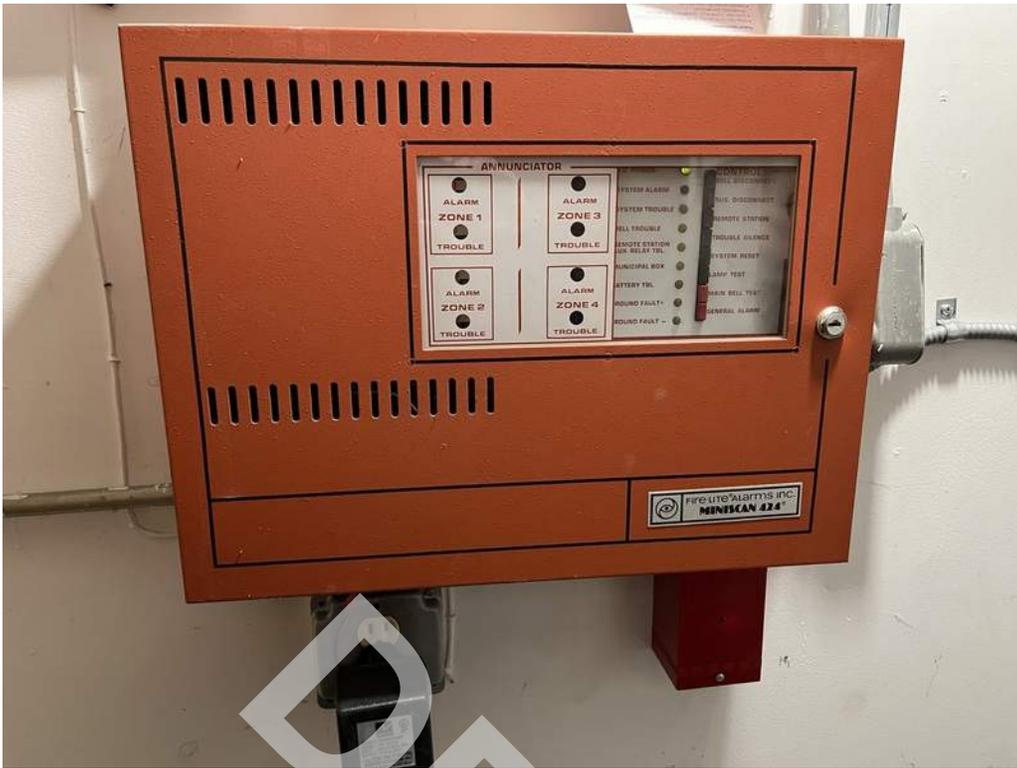
55 - The building is provided with a Miniscan 424 Fire Alarm Panel.

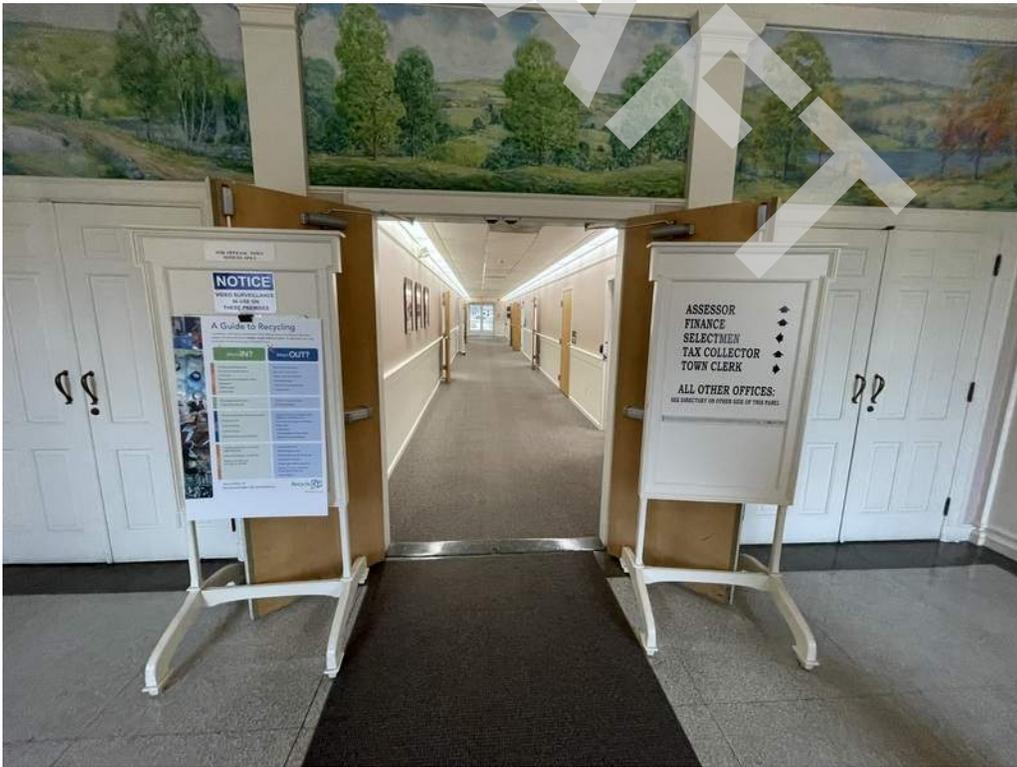
56 - Fire rated doors are held open by signage.

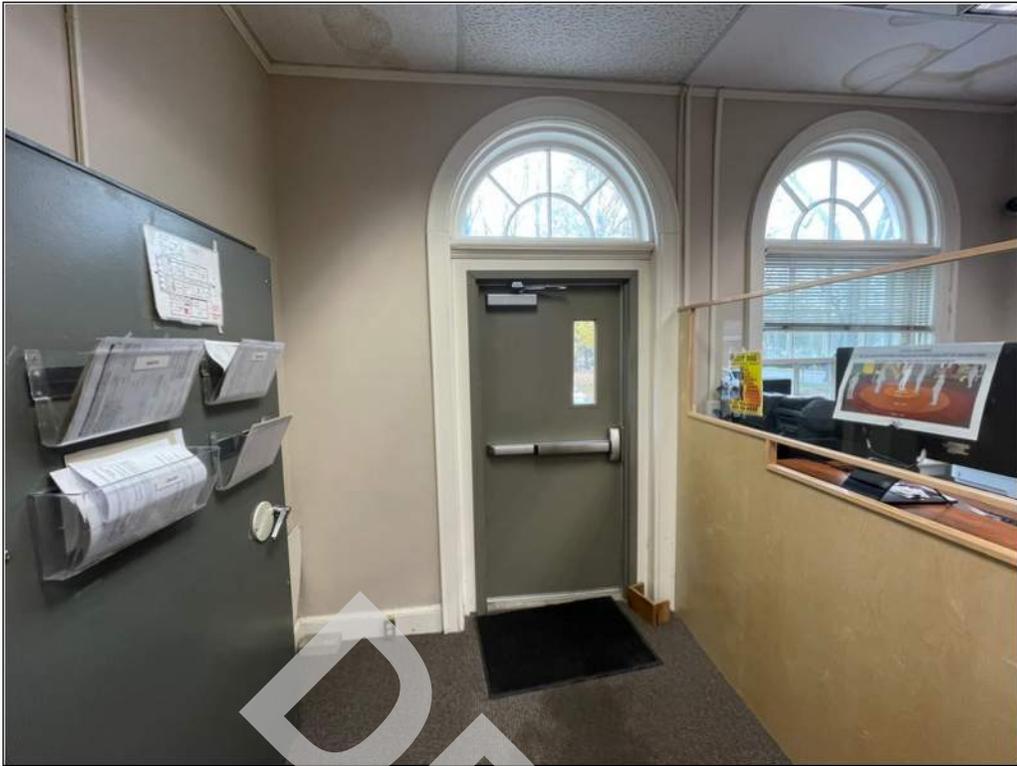
57 - Exit signage and pull alarm are not provided at the egress door.

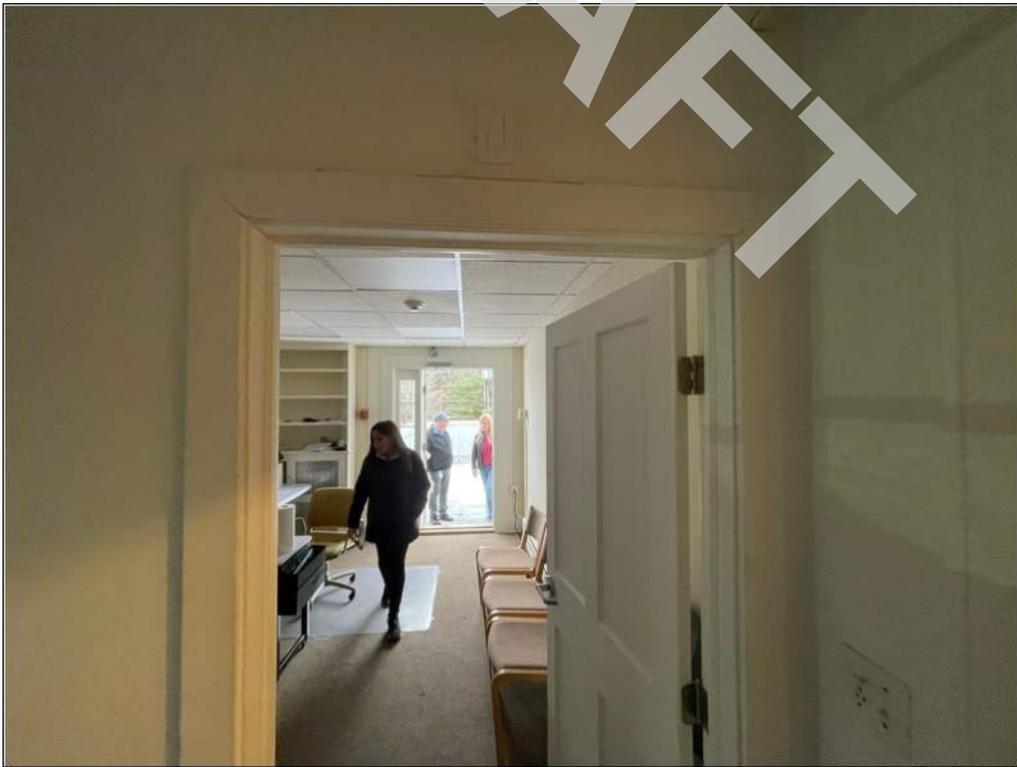
58 - Exit signage is not provided at the second floor.

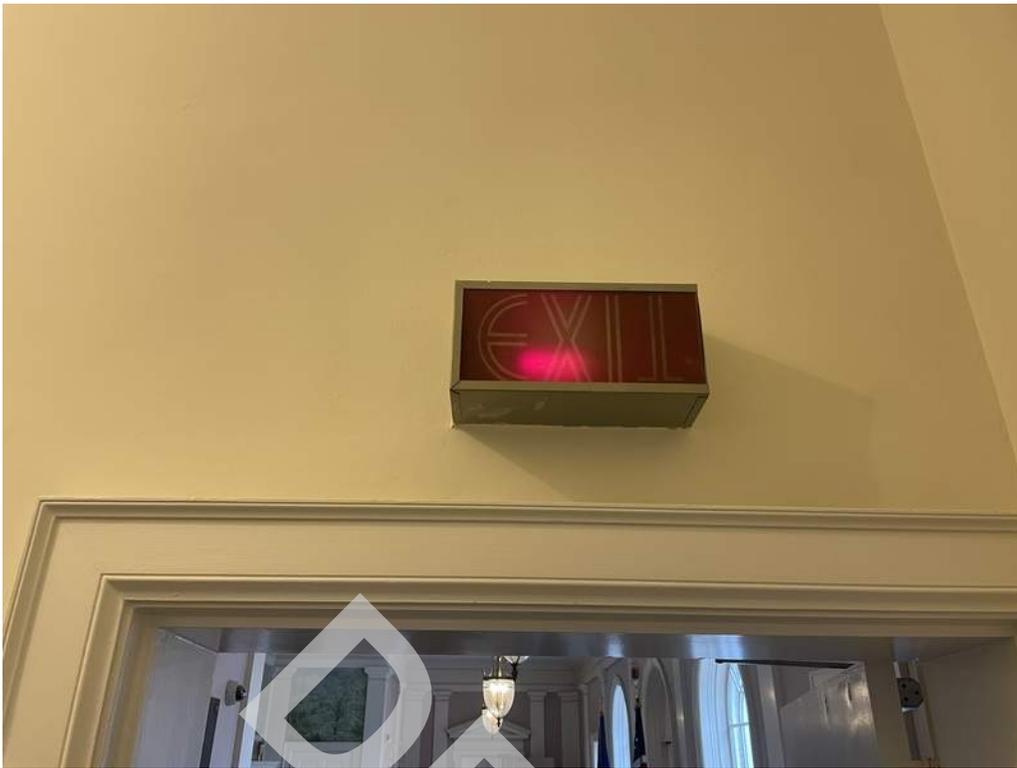
59 - Illuminated exit signage is outdated.

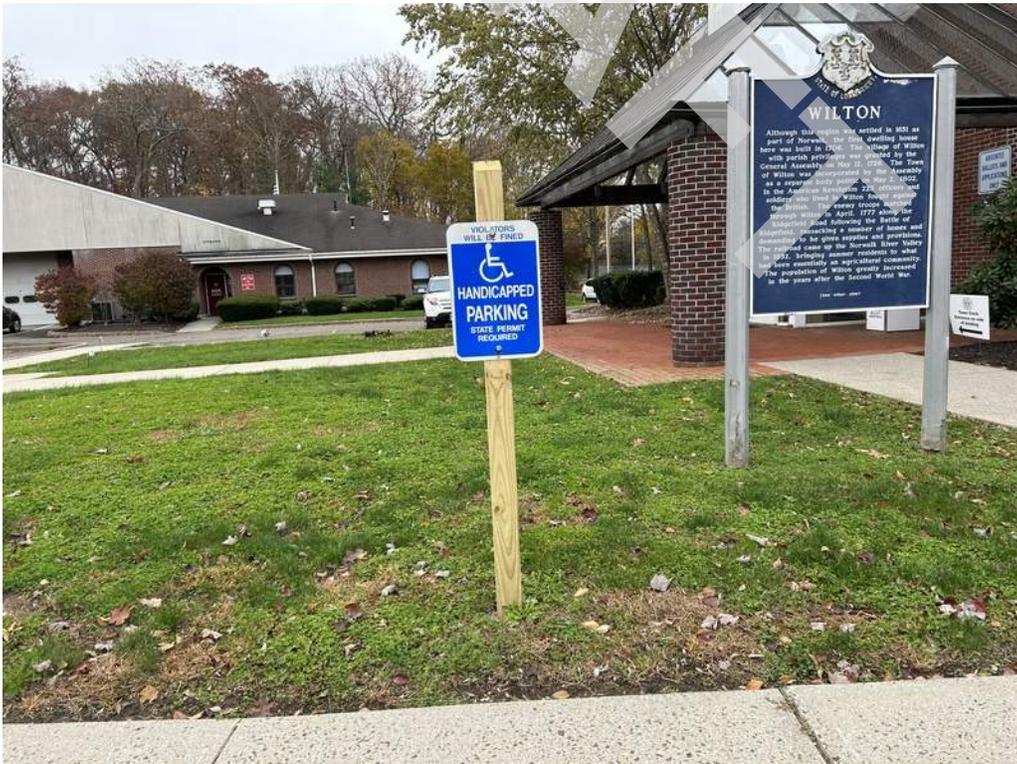
60 - Parking signage is mounted below the required minimum complaint height.

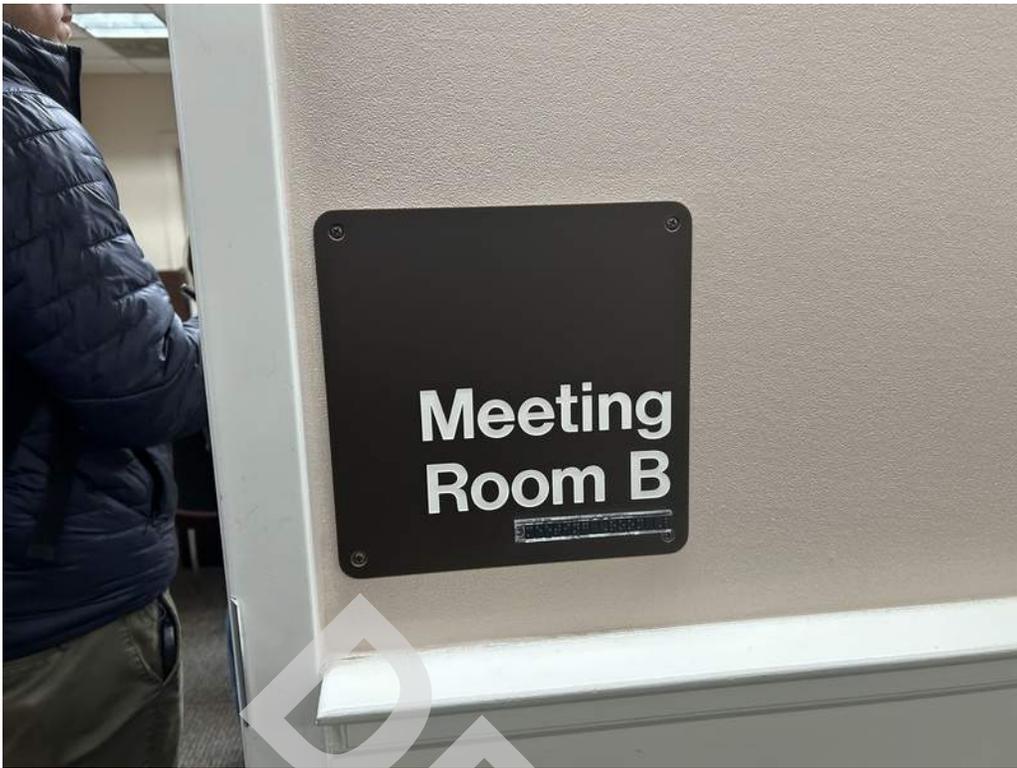
61 - Signage is mounted below the required height and is non compliant.

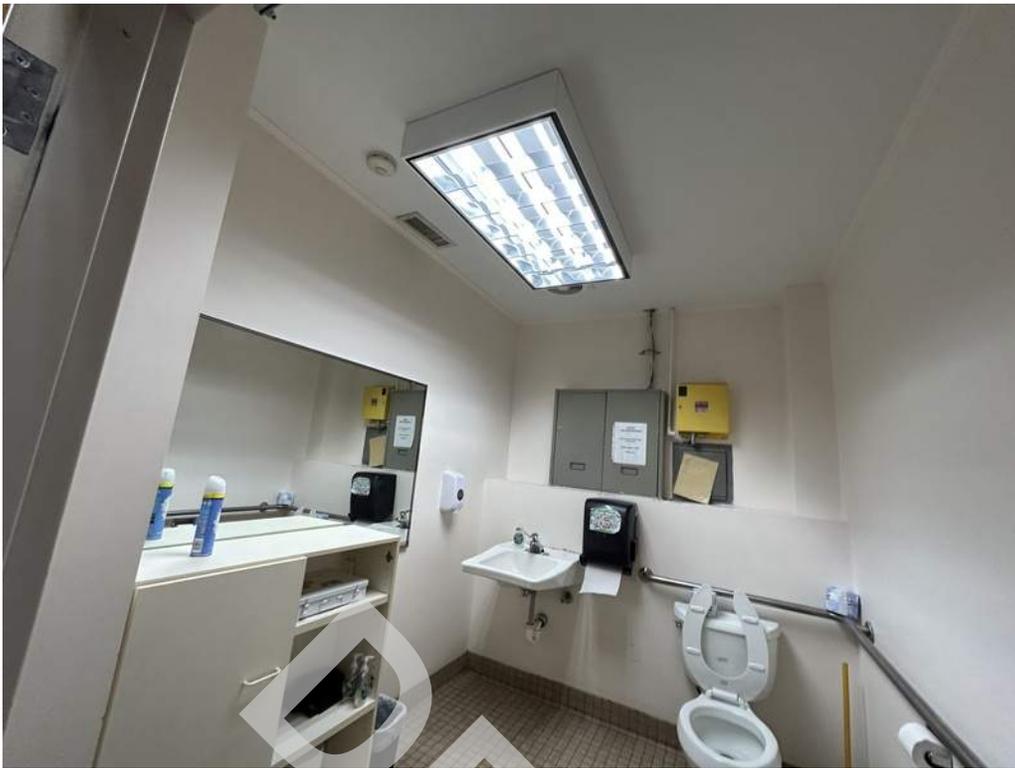
63 - The single user restroom on the ground floor was noted to have various non-compliant items. Items include center of toilet mounted above the the range tolerance from the side wall, inadequate sink depth and clear floor space, and missing scald guard protection beneath the lavatory.

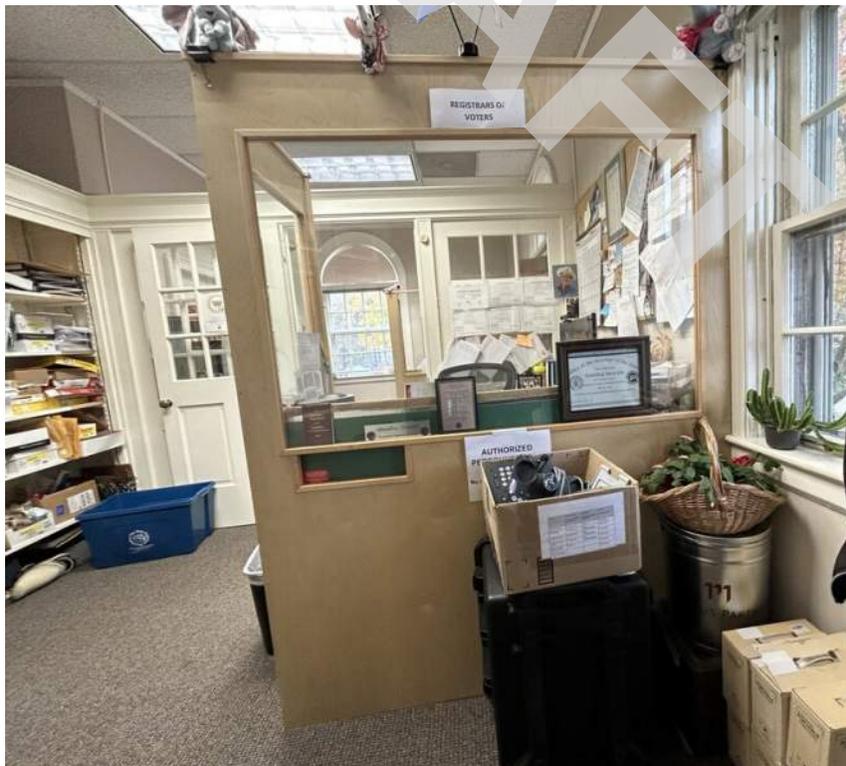
64 - A lowered counter area is not provided at the Registrants of Voters office.

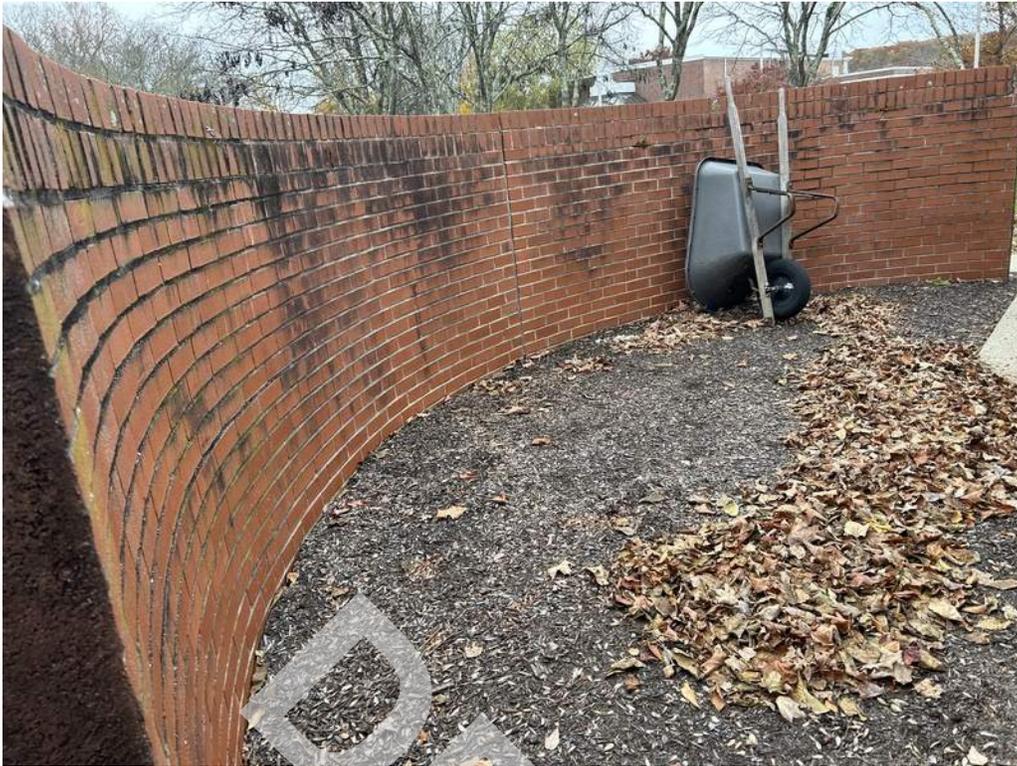
5 - Staining and deteriorated mortar was observed at the brick garden wall along the east façade.

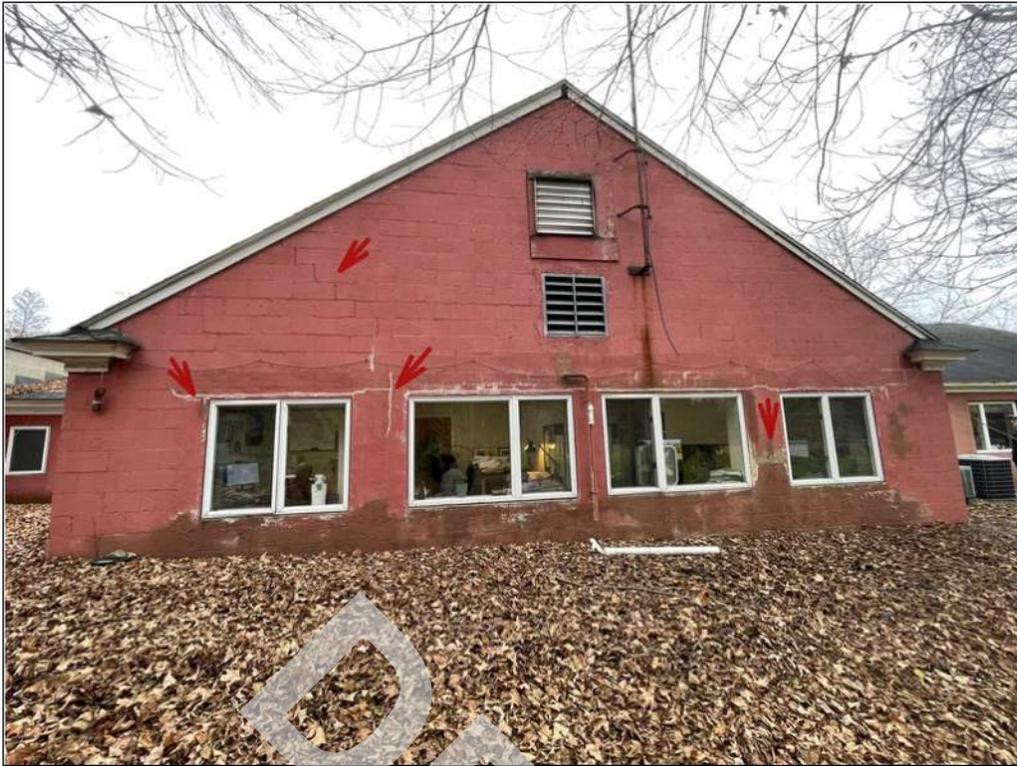
7 - Localized areas of the CMU (concrete masonry unit) facade have stepped cracking, cracked mortar joint and cracked units along the window lintel. Parging coat is peeling along the base CMU courses. Windows are in poor condition.

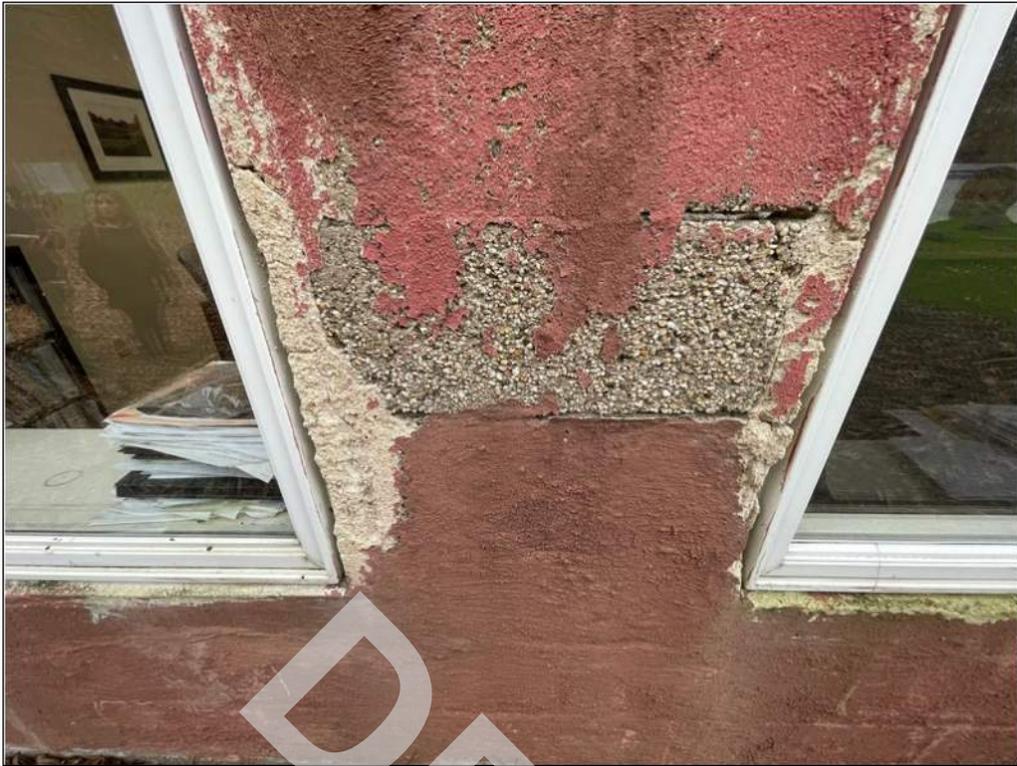
9 - CMU finishes and mortar joints along the facade are deteriorating.

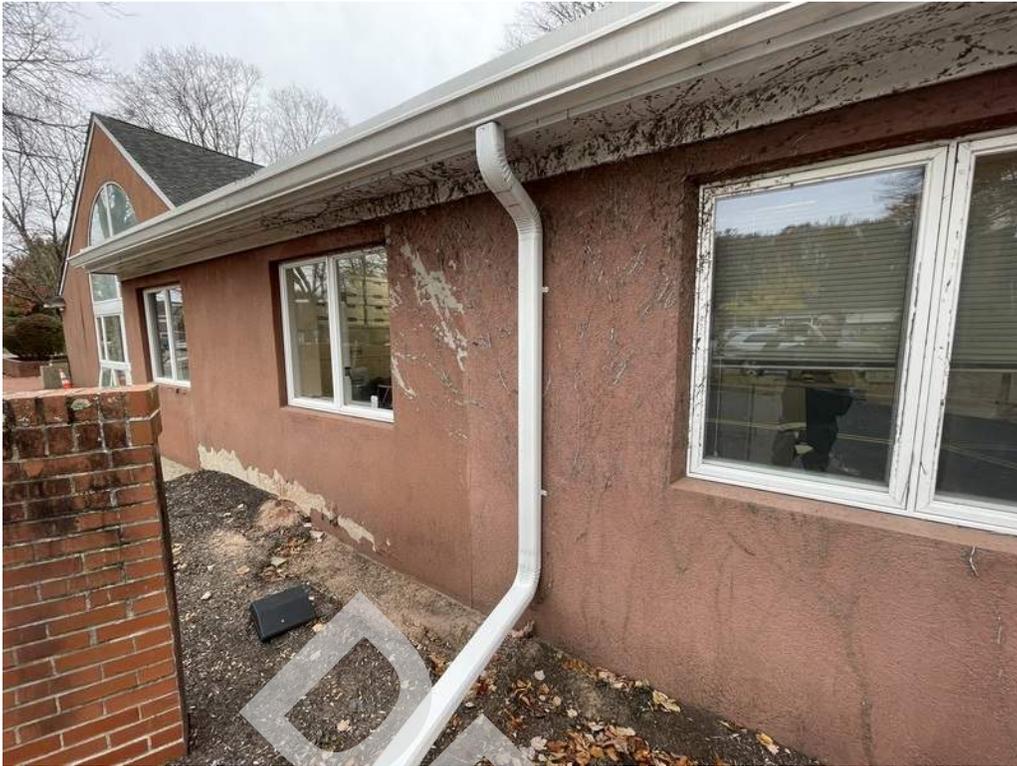
13 - Window units along the south facade are in fair condition.

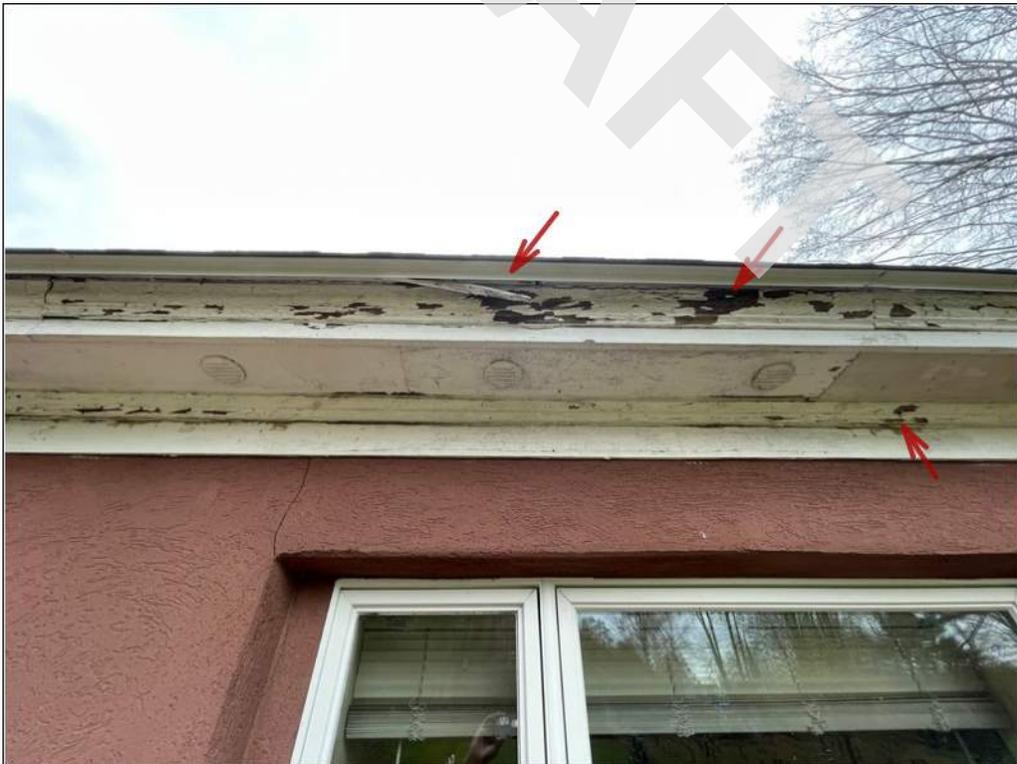
16 - Wooden trim and soffits along the roof perimeter are in poor condition. Wood has rotted and paint finish is peeling.

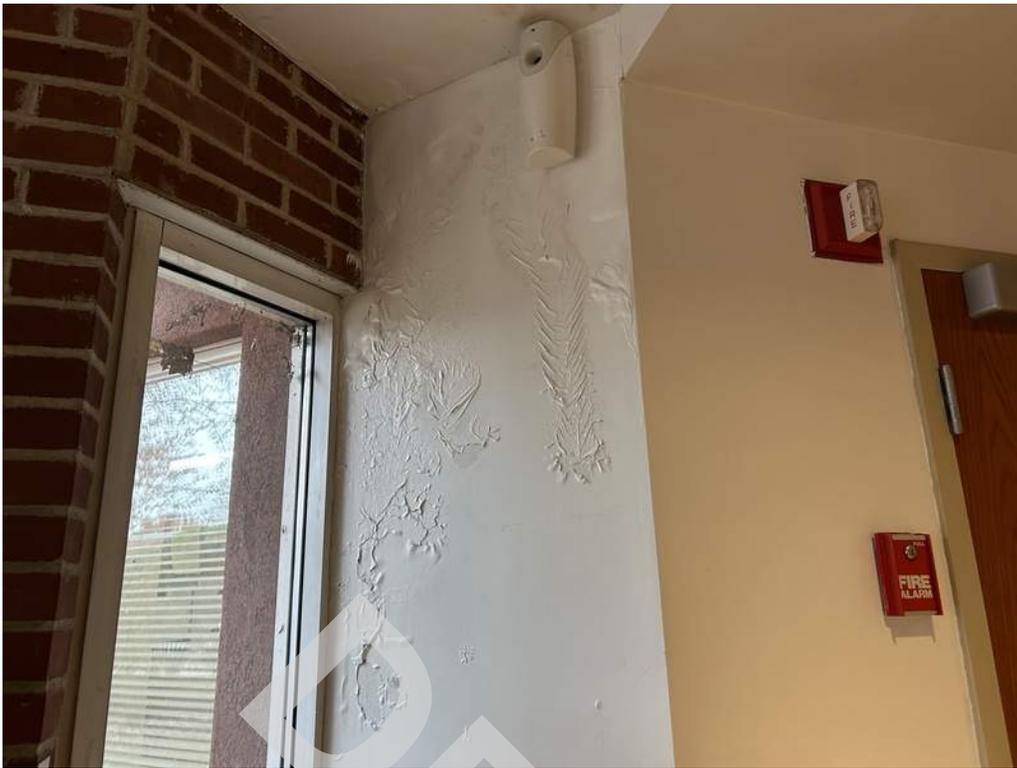
21 - Instances of paint peeling at isolated areas was observed at the facility.

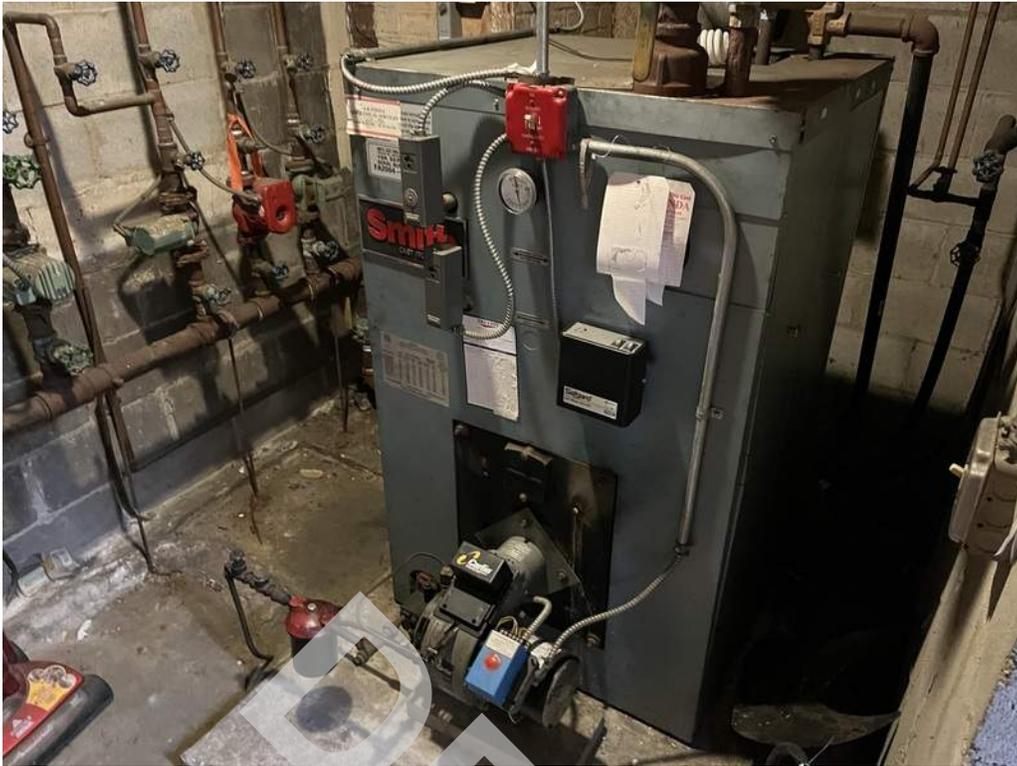
23 - An oil fired boiler located in a mechanical closet provides heating hot water throughout the building.

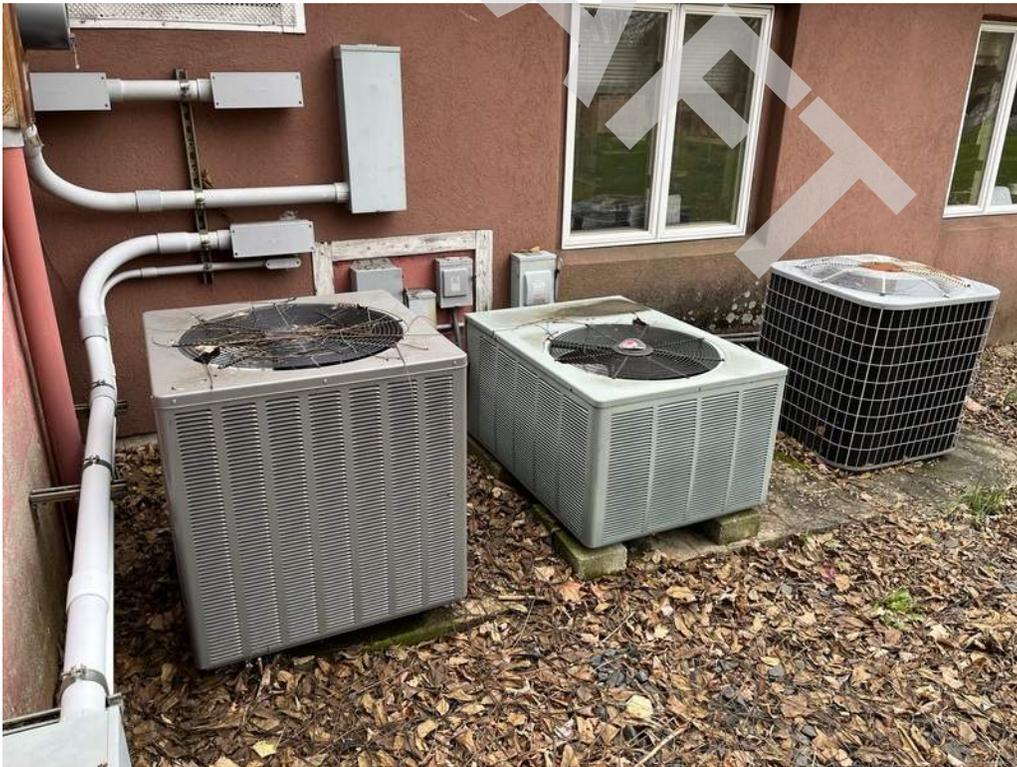
24 - Split system air conditioning units are located on the exterior and provide cooling to the building.

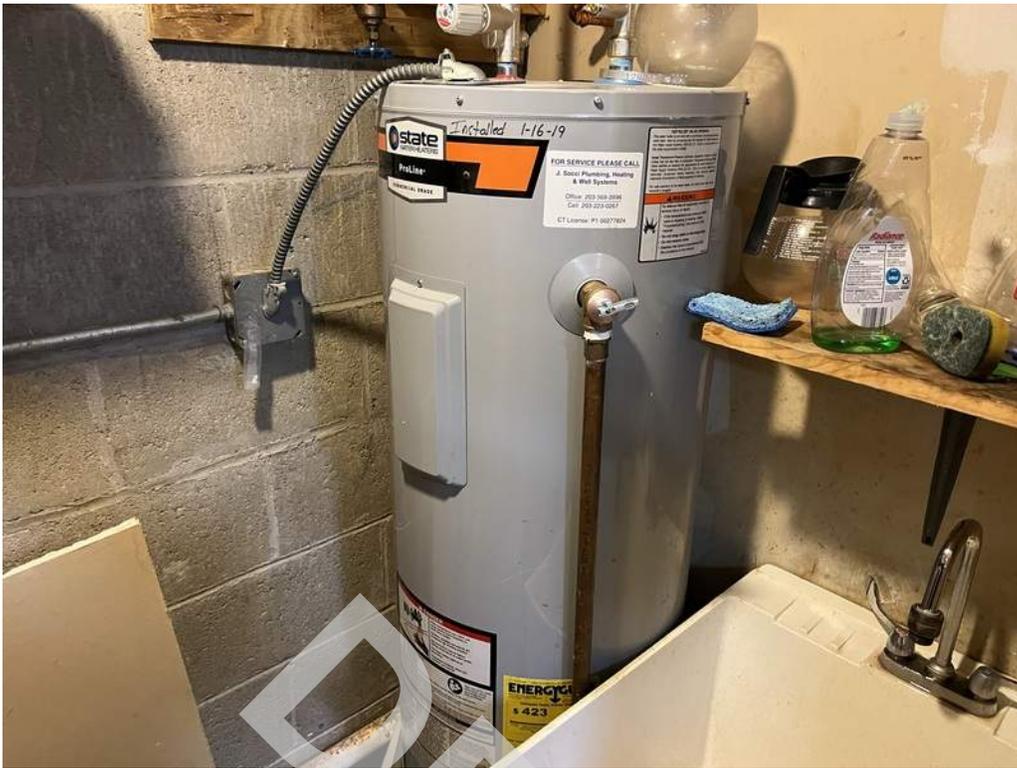
25 - An electric storage-type water heater is located in a closet and provides hot water throughout the building.

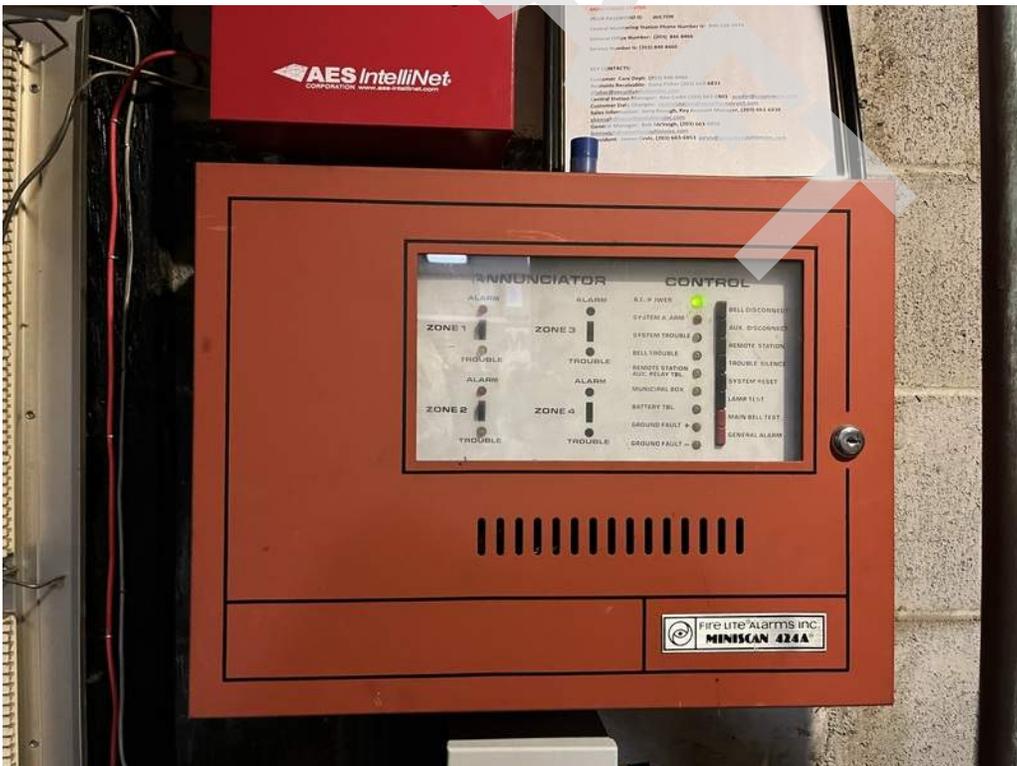
26 - The building is provided with a Miniscan 424 Fire Alarm Panel.

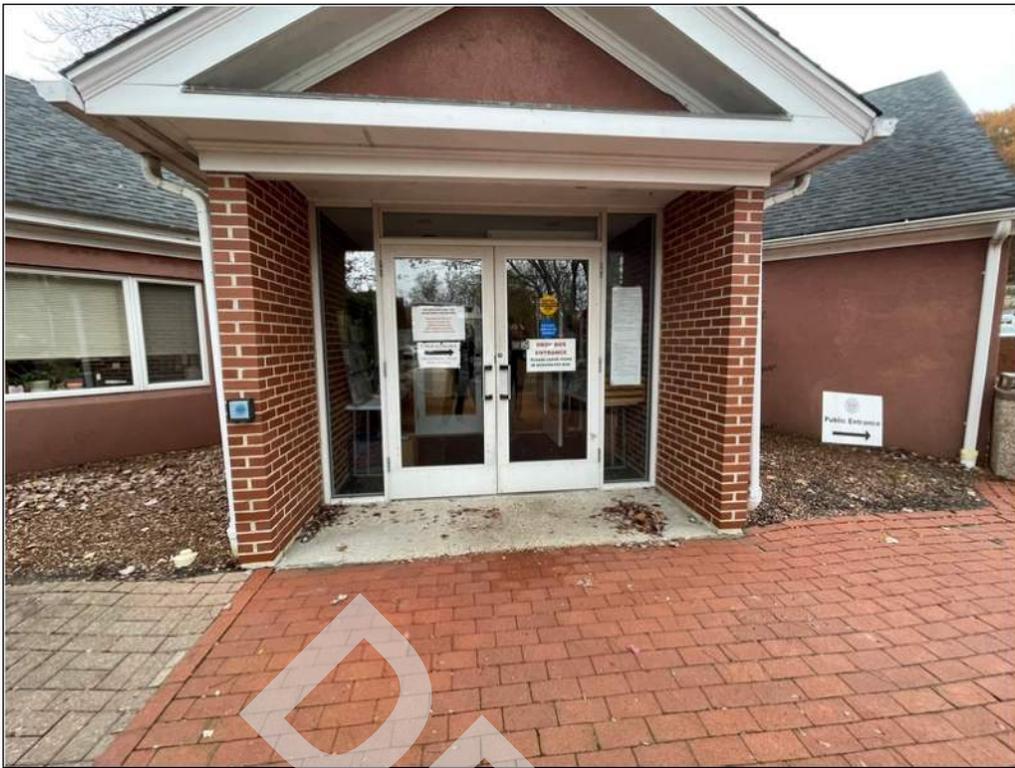
27 - Power assisted door at the drop box entrance is not operating.
