# FACILITY CONDITION ASSESSMENT

## TOWN OF WILTON – TOWN BUILDINGS

Wilton, Connecticut

Draft: February 2, 2024

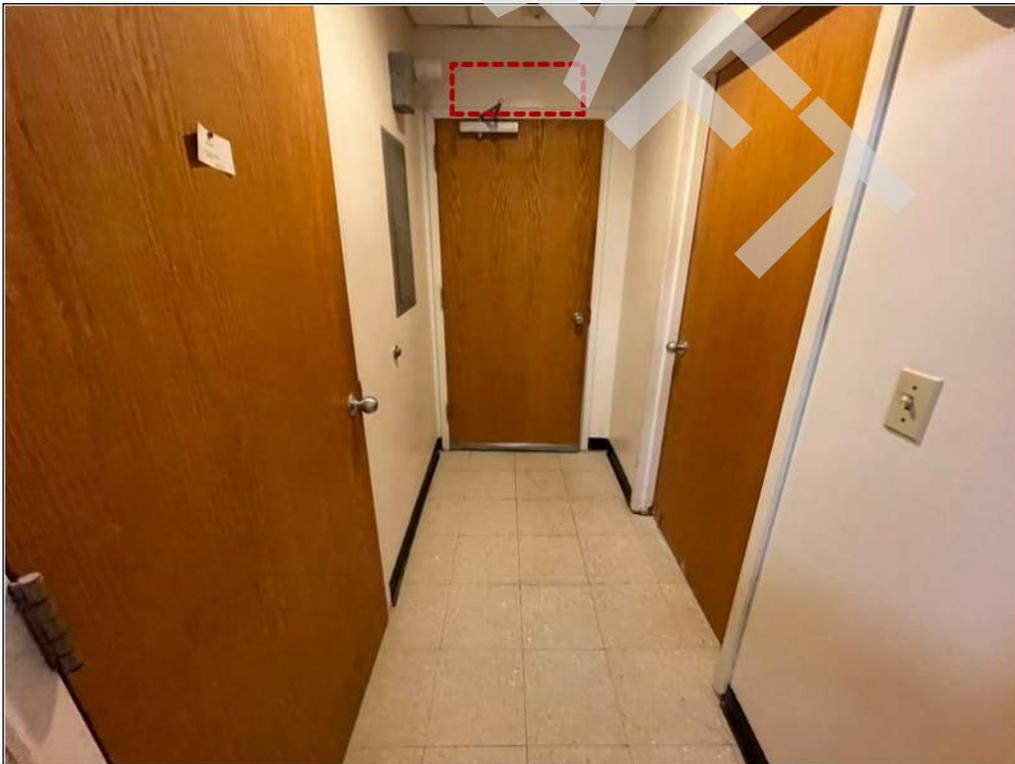
28 - Illuminated exit signs are not provided along the path of egress.

3	Life Safety Code Compliance: Based on the results of the review by the fire life safety professional, provide exit signage and devices where required. Scope may include providing new exit signage, including wiring, pull station, and compliant hardware at egress doors. Quantity and final budget will be based on the results of the fire life safety review. A preliminary budget is provided for reference.	1	LS	\$5,000.00	100%	\$5,000	Priority 1 - Current Critical.
4	Life Safety Code Compliance: Battery powered emergency lighting is provided throughout the annex building. Each light observed was tested to confirm it was functional. Two of the emergency lights in the hallway did not turn on when tested. Replace the non-functioning lights with new. It is recommended to regularly test all emergency lights.	2	EA	\$1,000.00	100%	\$2,000	Priority 1 - Current Critical.
<b>ACCESSIBILITY</b>							
5	ADA: The drop box entrance is provided with a power assisted door with an actuator. The power assisted door was not operating during out visit. Additionally, door hardware was observed to be orbital at select spaces. Replace with lever type hardware to meet compliance and repair power assisted door hardware.	1	EA	\$5,000.00	100%	\$5,000	Priority 1 - Current Critical.

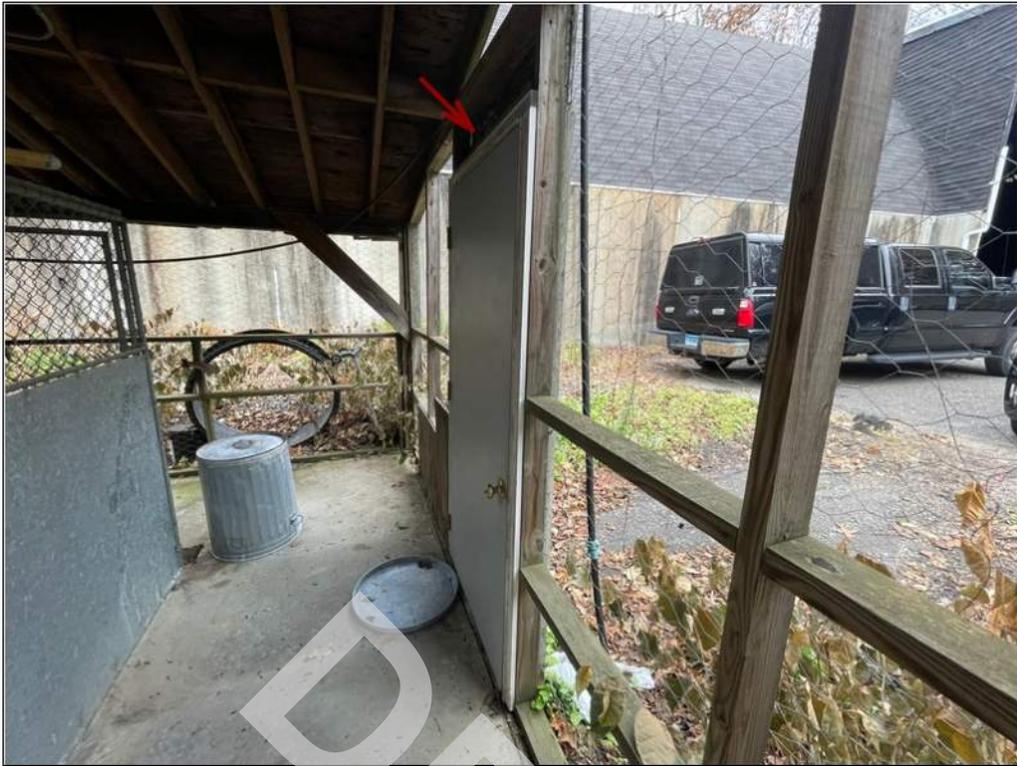
29 - Illuminated exit sign is not provided at the door exiting from the animal shelter kennel.

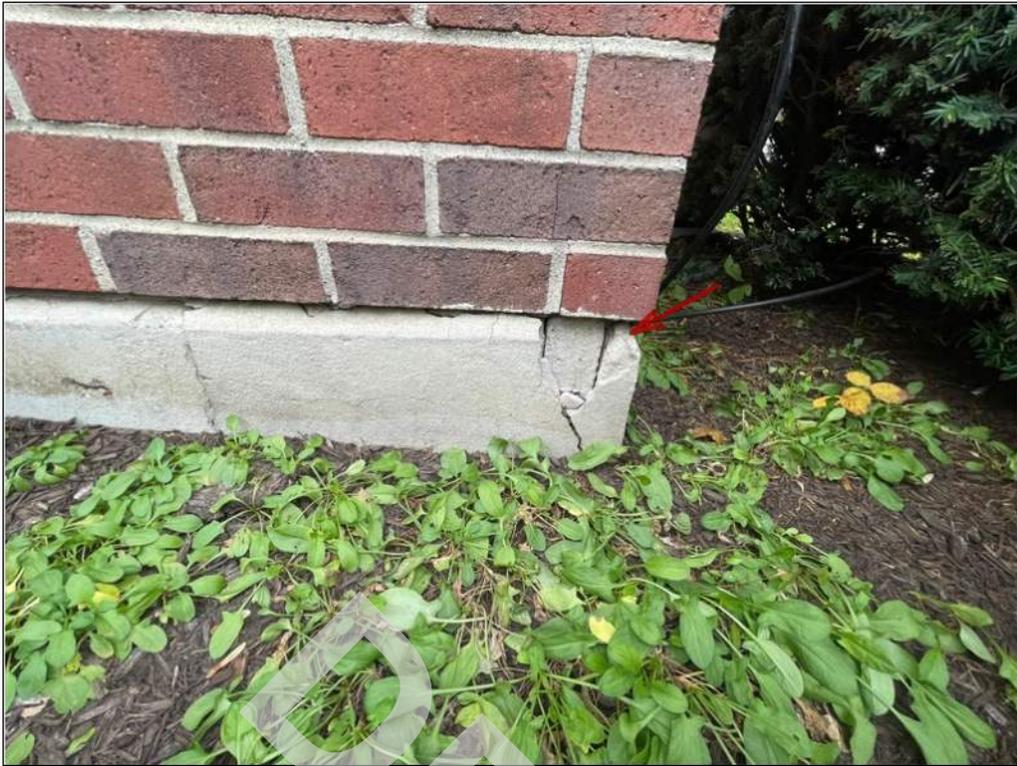
3 - Areas along of the cast-in-place reinforced concrete foundations walls have spalled and appear to have been previously repaired.

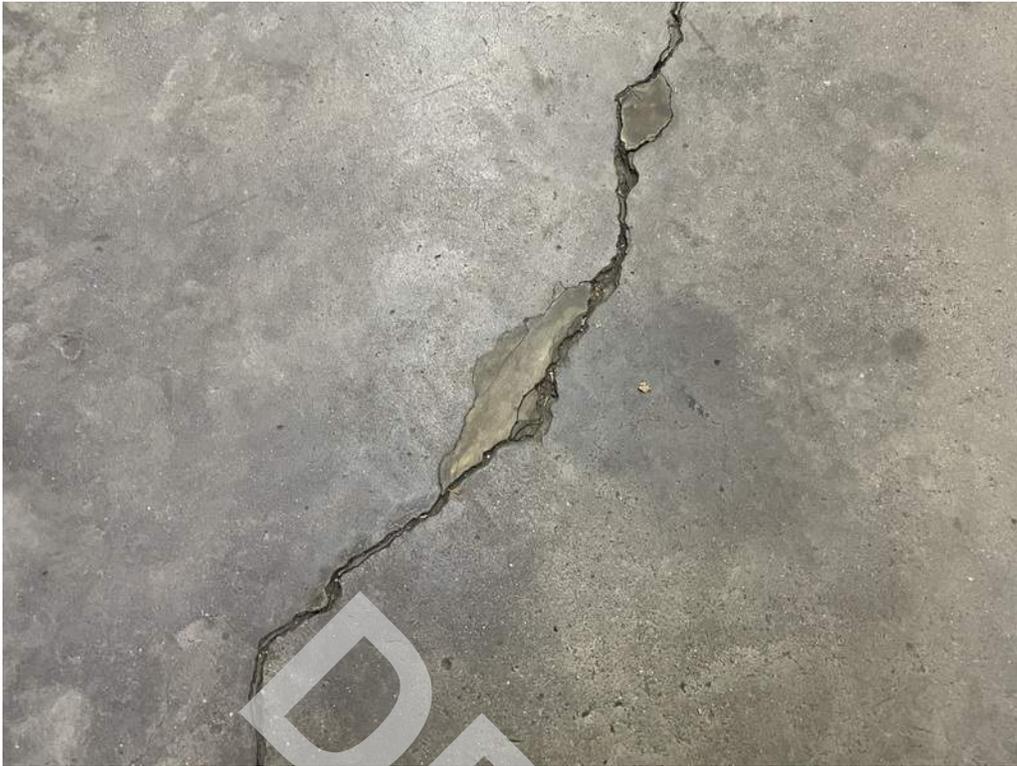
5 - Evidence of previously repaired cracks on the apparatus room slab on grade.

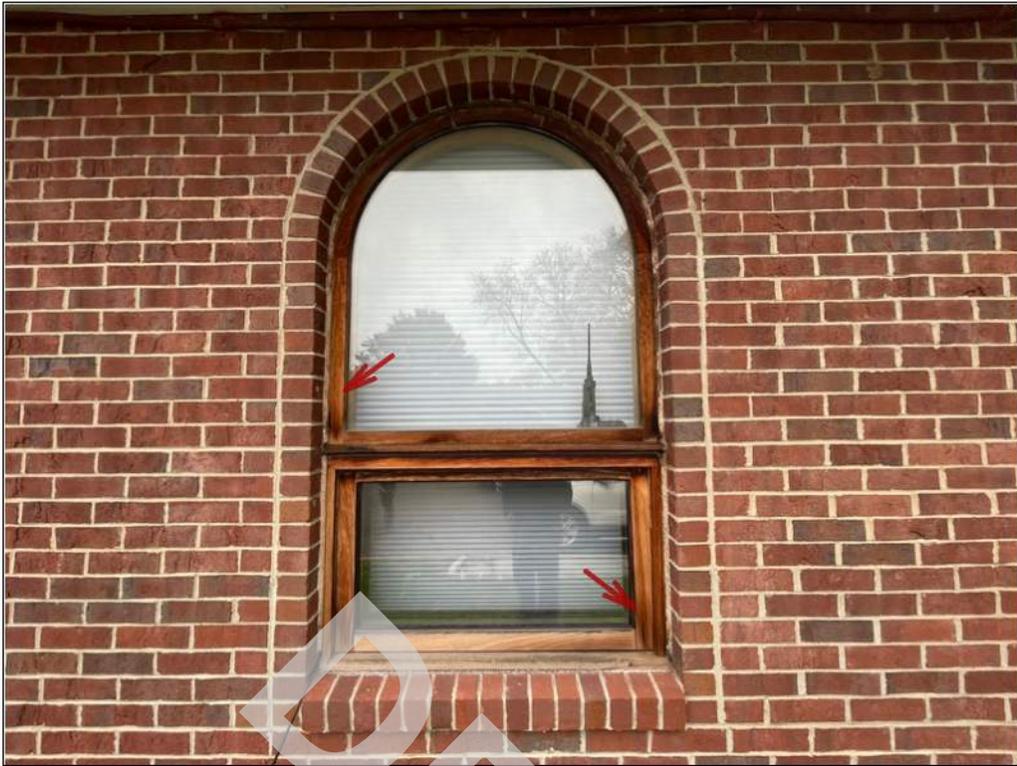
11 - Wood framing surfaces at the operable and fixed windows throughout the building have worn out and are in fair condition.

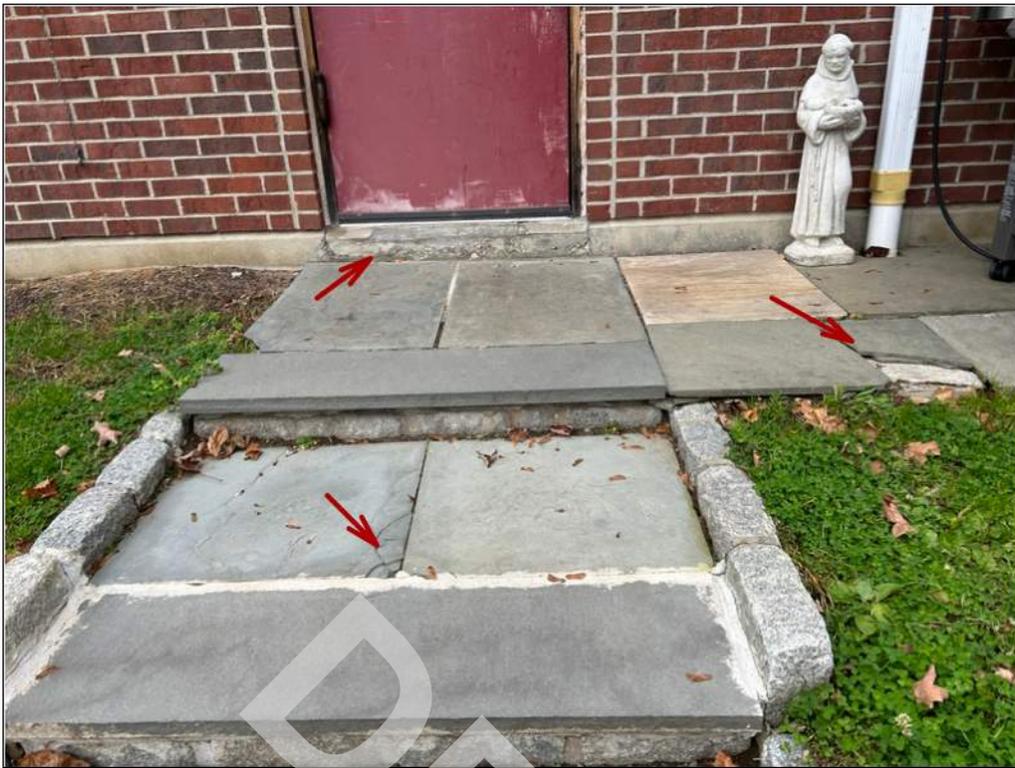
17 - Stone pavers have cracked and are missing pieces.

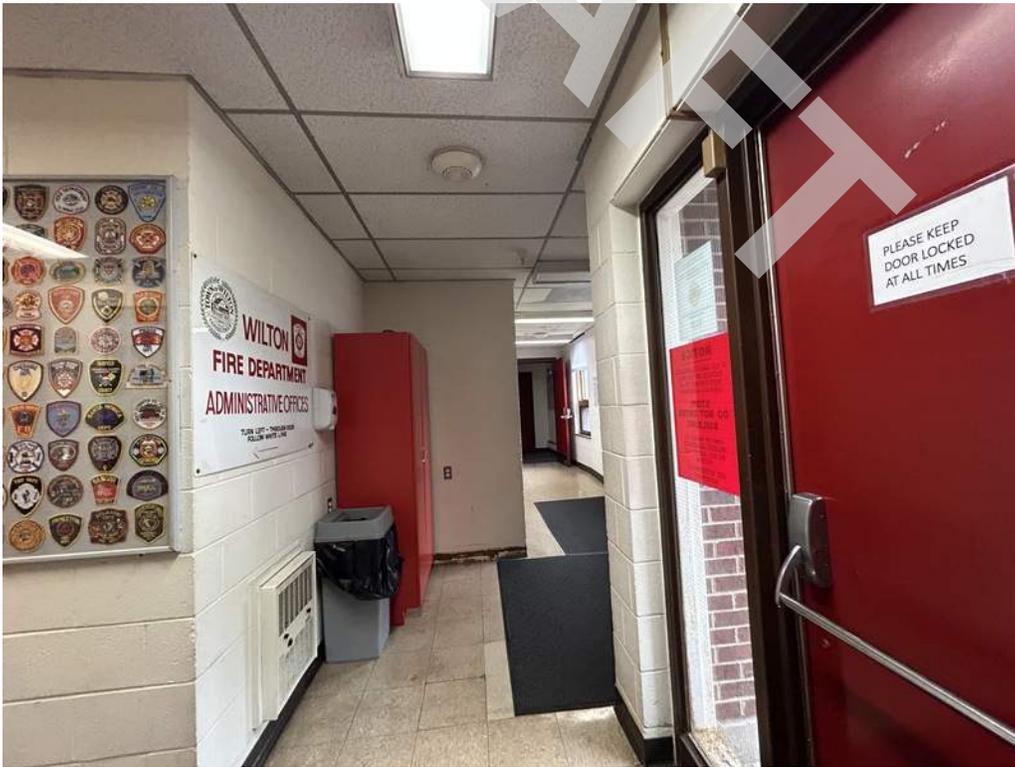
18 - Interior corridor finishes generally consist of painted gypsum walls boards or masonry, suspended ceilings with acoustic tiles, and vinyl composite tile floors. Chipped floor tiles and missing baseboards were observed.

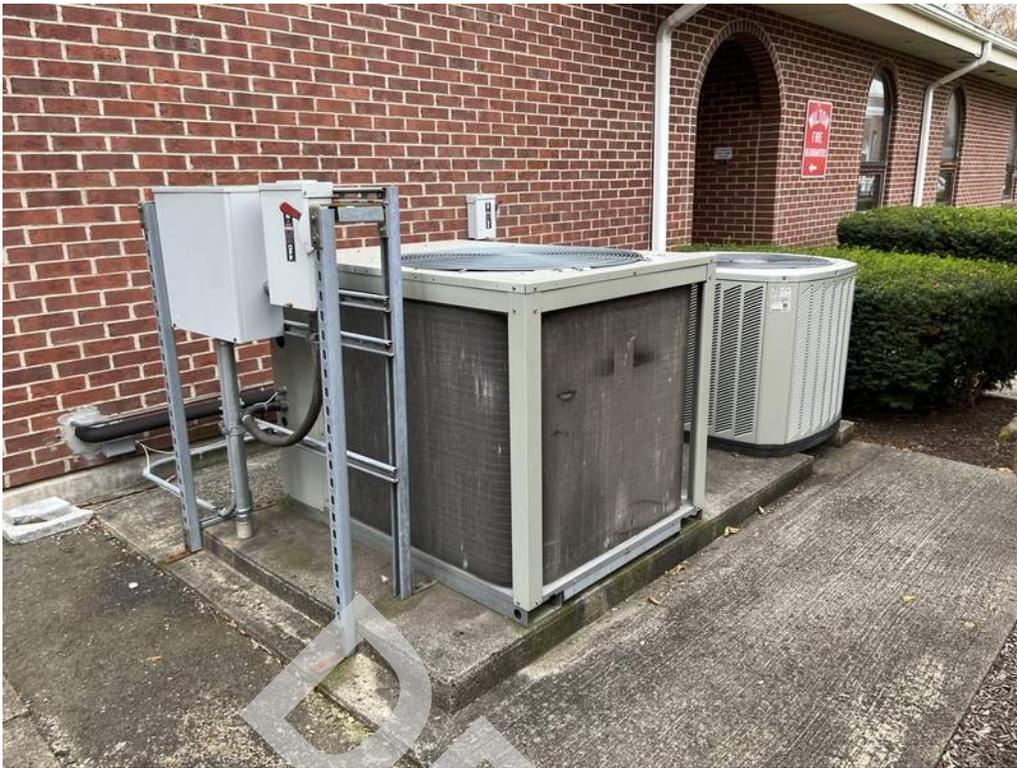
19 - Split system air conditioning units are located on the exterior of the building and provide cooling throughout the building.

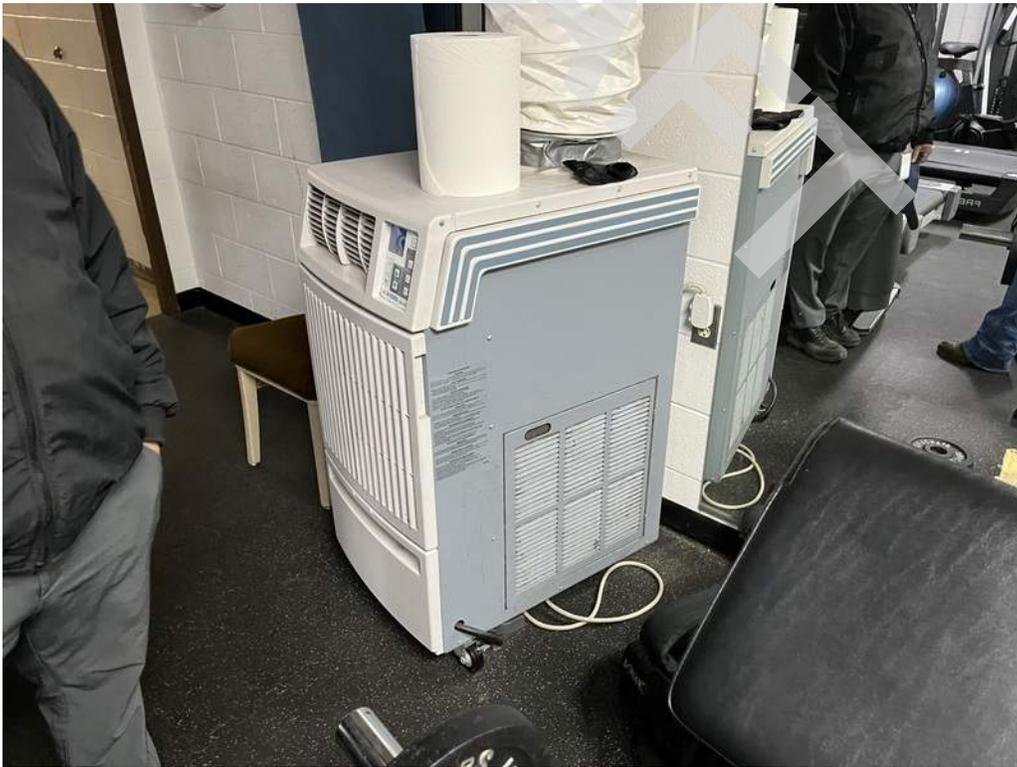
20 - A portable air conditioning unit is utilized for supplemental cooling in the gym.

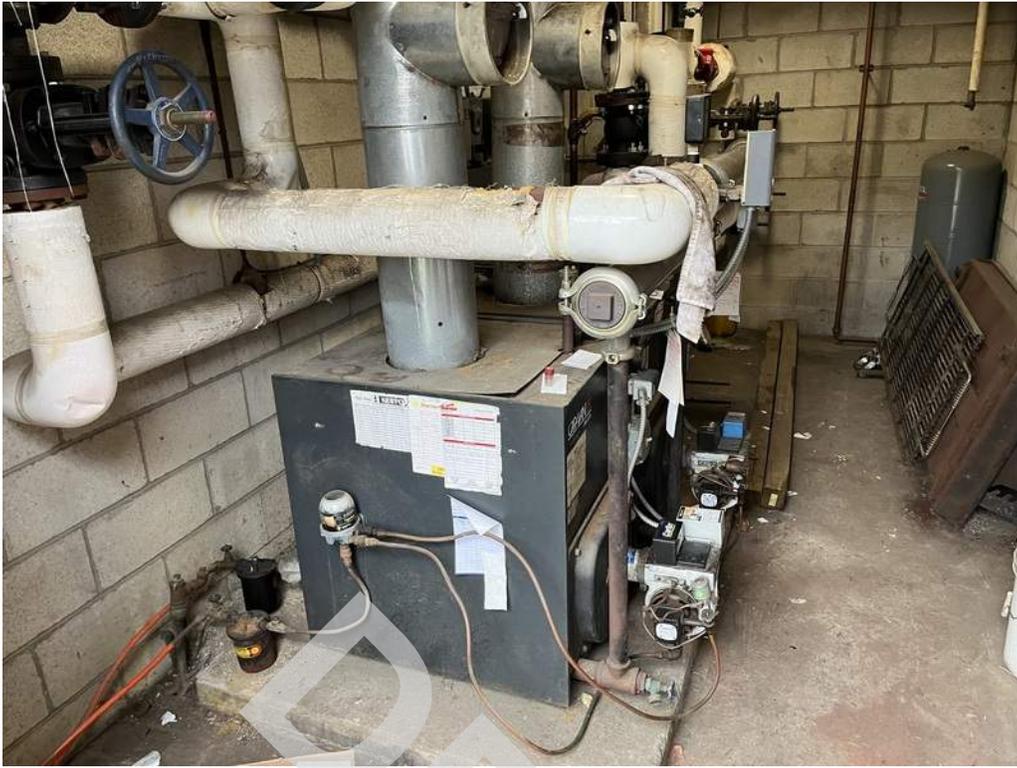
21 - Two oil fired boilers provide heating hot water throughout the building.

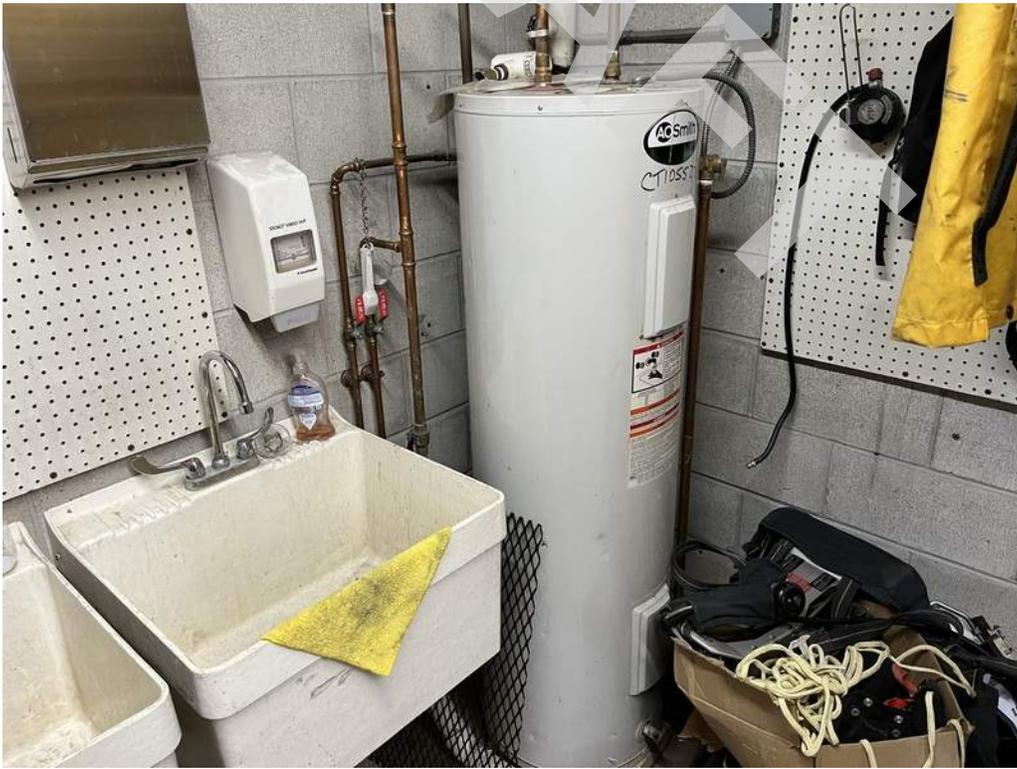
22 - An electric storage-type water heater located on the first floor provides hot water throughout the building.

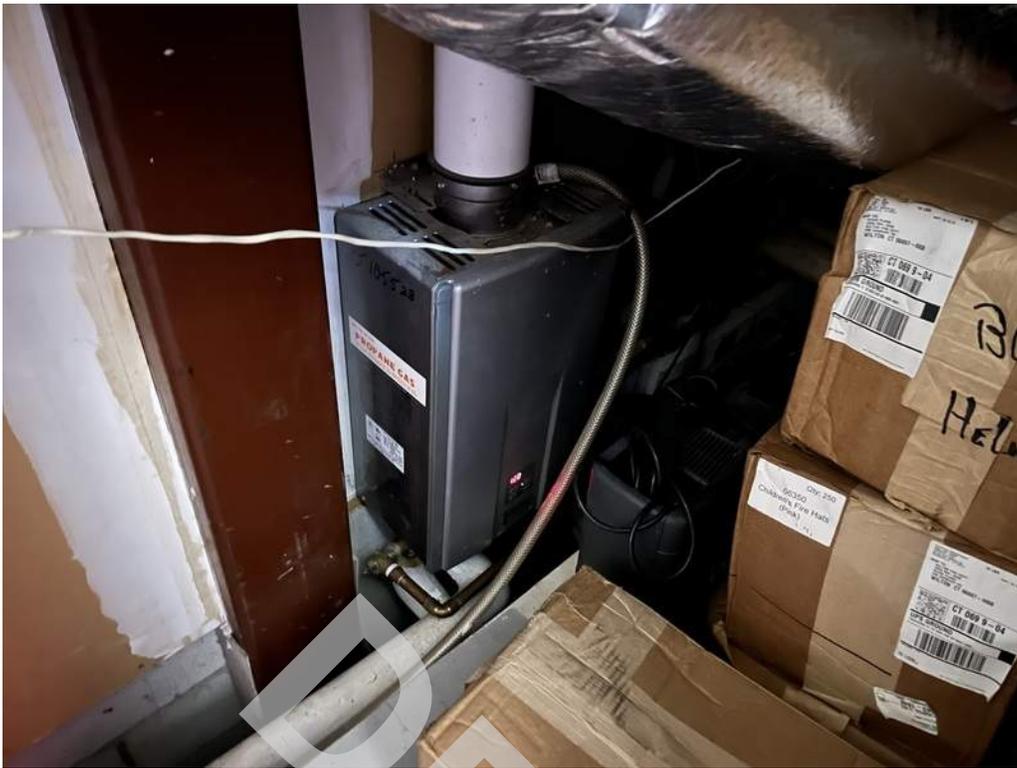
23 - A propane fired tankless water heater is located on the second floor and provides hot water throughout the building.

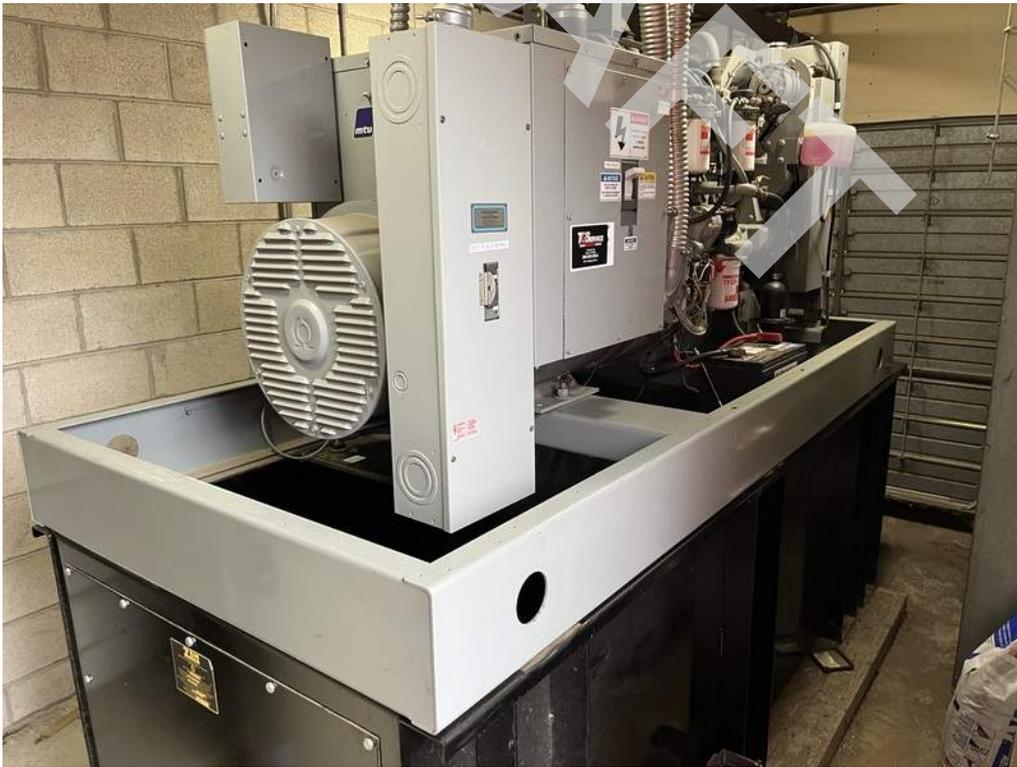
24 - A diesel-fired emergency generator located in a generator room in the Fire Headquarters provides emergency power to the Fire Headquarters and Garage buildings.

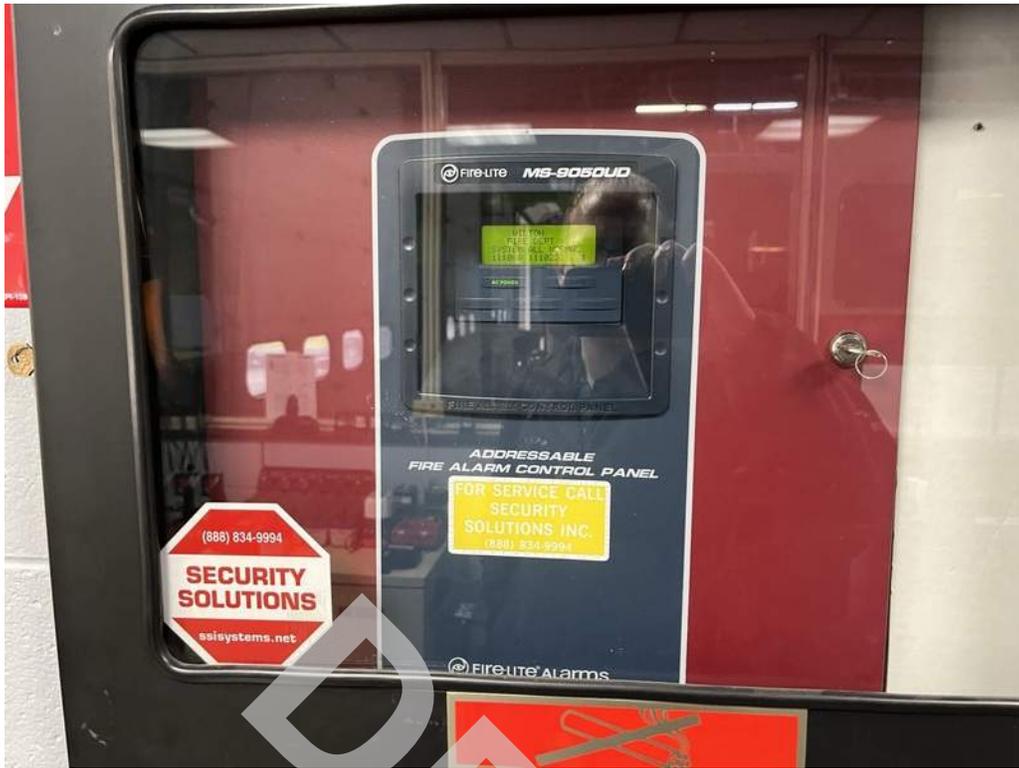
25 - The building is provided with a MS-9050UD Fire Alarm Panel.

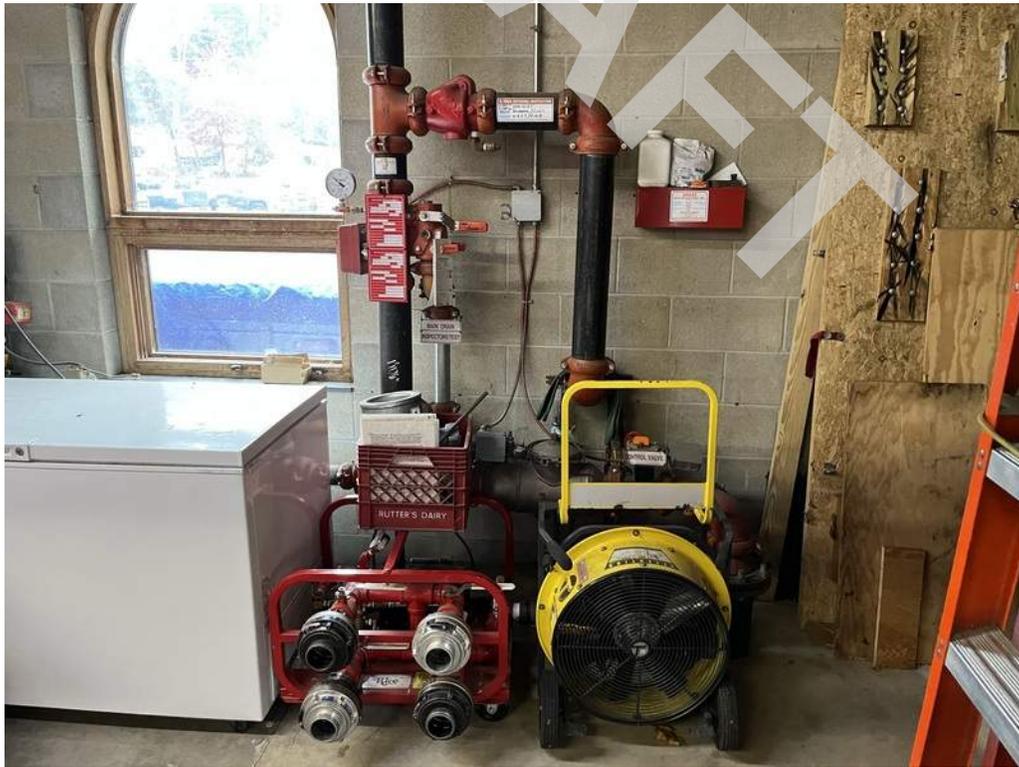
26 - The building is equipped with a wet sprinkler system.

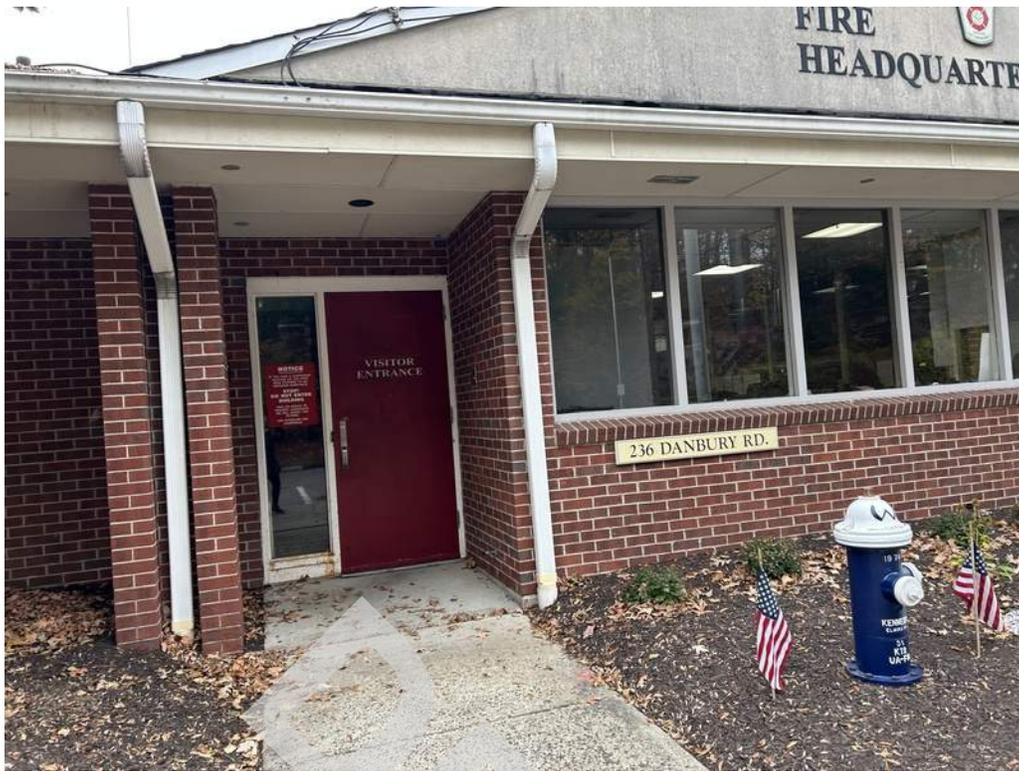
27 - The visitor entrance provided at the rear side of the building is non compliant as the threshold exceeds the allowable height.

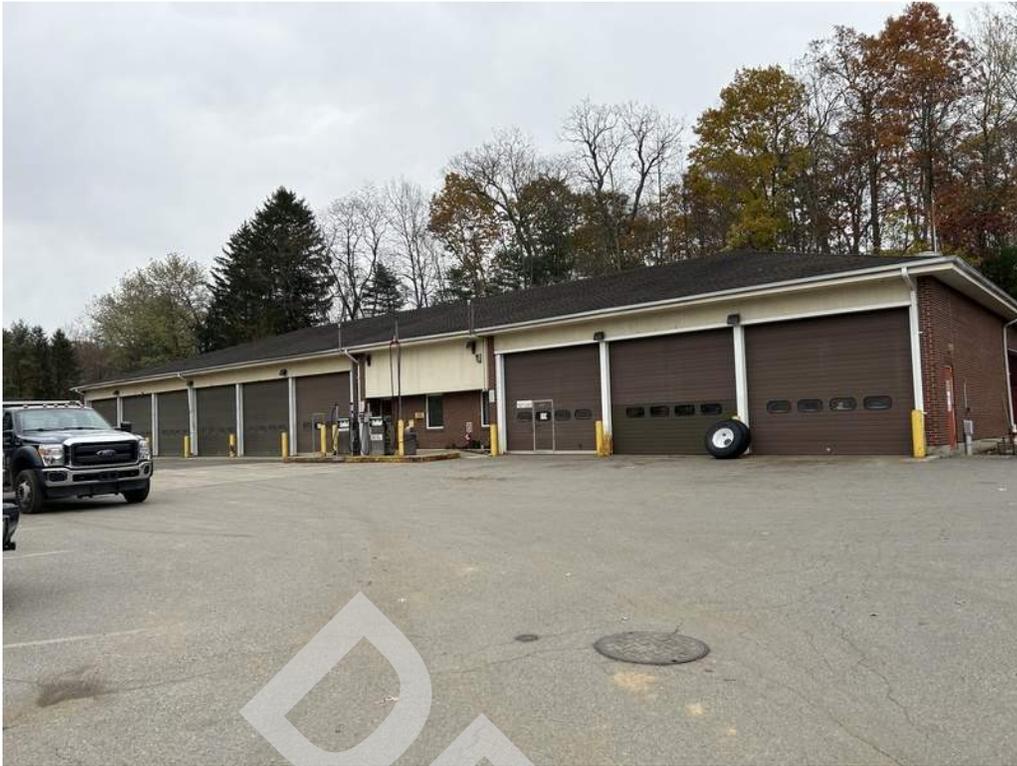
1 - Overview of the garage building.

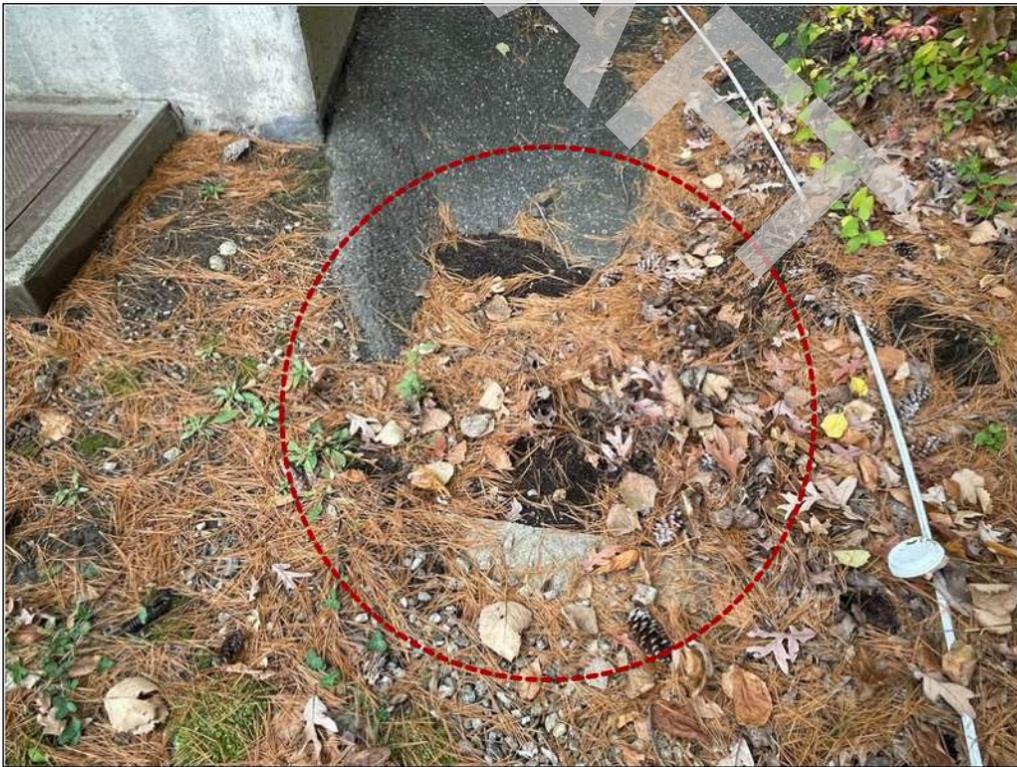
2 - Debris from the adjacent vegetation has clogged the catch basin.

#	Item	QTY	Unit	Unit Cost	EUL	EFF Age	Year 1	Year 2	Year 3	Year 4	Year 5	Year 6	Year 7	Year 8	Year 9	Year 10	Total Cost	Comments
<b>SITE</b>																		
1	Ⓟ Building Integrity: Advisory - The catch basin at the south west corner of the building was noted to have debris accumulation and does not appear to be providing adequate drainage. Remove all debris as part of a regular maintenance and repair program. Work can be done by maintenance personnel, therefore, no budget is provided.	0	EA	\$0.00			\$0										\$0	Priority 2 - Potentially Critical.
2	Appearance - See the Town Hall cost table for recommendations on asphalt paved drive lanes and parking areas.	0	EA	\$0.00	0	0	\$0										\$0	Priority 4 - Recommended.
3	Ⓟ Building Integrity: Instances of spalled and cracked concrete was observed a localized areas at the concrete aprons and walkways. Patch or remove and repour concrete. Budget includes approximately 10% of the concrete paved surfaces. Work to include scraping and repainting bollards.	250	SF	\$20.00	0	0	\$5,000										\$5,000	Priority 4 - Recommended.

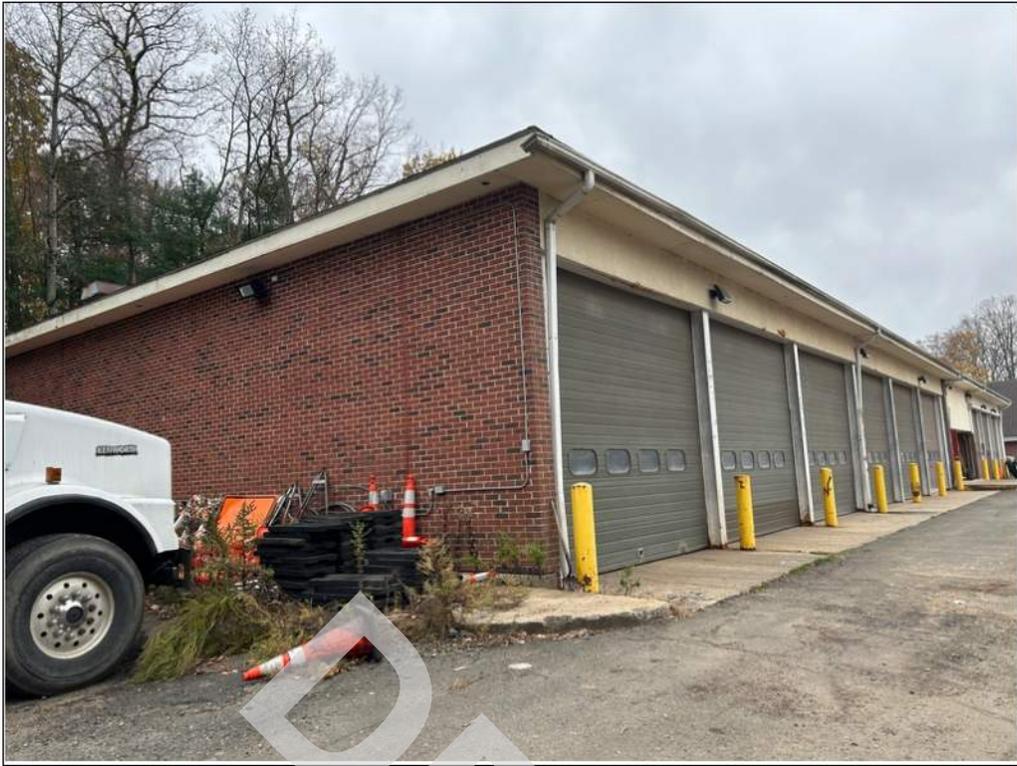
3 - Spalled concrete was observed at the concrete aprons and corrosion was noted as several bollards.

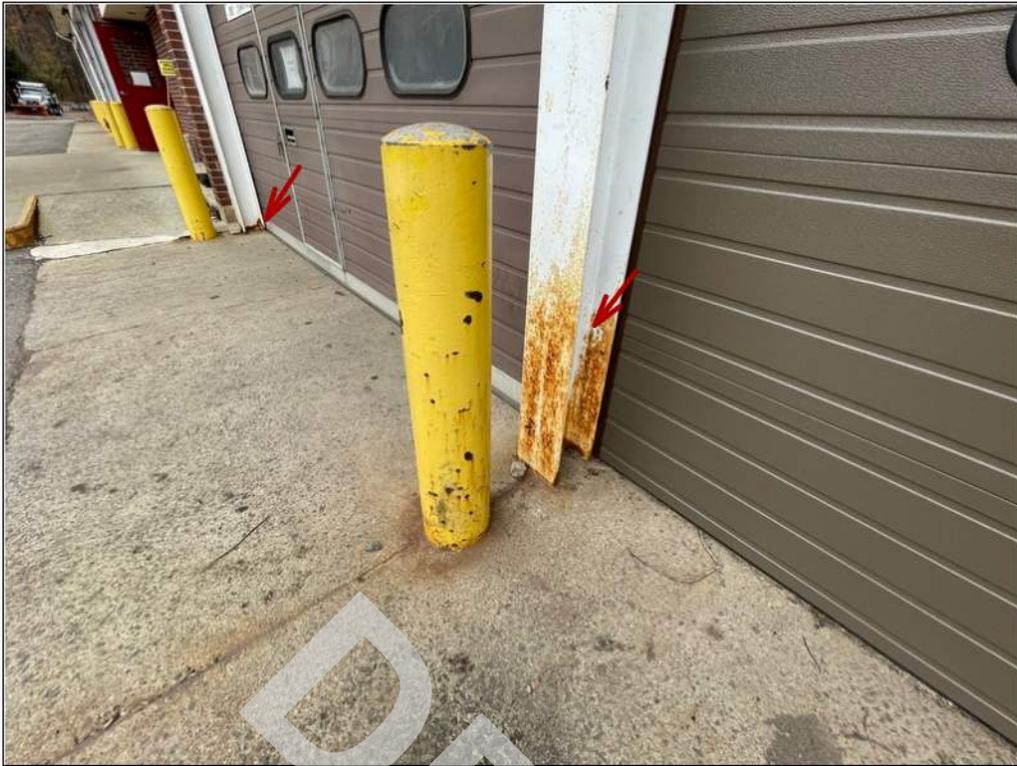
5 - Steel column surfaces have corroded.

<b>STRUCTURE</b>																		
4	Ⓟ Building Integrity: Vertical support system consist of steel columns along the exterior perimeter of the building. Metal surfaces and finishes are in poor condition, including corroded metal surfaces and peeling finish. Remove corrosion from metal surfaces, prepare for painting and paint throughout.	150	EA	\$20.00			\$3,000										\$3,000	Priority 3 - Necessary - Not Yet Critical.
5	Ⓟ Building Integrity: The building enclosure and structure along the south side of the building consists of cast-in-place reinforced concrete walls. Localized cracks along the interior wall surfaces were noted. Repair cracks.	50	LF	\$100.00			\$5,000										\$5,000	Priority 3 - Necessary - Not Yet Critical.
6	Ⓟ Building Integrity: The slabs at the garages consist of reinforced concrete slabs-on-grade. Localized areas of the slabs have cracked and spalled. Perform a phased slab replacement program, starting with the damaged areas in the first stage and the remaining areas when they reach the end of their useful life. Scope of work includes providing new floor drains, piping, vapor barrier, and repairing subgrade conditions.	9,000	SF	\$25.00	50	44	\$160,000					\$65,000					\$225,000	Priority 3 - Necessary - Not Yet Critical.

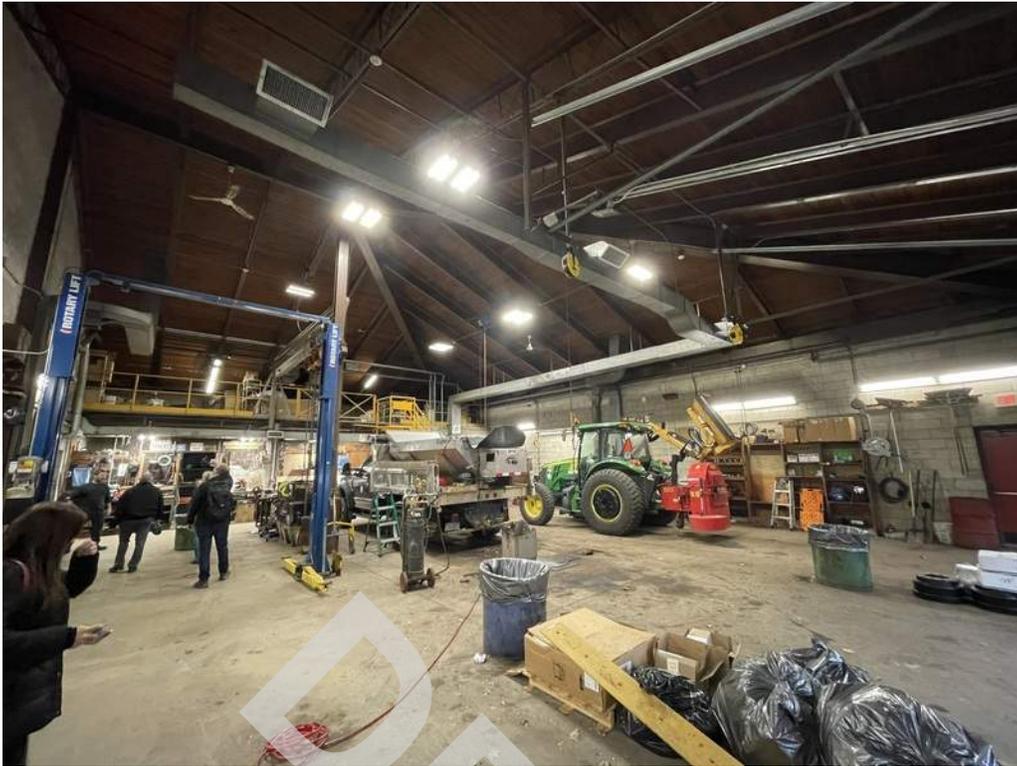
7 - Overview of the east side garage bays.

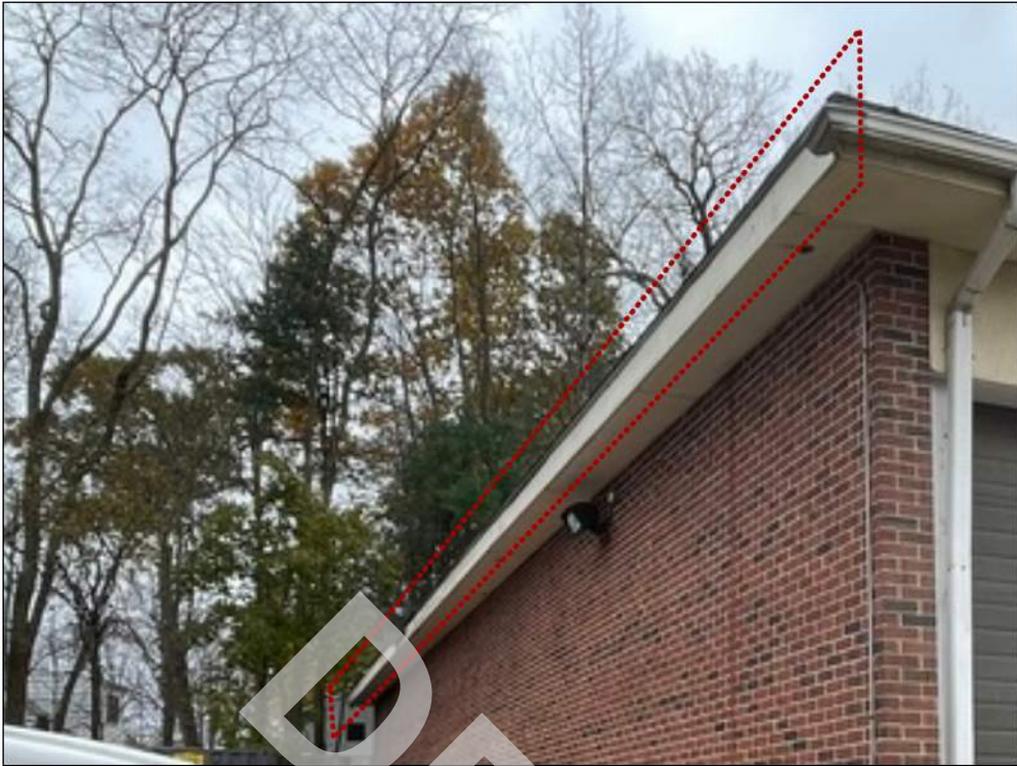
11 - Close up view of missing roof gutter along the east end of the building.

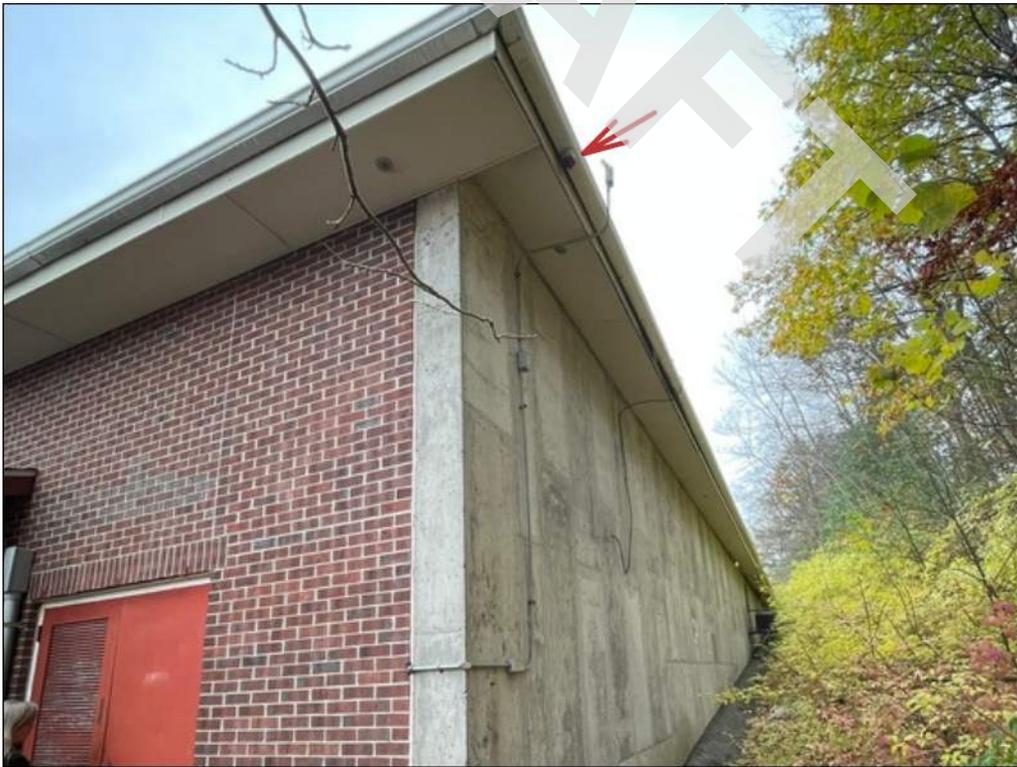
12 - A roof leader is missing along the south side of the building.

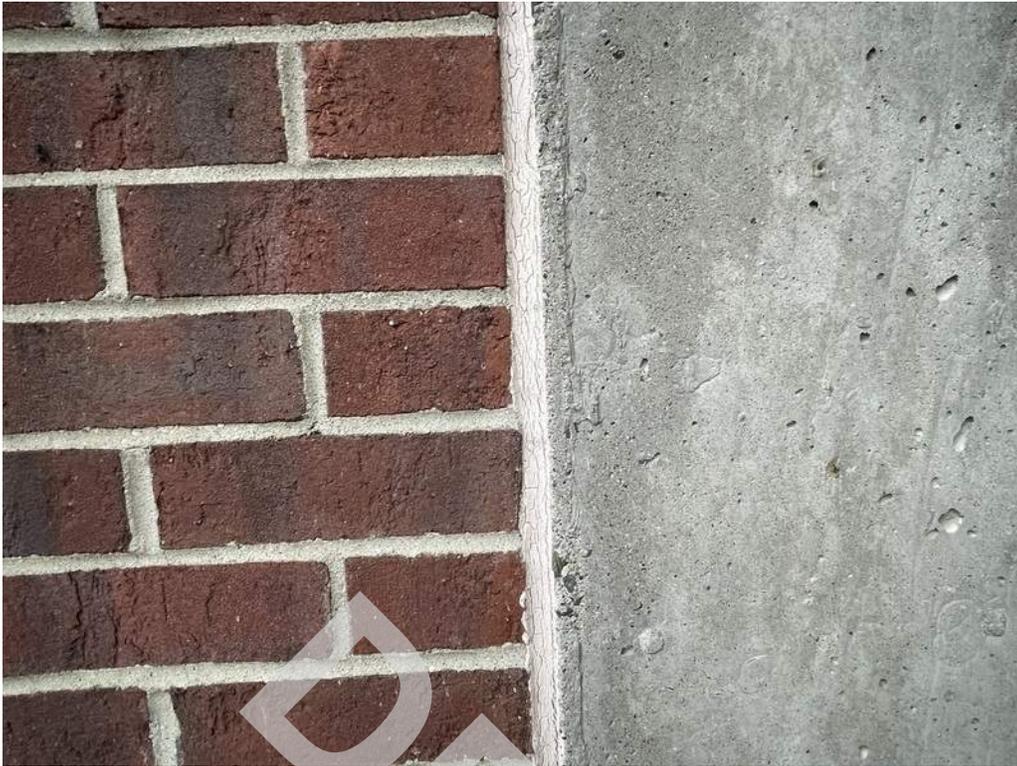
13 - The joint sealant between the brick masonry unit and concrete wall has failed.

15	Ⓟ Building Integrity: Façade consist of brick masonry unit walls with control joint sealant. Sealant appears to be in poor condition and is nearing the end of its useful life. Replace all exterior wall joint sealant. Budget includes façade access.	300	LF	\$15.00	15	14	\$4,500										\$4,500	Priority 3 - Necessary - Not Yet Critical.
16	Ⓟ Building Integrity: The building enclosure along the north façade includes an EIFS (exterior insulation finishing system). Localized areas of the EIFS are damaged. Patch and repair damaged areas. Budget includes providing resilient corner guards and façade access.	150	SF	\$30.00			\$4,500										\$4,500	Priority 3 - Necessary - Not Yet Critical.
17	Ⓟ Building Integrity: Doors around the perimeter consist of hollow metal door frames set in metal frames. The surfaces and finishes along the doors are in poor condition. Perform a door refurbishment program consisting on replacing damaged weather stripping components prepare for painting and painting metal door surfaces and frames.	1	LS	\$5,000.00			\$5,000										\$5,000	Priority 3 - Necessary - Not Yet Critical.

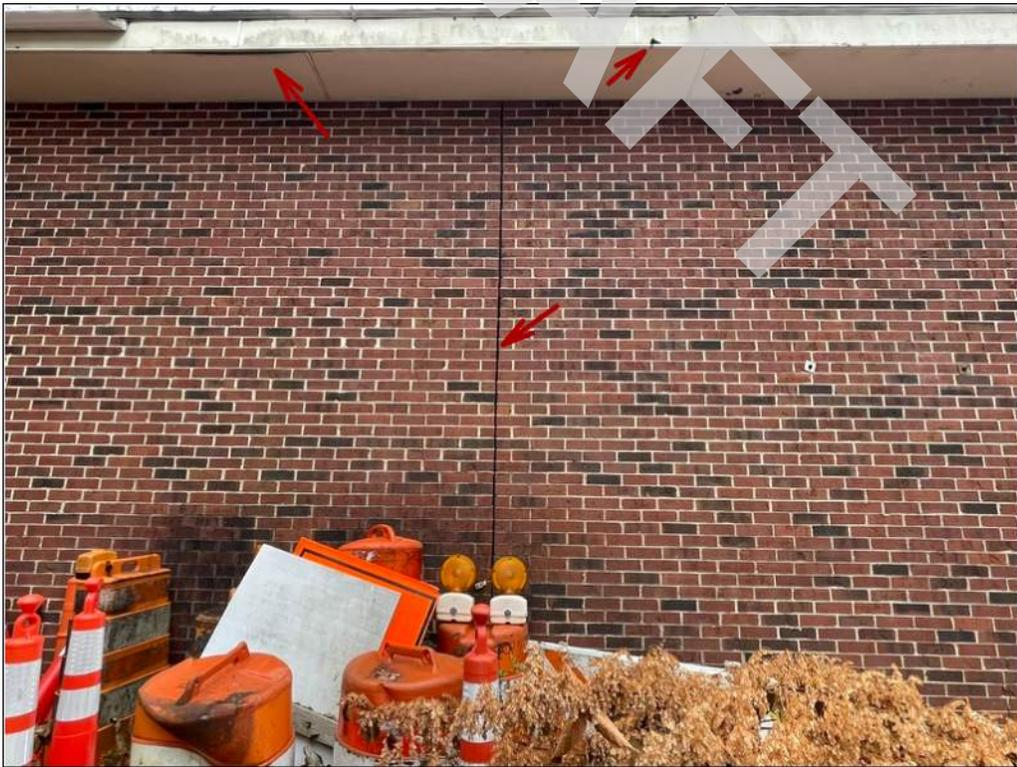
14 - Brick masonry unit wall control joint sealant is in poor condition. Soffit and fascia panels are aging.

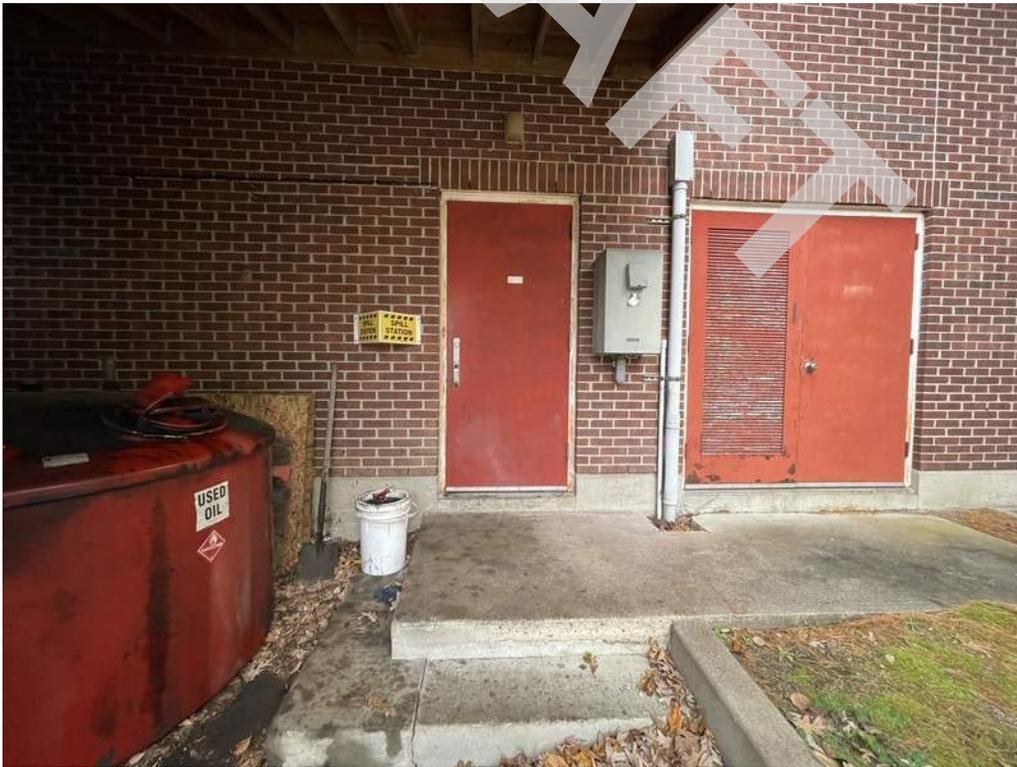
16 - Hollow metal frames and door surfaces are starting to corrode.
