# FACILITY CONDITION ASSESSMENT

## TOWN OF WILTON – TOWN BUILDINGS

Wilton, Connecticut

Draft: February 2, 2024

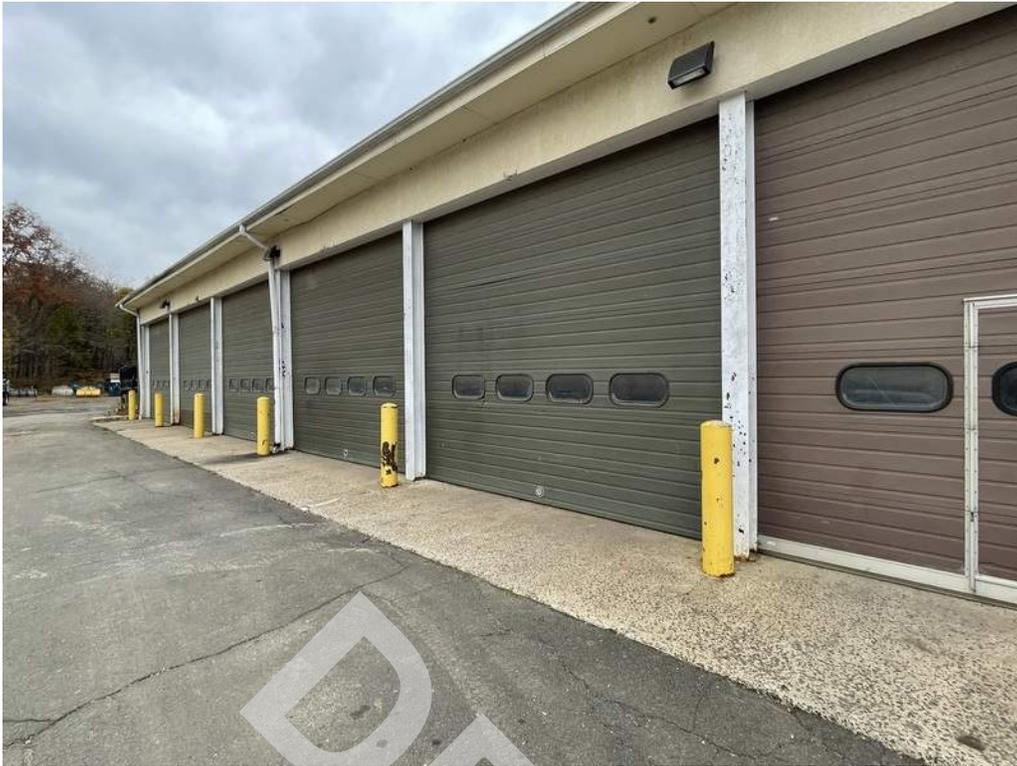
17 - Sectional overhead doors are provided at the garage.

18	Ⓟ Building Integrity: The building included nine sectional overhead doors. The doors appear to be in fair to poor condition with signs of repaired sections and corrosion along the metal rails and other metal components. No information was provided regarding the age of the doors and appear to be original to the construction of the building. Perform a phased replacement of all doors.	9	EA	\$10,000.00					\$30,000			\$30,000			\$30,000		\$90,000	Priority 3 - Necessary - Not Yet Critical.
19	Ⓟ Building Integrity: Soffit and trim along the perimeter of the room is in fair condition, with localized areas of sagging and detached panels. Repair or replace damaged panels throughout. Repair and replacement represents approximately 20% of all trim and soffit surfaces around the perimeter of the building. Budget includes façade access equipment	250	SF	\$24.00			\$6,000										\$6,000	Priority 3 - Necessary - Not Yet Critical.

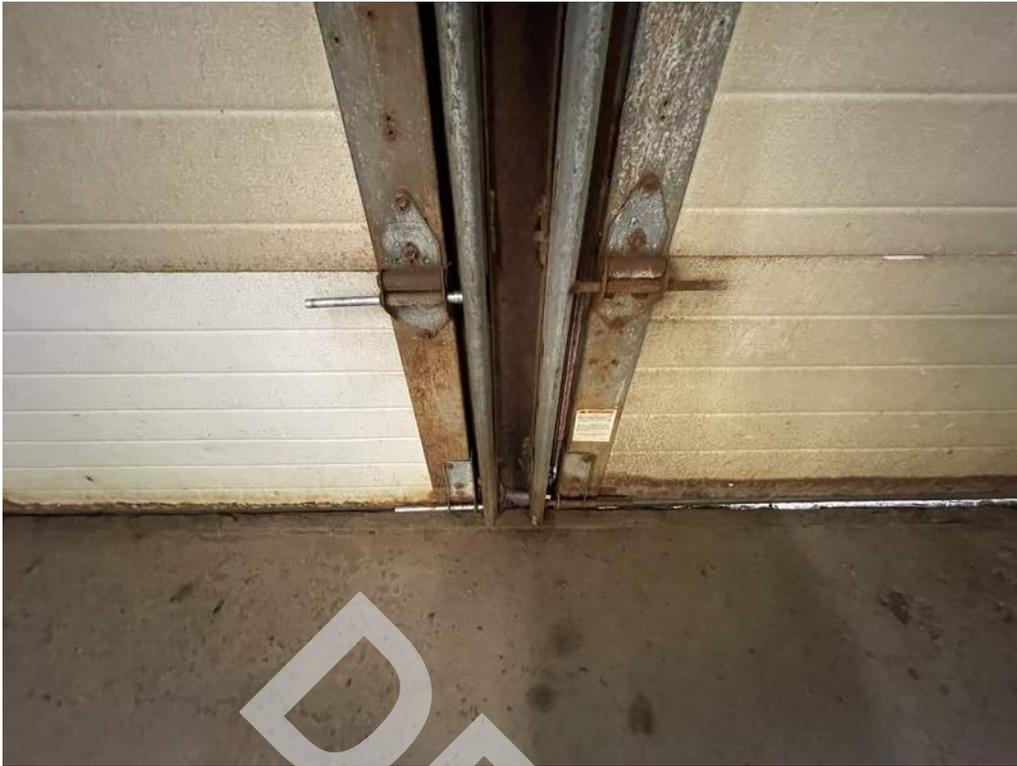
19 - Sectional overhead door metal components have corroded.

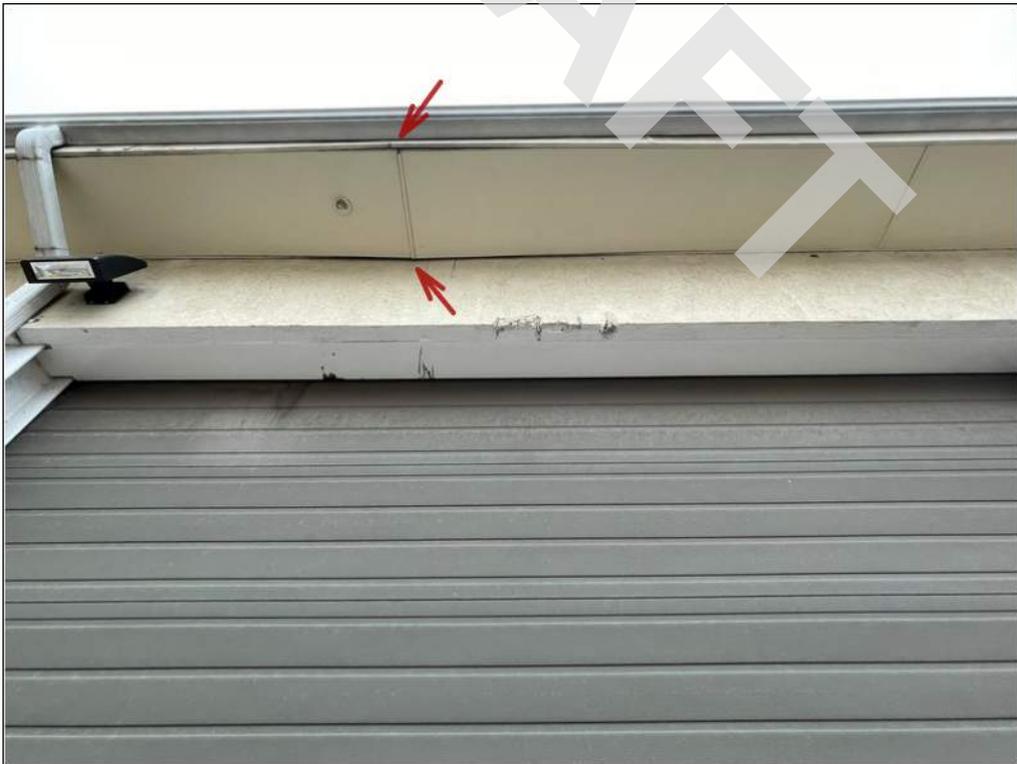
20 - Soffit and fascias are displacing.

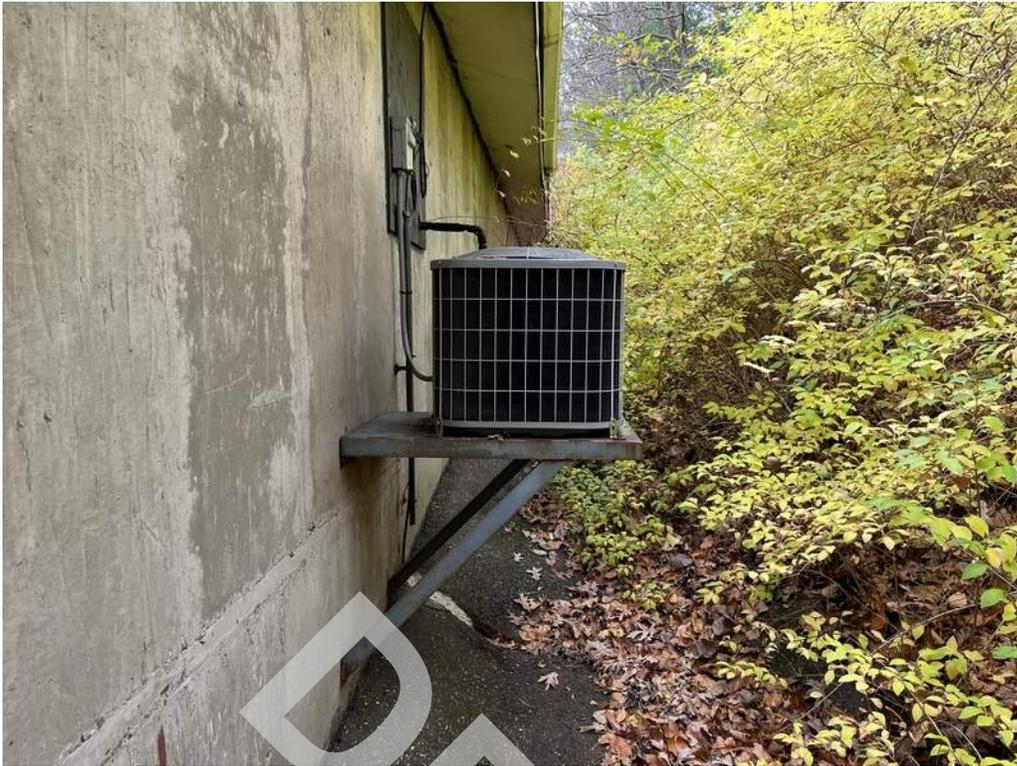
21 - A split system air conditioning unit located on the exterior of the building provides cooling to a portion of the building.

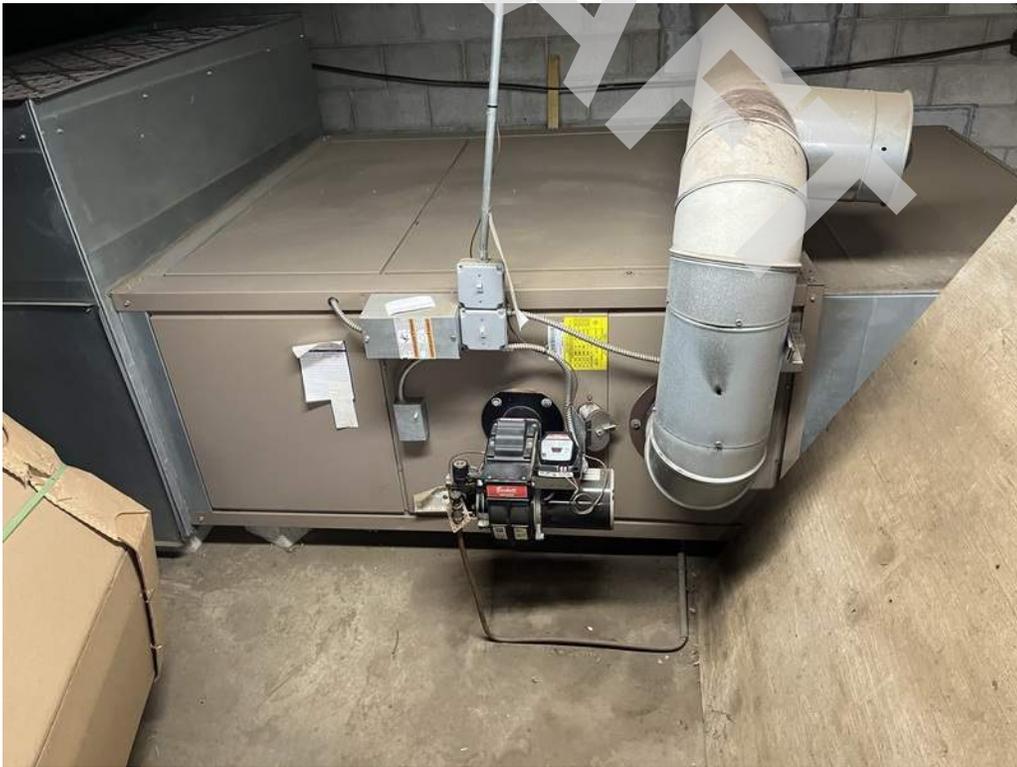
22 - Three oil fired furnaces located throughout the building provide heating throughout the building.

29	Building Integrity: Three oil fired furnaces provide heating to the building. The furnaces are located throughout the building, and have capacities ranging from 156,000 to 350,000 British Thermal Units (BTU) per hour. The furnaces were installed between 2005 and 2017 and reportedly function properly and appear to be in good condition. Replacement of the two older furnaces is recommended as they reach the end of their service life or as maintenance costs dictate. The budget includes a replacement in kind of the furnaces with the reuse of all associated piping. The furnaces were manufactured by Thermo Pride, Concord, and Allied Air.	2	EA	\$12,000.00	18	17	\$24,000										\$24,000	Priority 3 - Necessary - Not Yet Critical
30	Building Integrity: The building has a 50-gallon electric water heater located in the mechanical room of the building. Replace the water heater when it reaches the end of its service life or as maintenance costs dictate. The budget includes a replacement in kind with the reuse of all associated piping and electrical wiring. The water heater was manufactured by Bradford White.	1	EA	\$3,000.00	10	3							\$3,000				\$3,000	Priority 3 - Necessary - Not Yet Critical

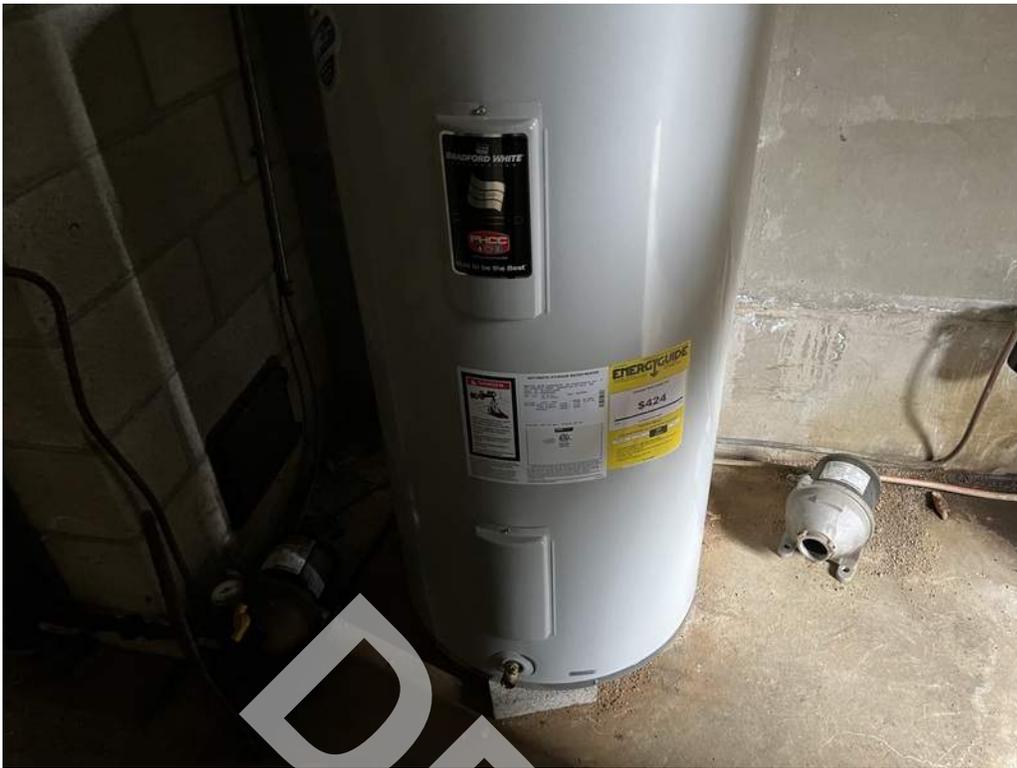
23 - An electric storage-type water heater is located in the mechanical room and provides hot water throughout the building.

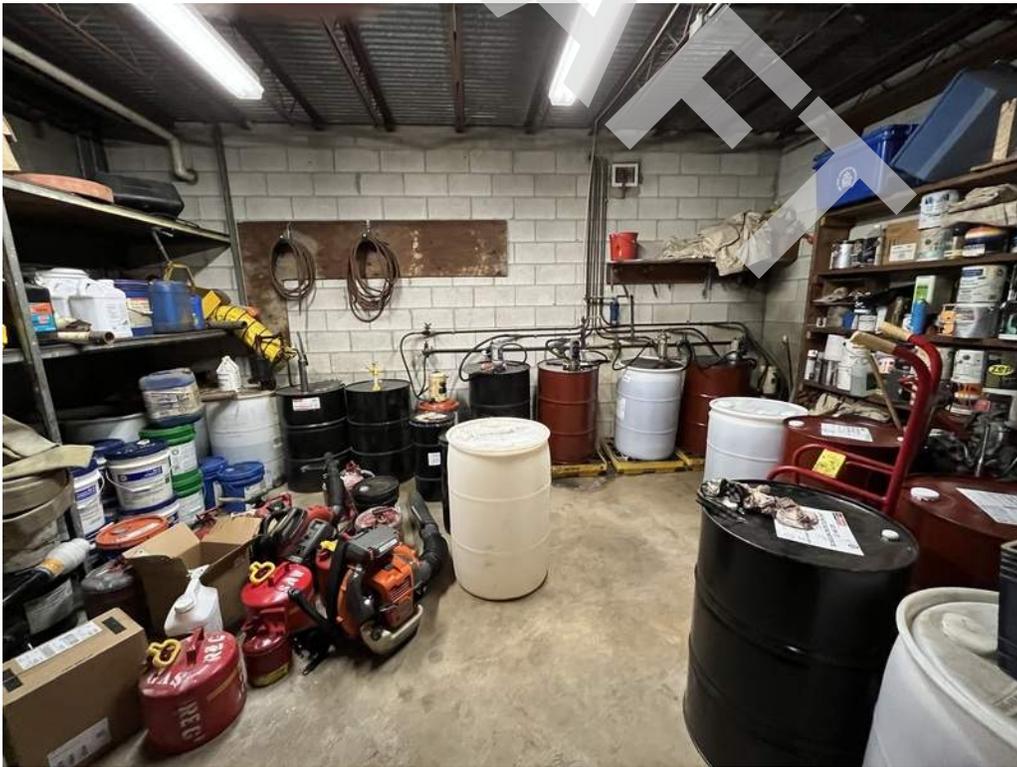
24 - Combustible liquids are stored in containers in a storage room.

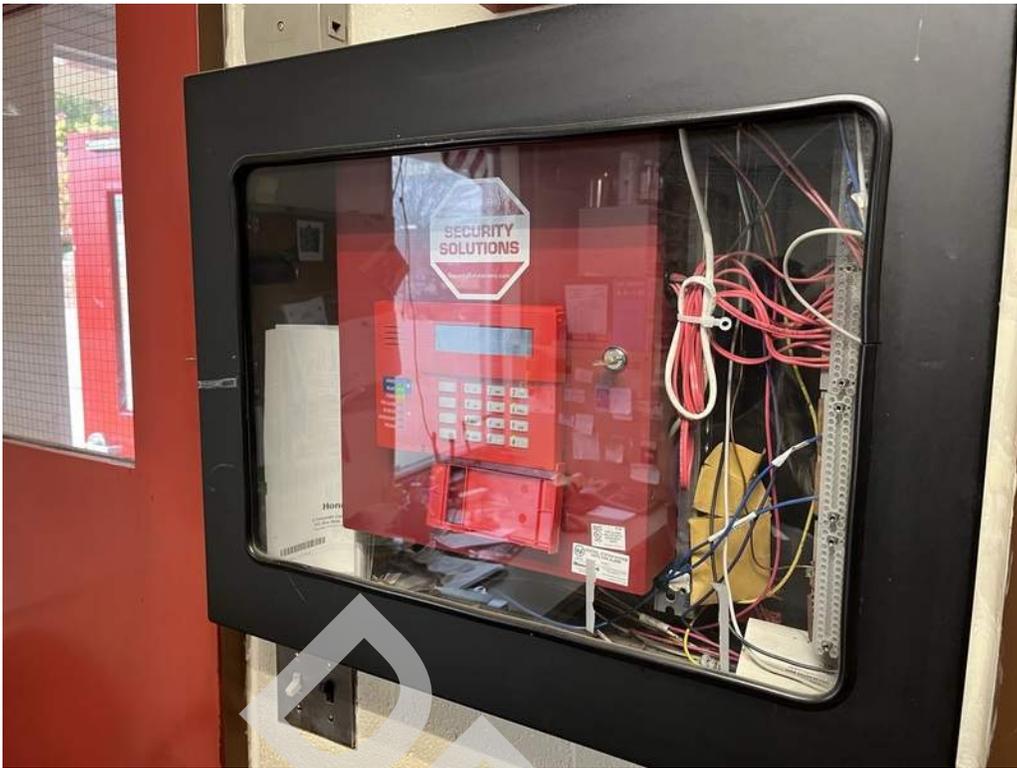
25 - The building is provided with a combination fire alarm/security alarm panel.

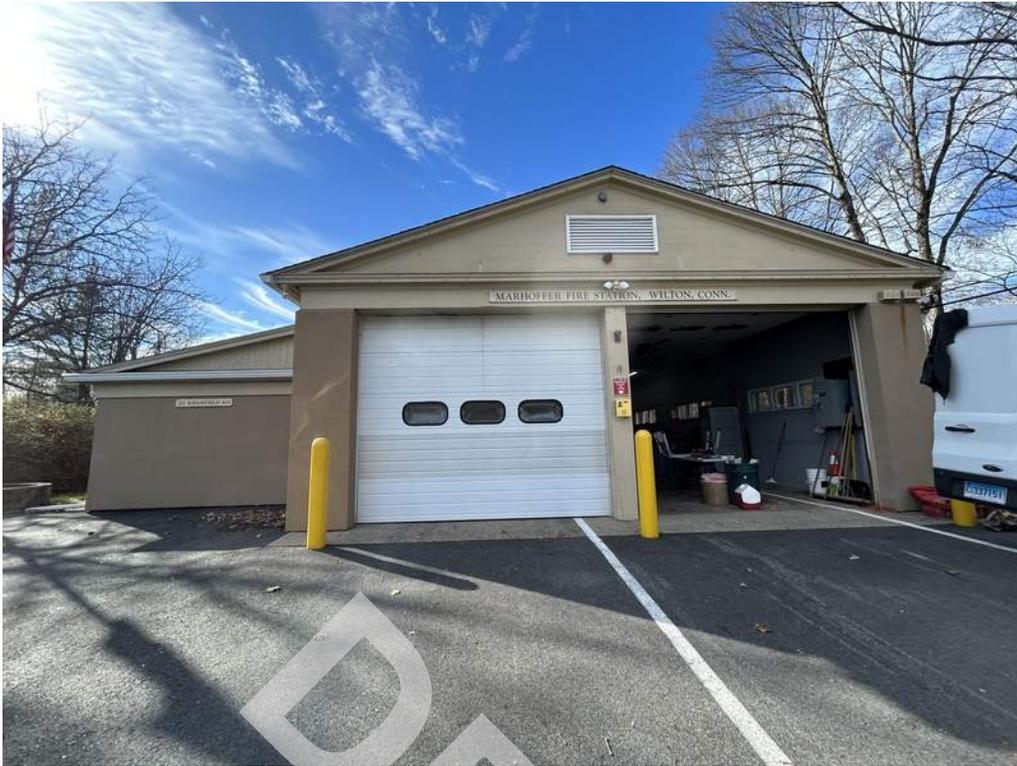
1 - Fire Station No. 2 front entrance.

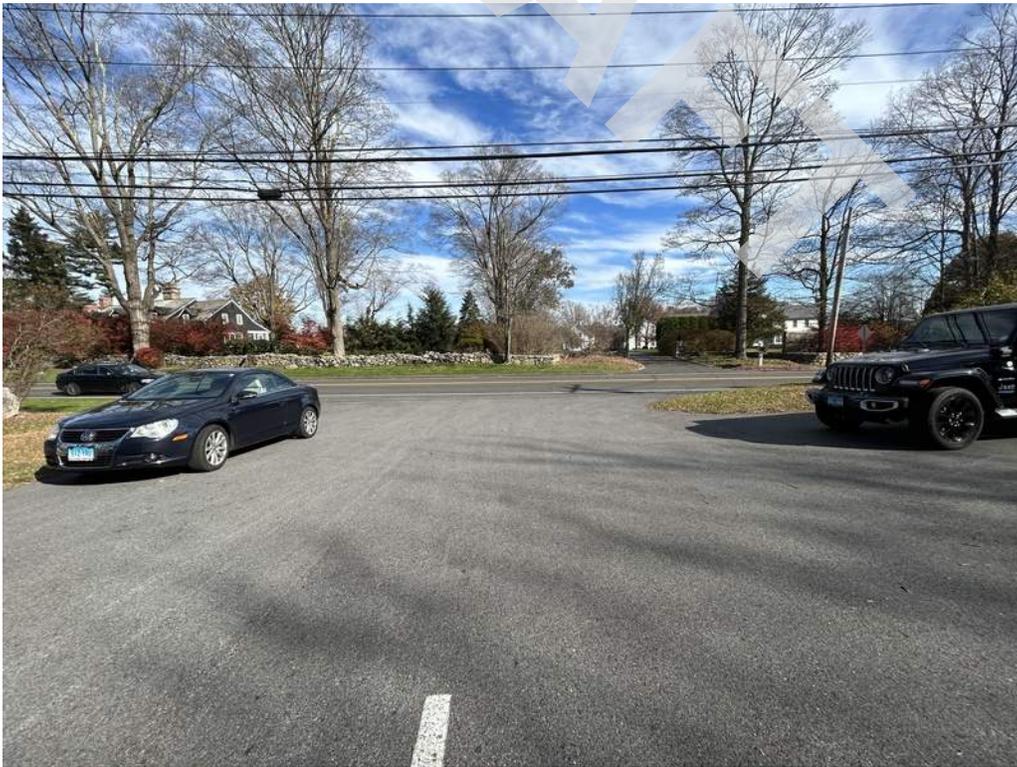
2 - The asphalt paved parking area was observed to generally be in good condition.

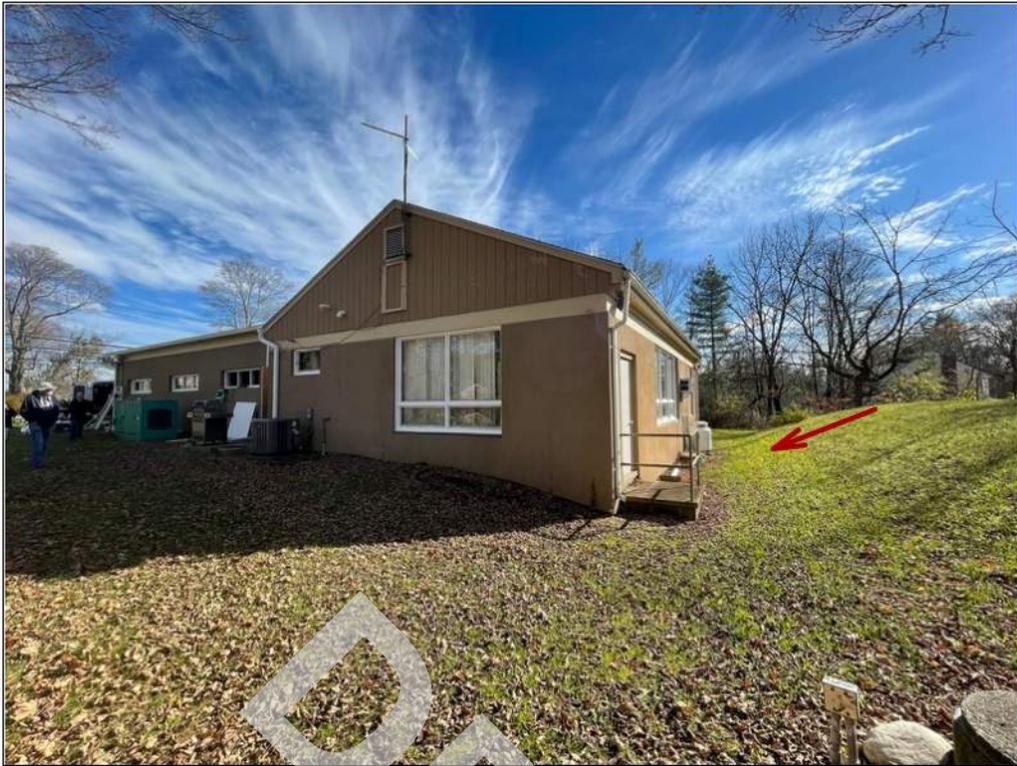
3 - Mound septic system is sloping towards the building's structure.

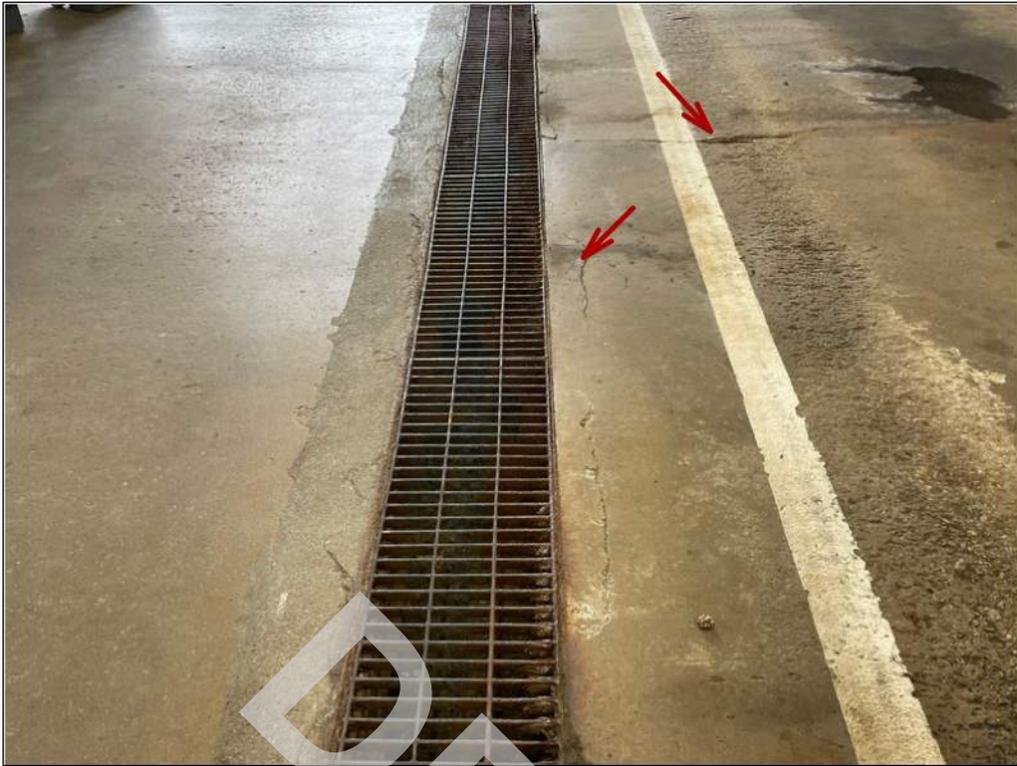
5 - Areas of the slab on the southern apparatus bay have cracked.

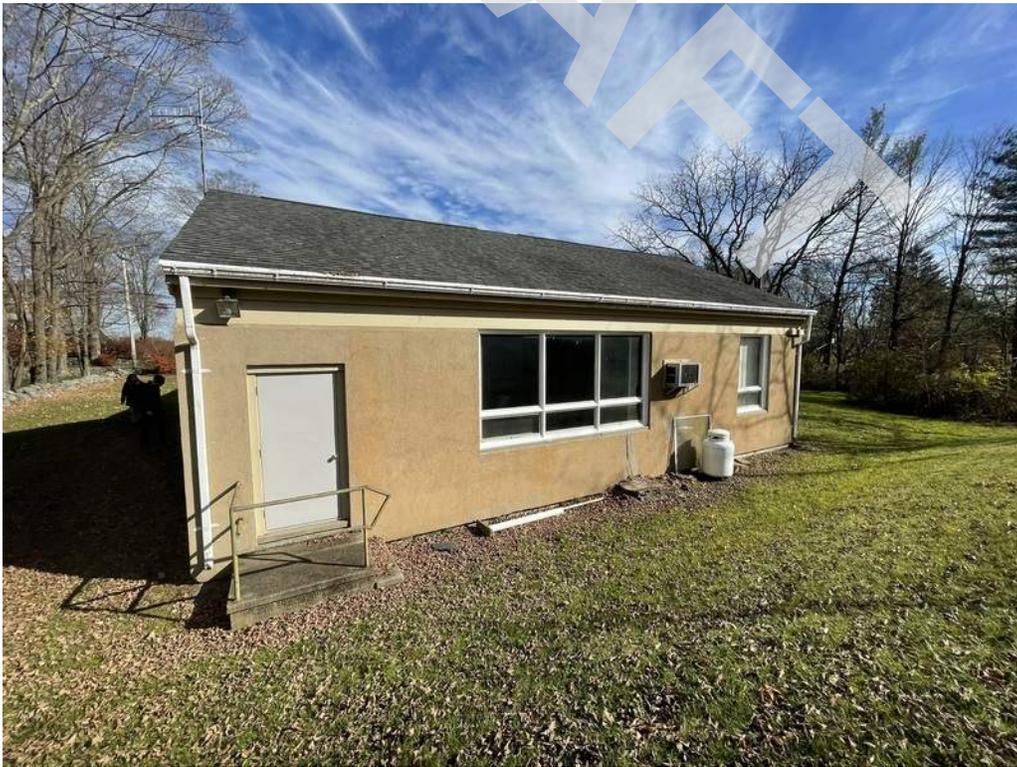
6 - Exterior walls consist of painted EIFS (exterior insulation finishing system). Windows consist of wood framed assemblies and the roof is covered with asphalt shingles.

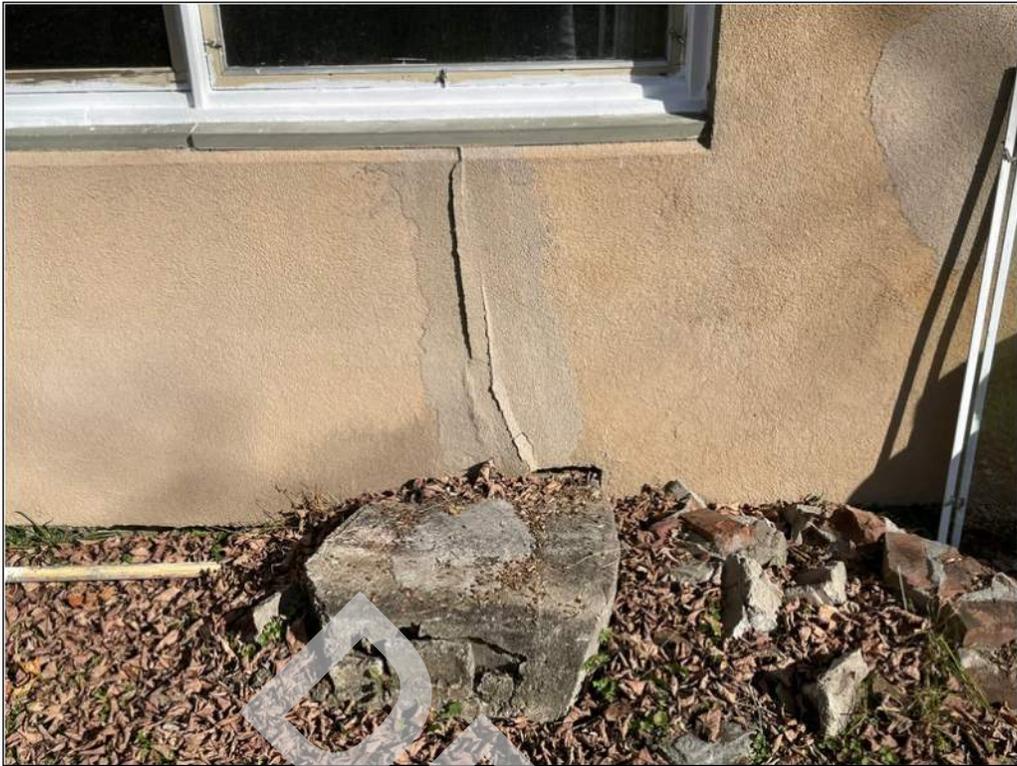
7 - Localized areas of the EIFS have cracked.

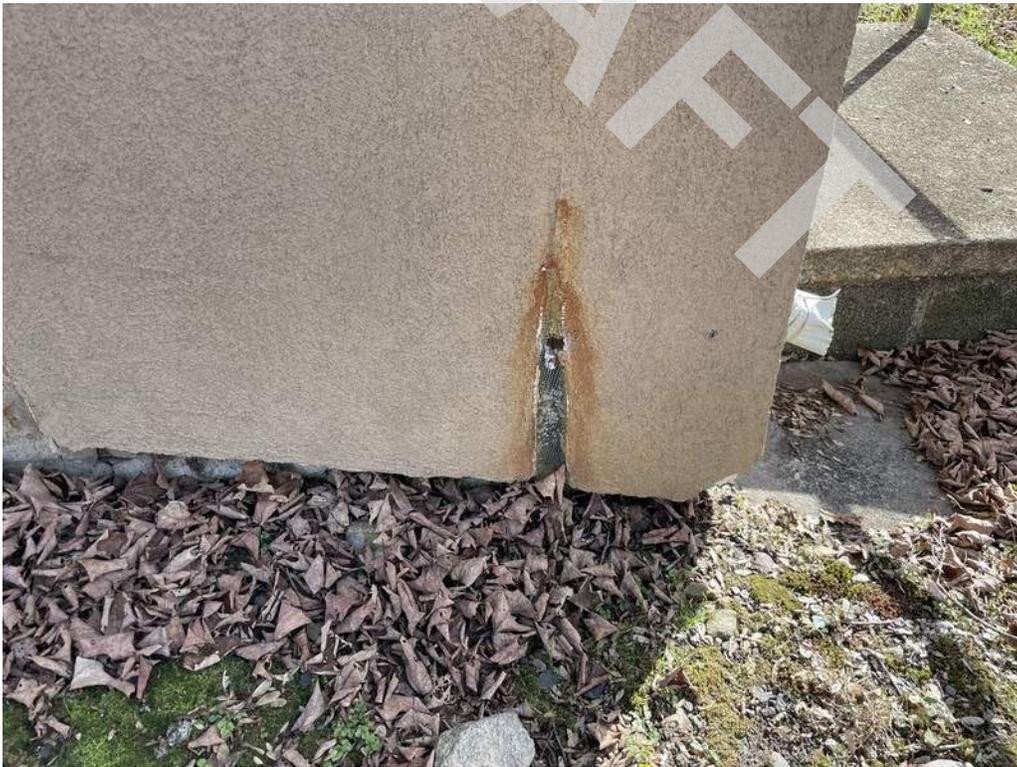
8 - Localized areas of the EIFS have eroded.

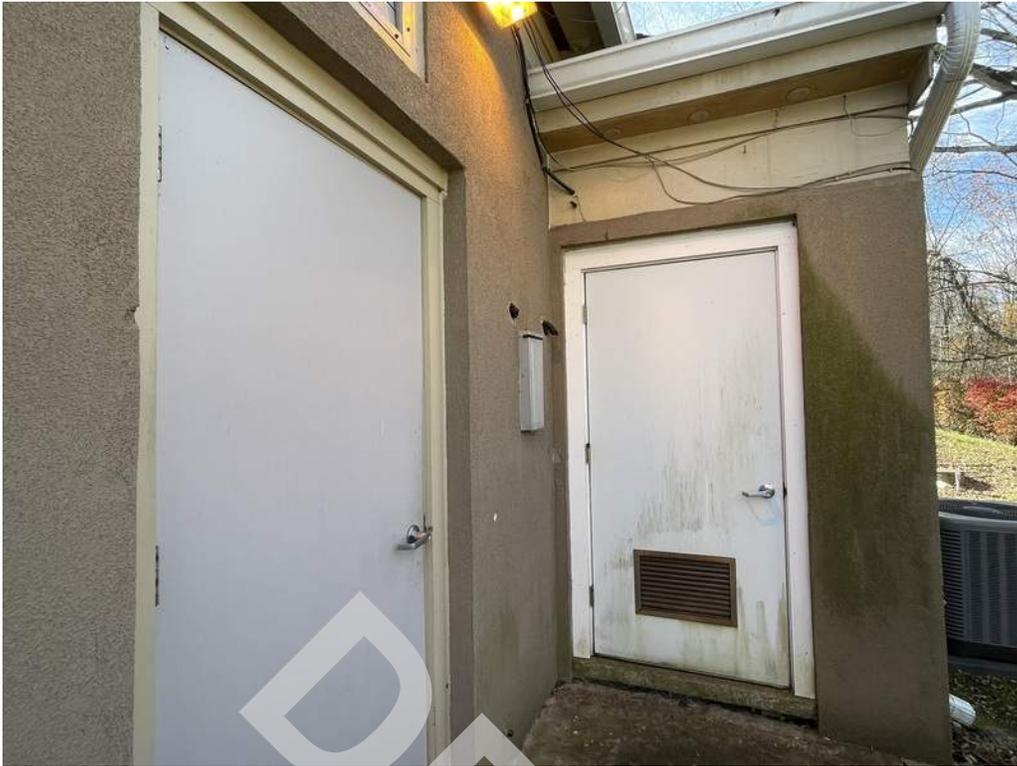
9 - Areas of the EIFS and doors have organic growth.

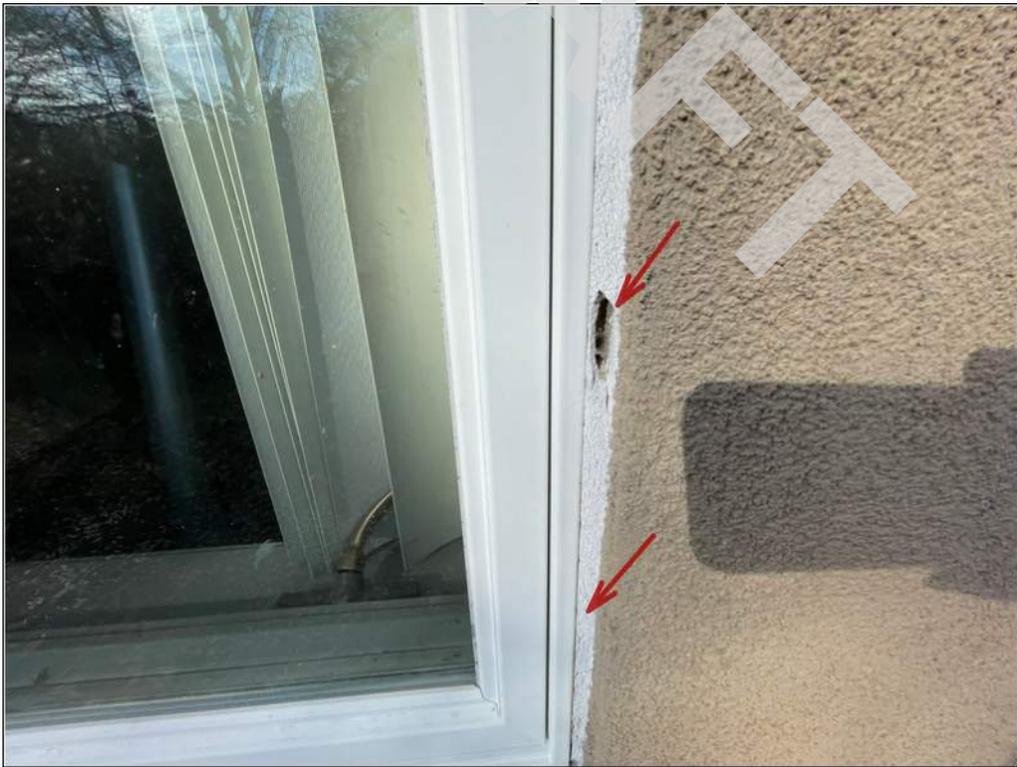
10 - Window perimeter joint sealant has failed. Surface is crazed and ruptured.

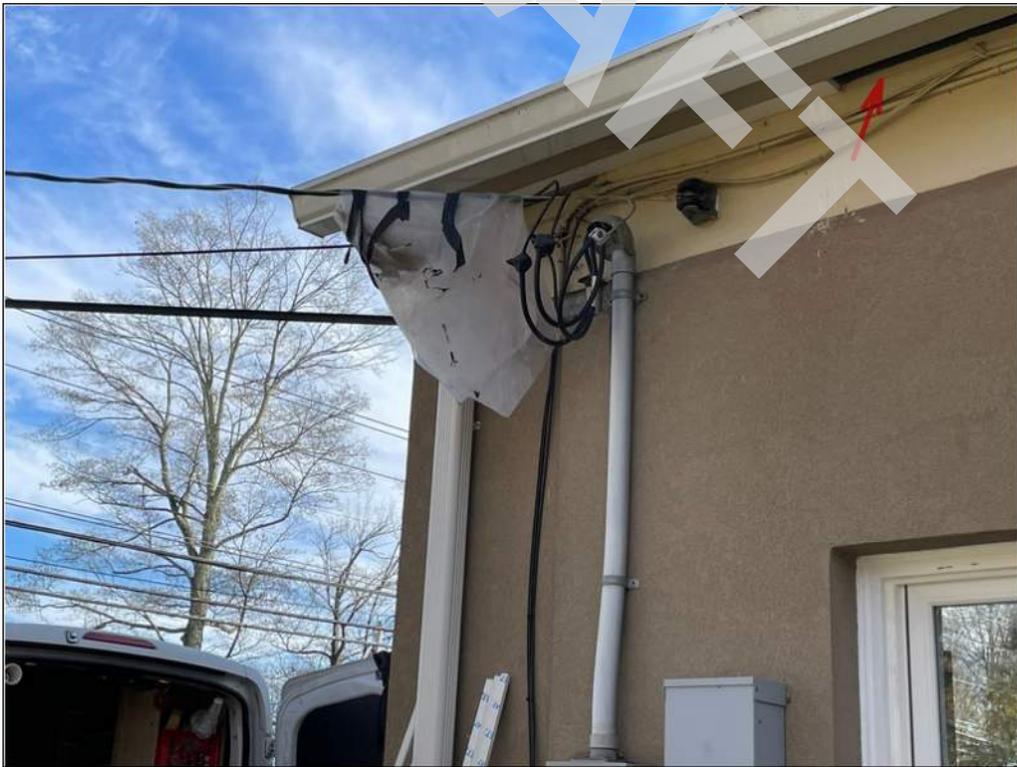
12 - Trim sections along the soffit are missing.

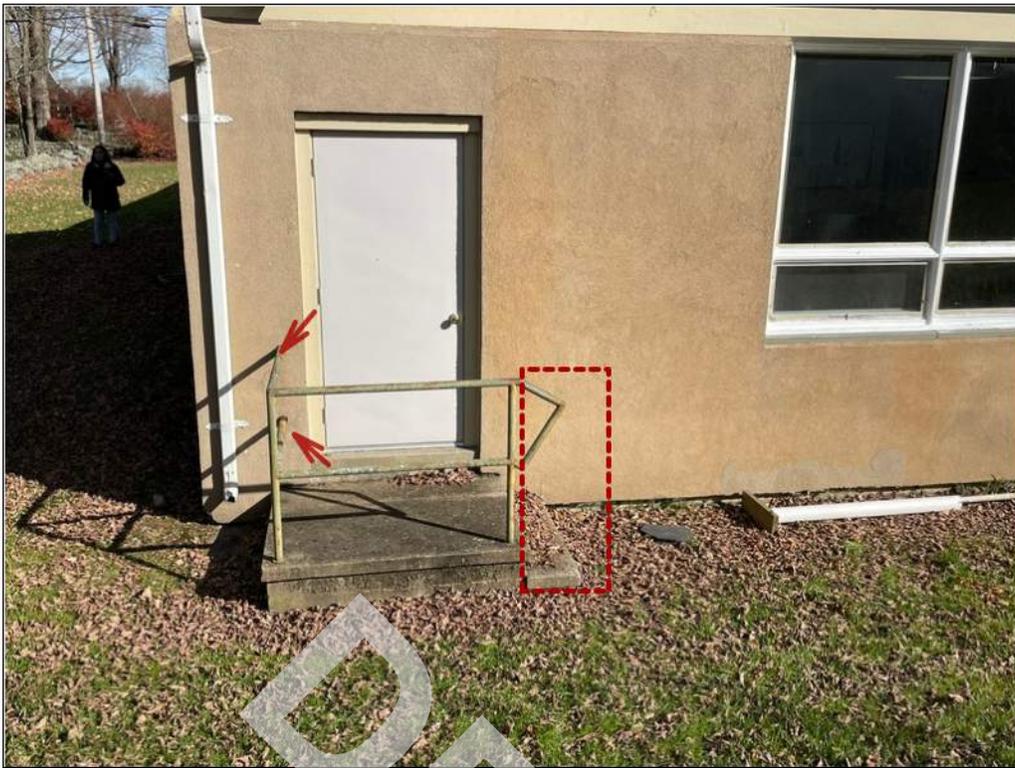
13 - Metal pipe handrail along the steps located at the west façade has corroded and does not extend beyond the last tread.

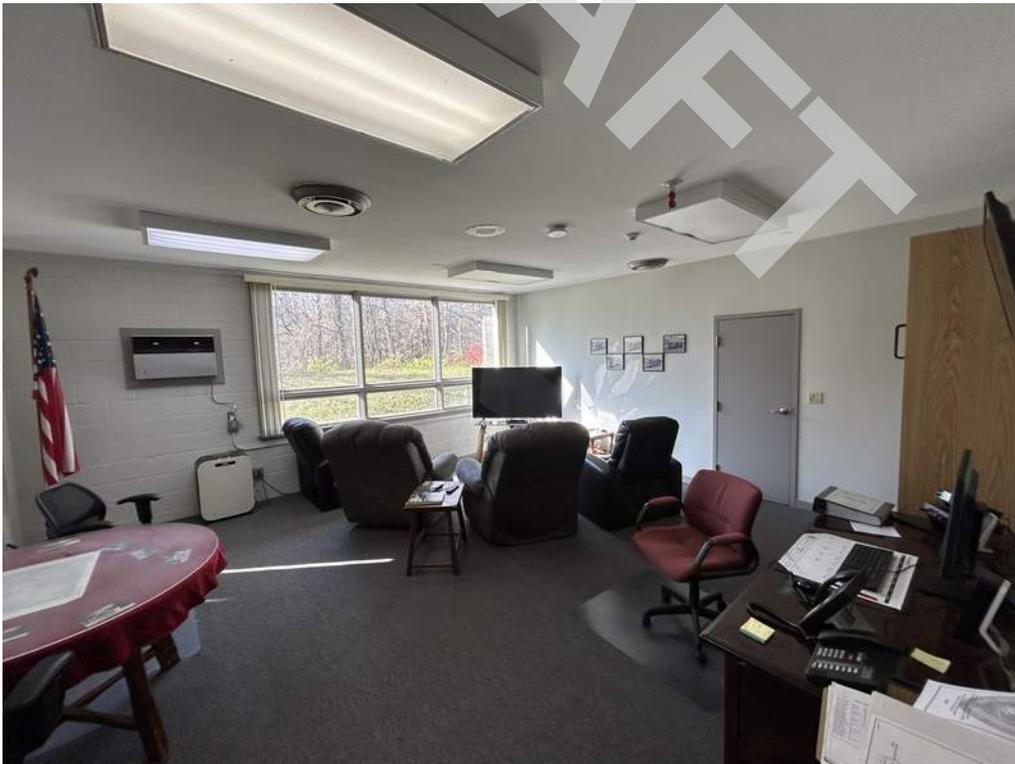
14 - Interior common space finishes consist of painted gypsum ceiling and wall boards and carpet floors. Exit signage directing occupants to the egress door along the west side of the building is not provided.

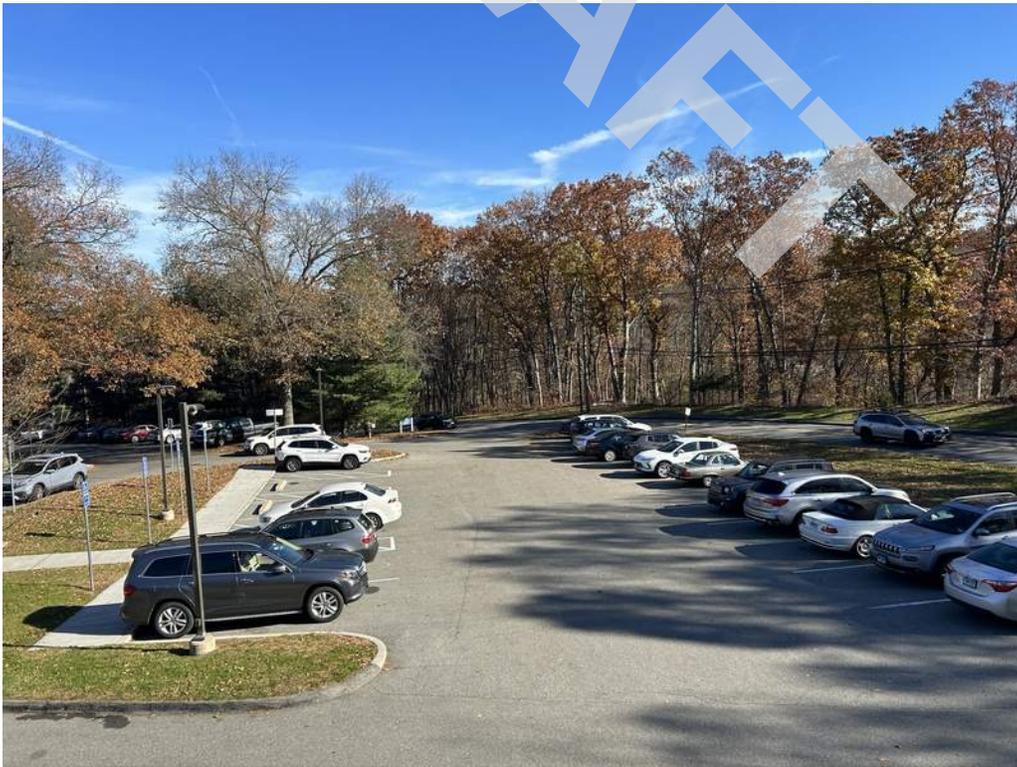
3 - The asphalt paved parking provided at the side of the building exhibits alligator and longitudinal cracking.

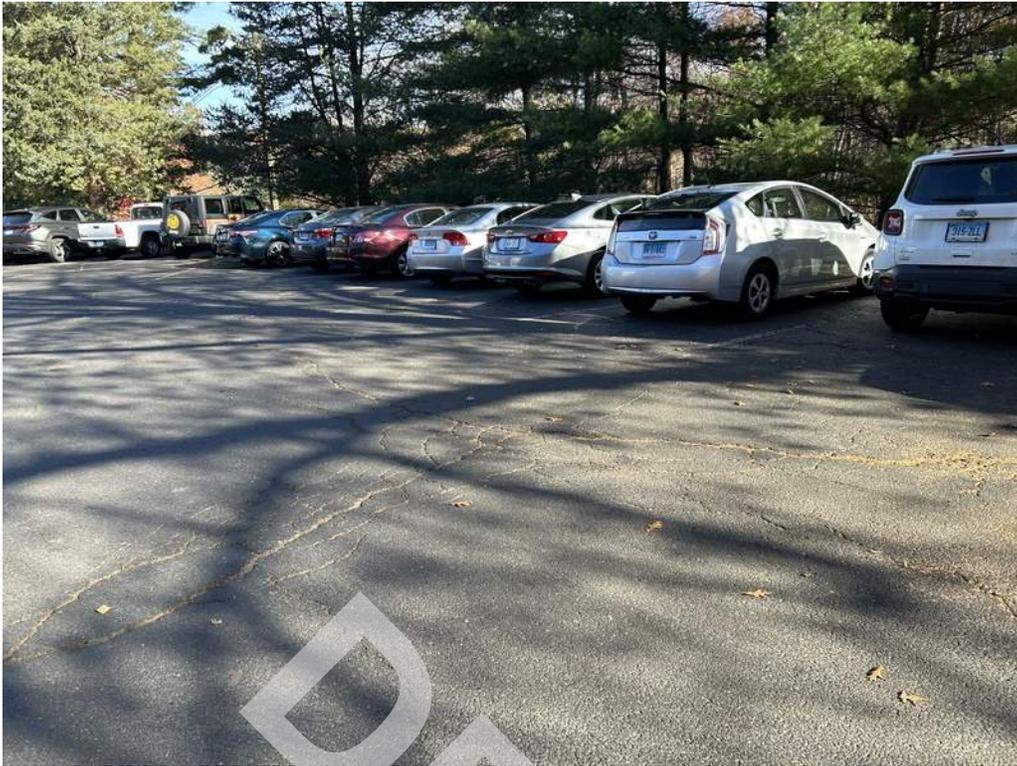
4 - One of the two additional parking lots exhibit cracking and damaged curbing.

3	Appearance: Two additional asphalt paved parking areas are provided on the west side of the property. The age of the paving areas is unknown and was noted to exhibit varying levels of deterioration. Phased milling, resurfacing, and restriping of the paved parking areas is recommended early in the term. Budget includes removing damaged concrete curbs and repouring. Levels of deterioration include alligator and longitudinal cracking and faded striping throughout.	22,000	LS	\$6.00	10	9	\$66,000	\$66,000									\$132,000	Priority 4 - Recommended.
4	Appearance: Repair local subgrade deterioration at asphalt pavement as identified during milling and repaving work at the additional parking areas, as noted in the line item above. The budget includes 10% of the paved asphalt areas.	14,000	SF	\$10.00	0	0	\$70,000	\$70,000									\$140,000	Priority 4 - Recommended
5	Appearance: A budget is recommended to reseal and restripe all the asphalt paved parking areas later in the term.	1	LS	\$39,200.00	9	0									\$19,600	\$19,600	\$39,200	Priority 4 - Recommended

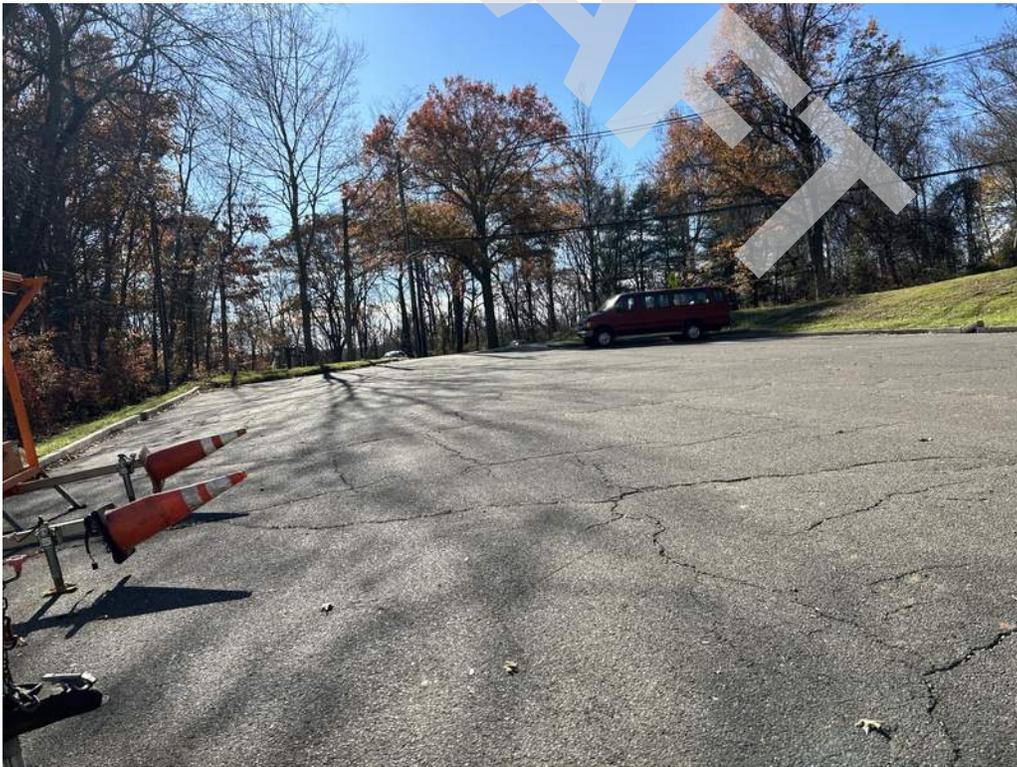
5 - Longitudinal and alligator cracking was observed at the second additional parking lot provided.

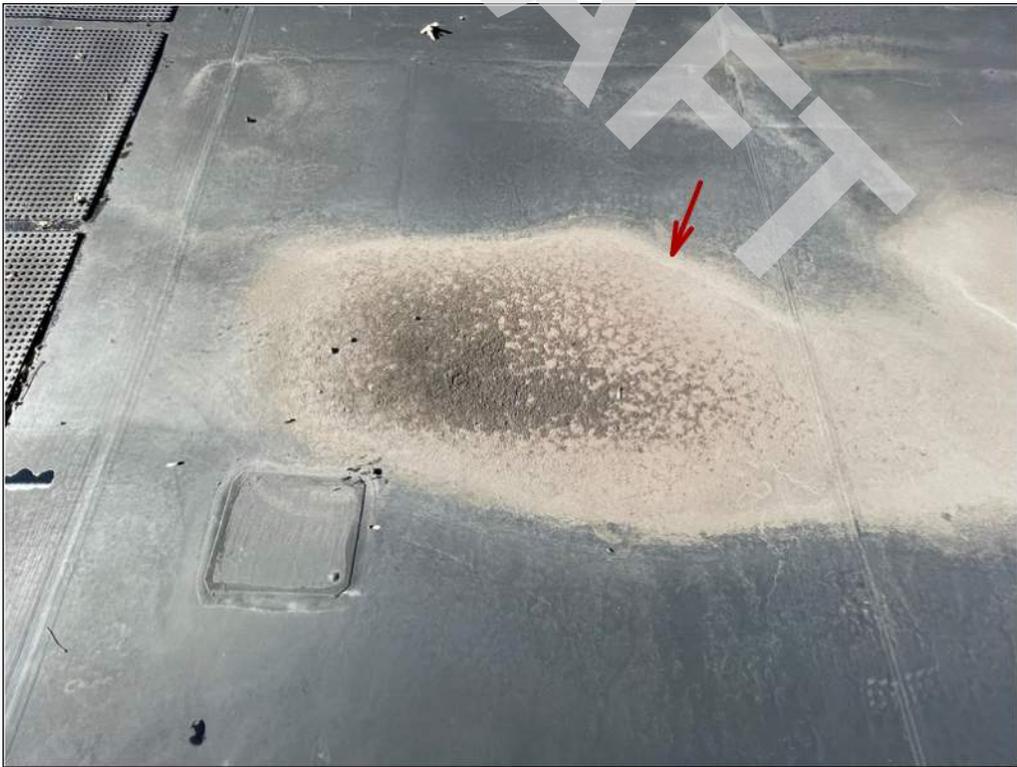
10 - Debris accumulation in a soft spot area of the roof.

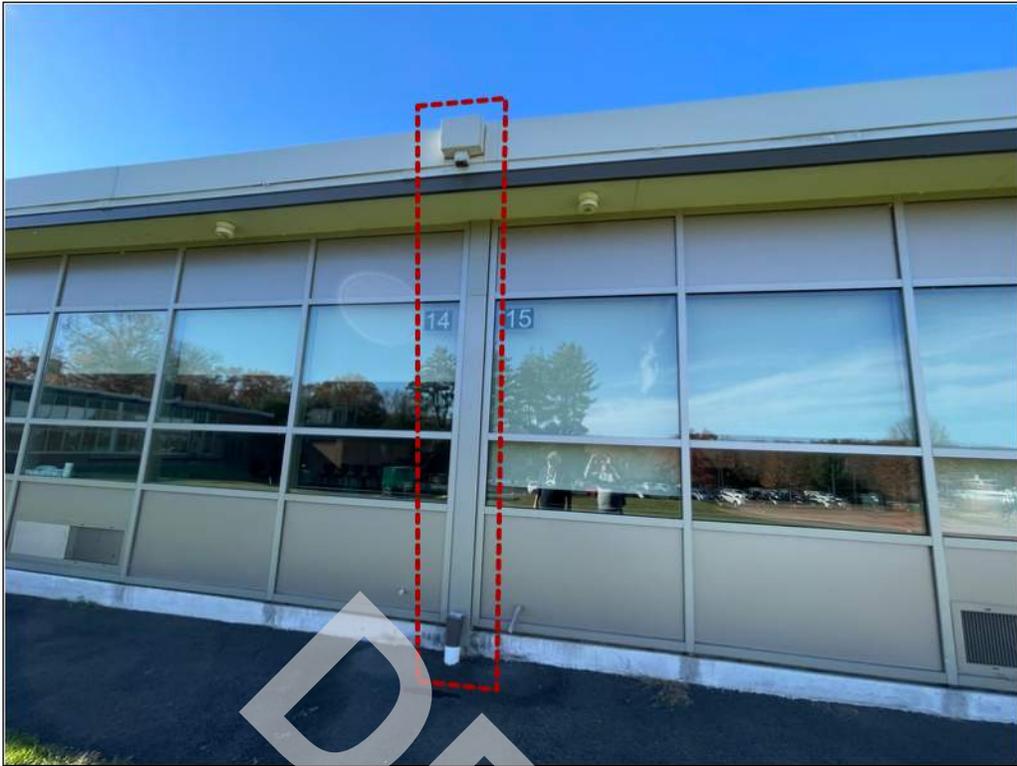
11 - The roof leader is missing.

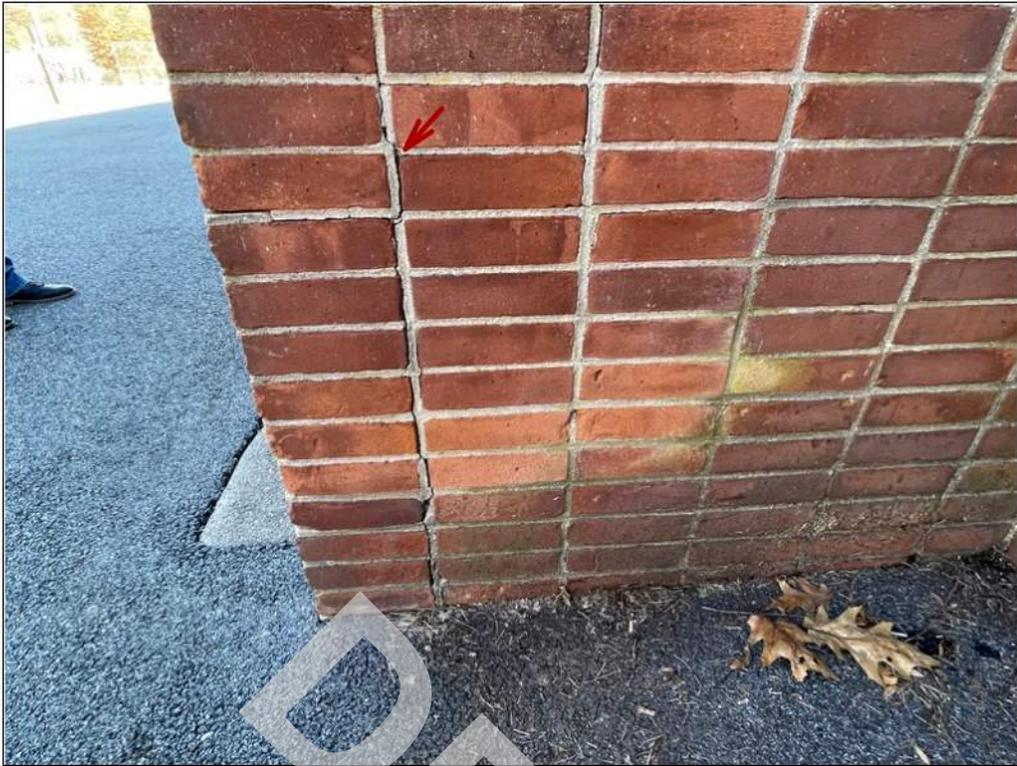
15 - Brick masonry unit mortar joints have cracked.

14	<b>P</b> Building Integrity: Brick mortar joints in localized areas of the brick masonry unit walls has eroded and it's in poor condition. Perform a phased repointing program throughout areas of damaged or missing mortar joint. Budget represents approximately 2% brick mortar joint repointing in each phase.	1,200	SF	\$20.00			\$8,000				\$8,000					\$8,000	\$24,000	Priority 3 - Necessary - Not Yet Critical.
15	<b>P</b> Building Integrity: Perimeter joint sealant throughout the brick masonry facade has failed. Perform a comprehensive phased joint sealant replacement program throughout the building. Budget represents approximately 20% sealant replacement in each phase.	7,500	LF	\$10.00	10	9	\$25,000				\$25,000					\$25,000	\$75,000	Priority 3 - Necessary - Not Yet Critical.
16	A budget is provided for general contractor overhead, profit, general conditions associated to the envelope and exterior.	1	LS	\$37,000.00			\$15,000				\$8,000					\$14,000	\$37,000

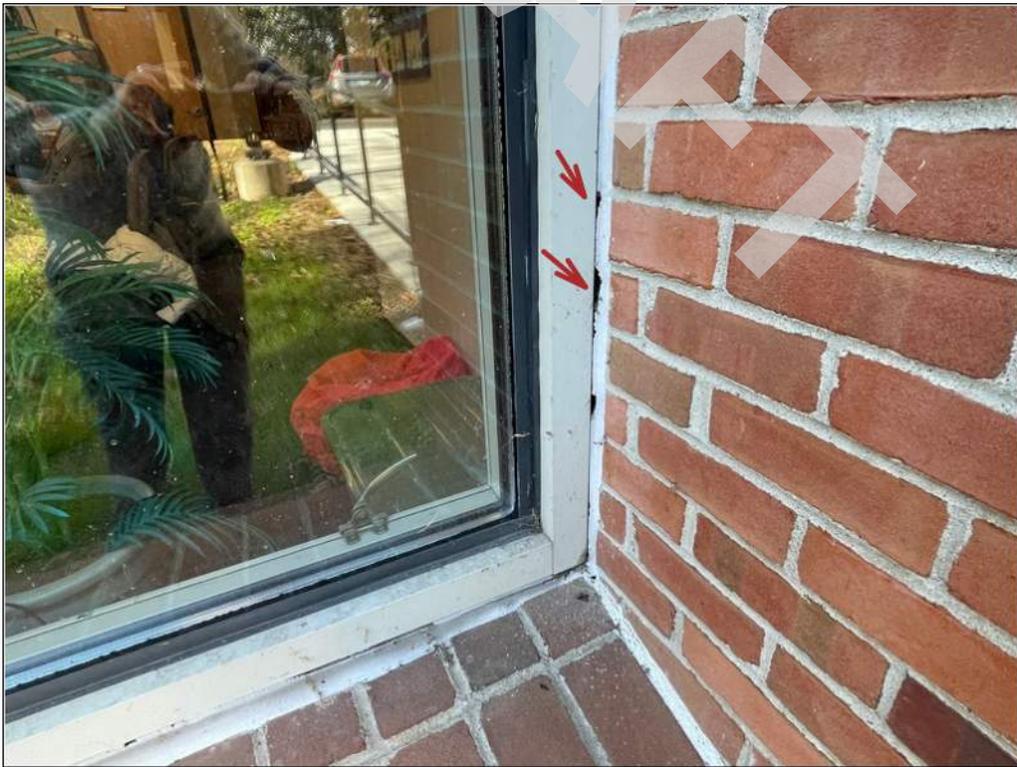
16 - Most perimeter joint sealant around windows has failed.
