# FACILITY CONDITION ASSESSMENT

## TOWN OF WILTON – TOWN BUILDINGS

Wilton, Connecticut

Draft: February 2, 2024

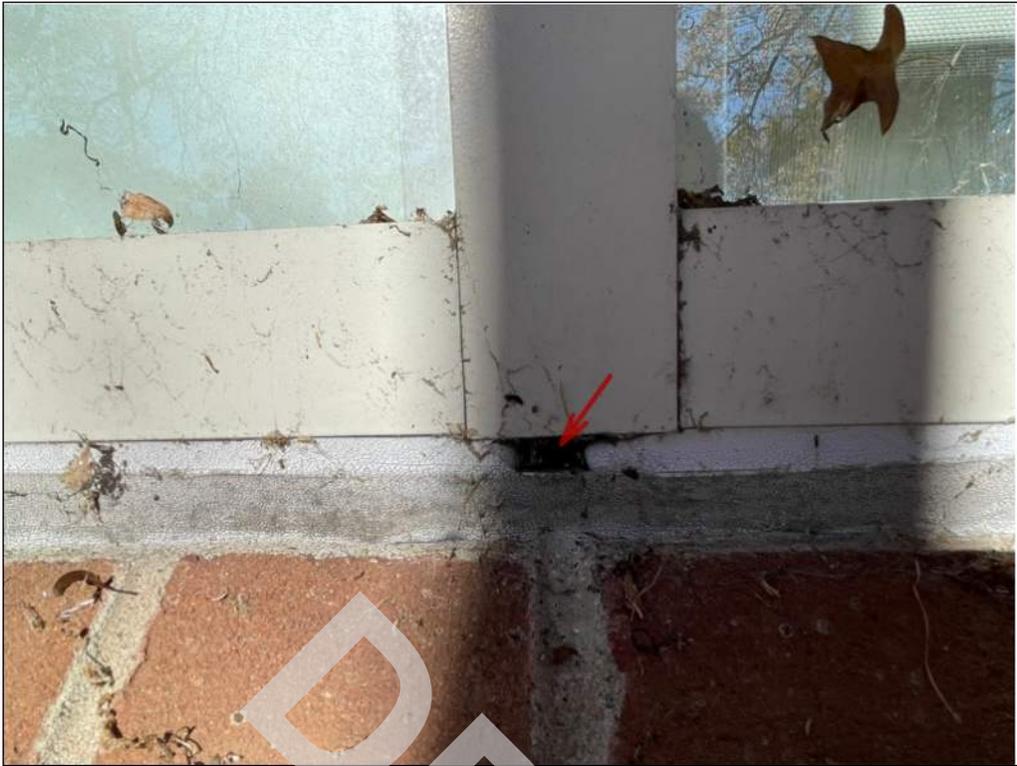
17 - Perimeter joint sealant along windows is in poor condition. Deficiencies include ruptured and crazed sealant.

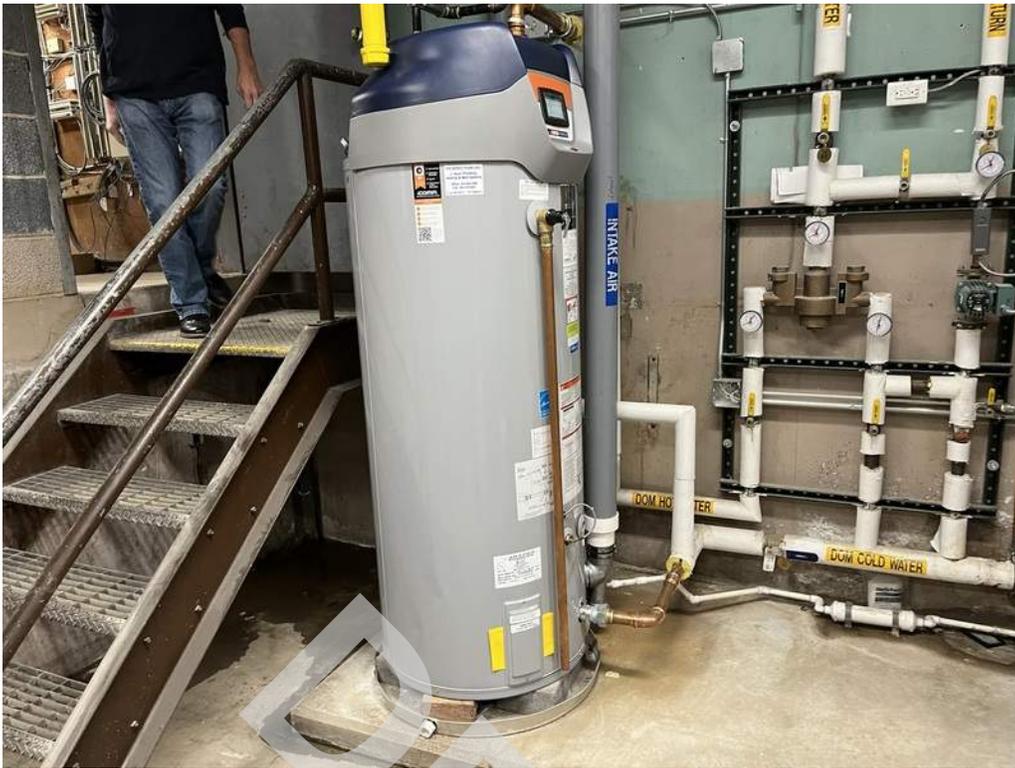
27 - A natural gas fired storage-type water heater is located in the lower level and provides hot water throughout the building.

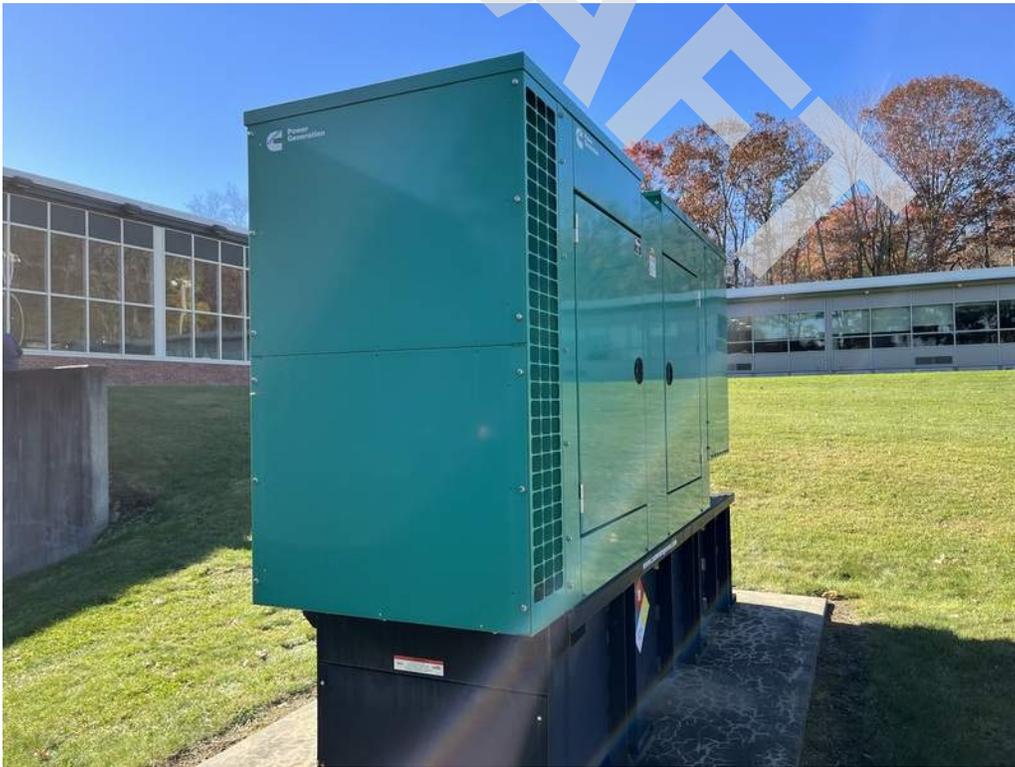
28 - A diesel-fired emergency generator located on the exterior of the building provides emergency power to the building.

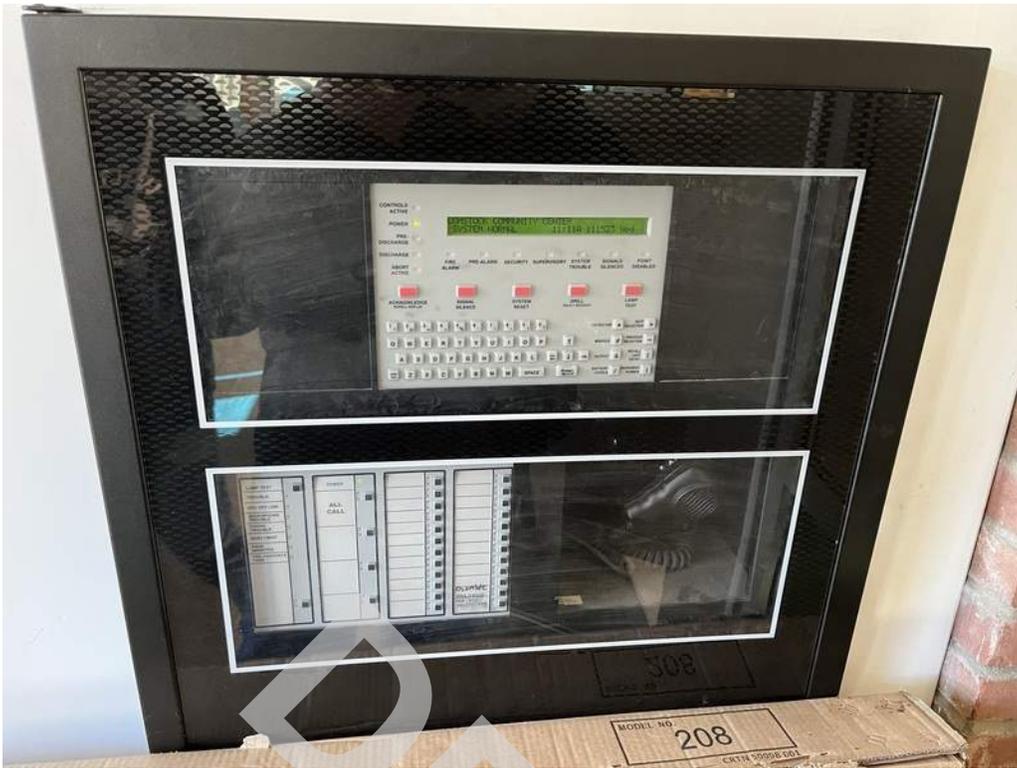
29 - The building is provided with a fire alarm panel which is located in the vestibule of the main entrance.

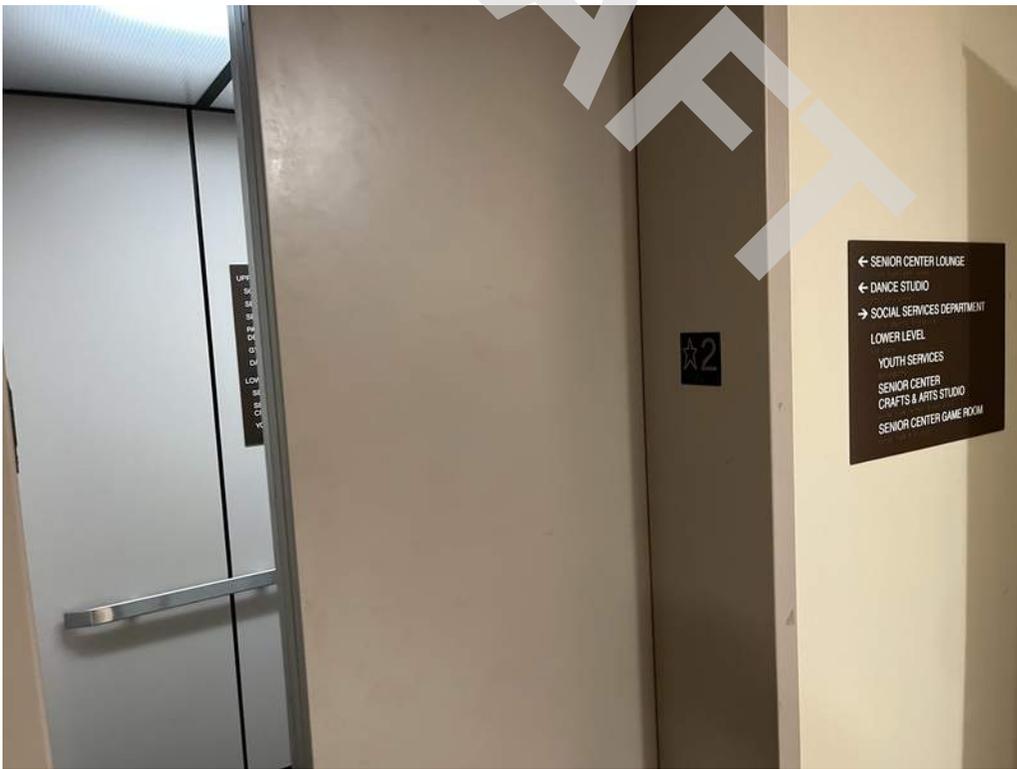
30 - The building is provided with a Kone hydraulic passenger elevator located in the east wing of the building.

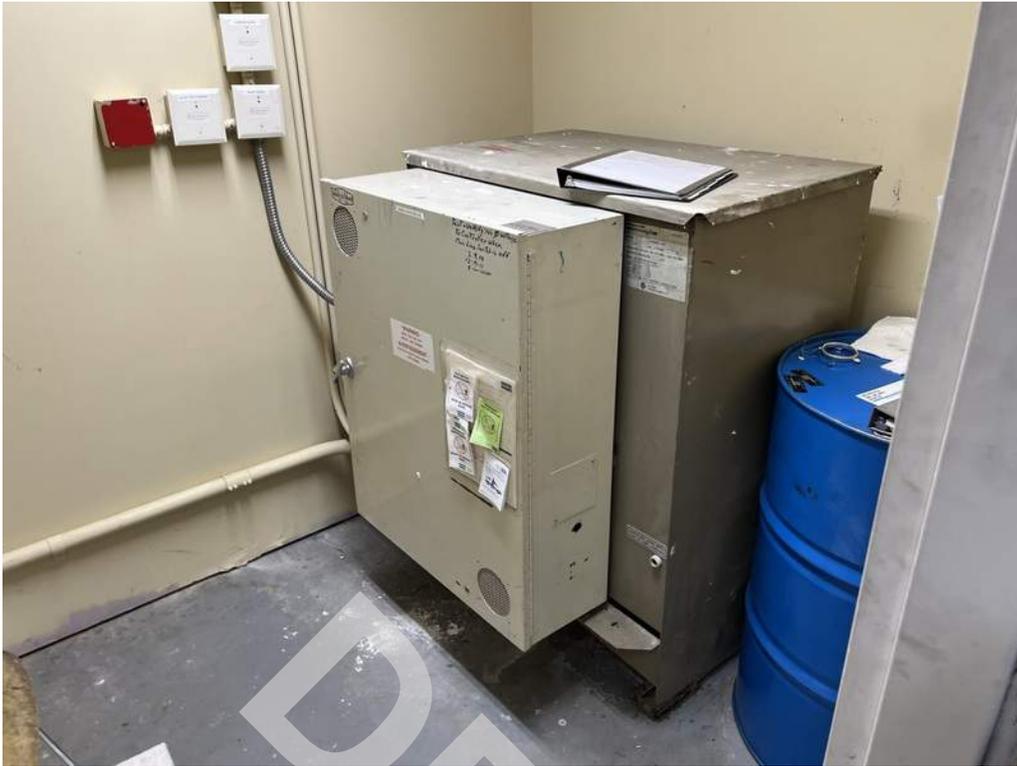
31 - Elevator equipment is located in the elevator equipment room on the lower level.

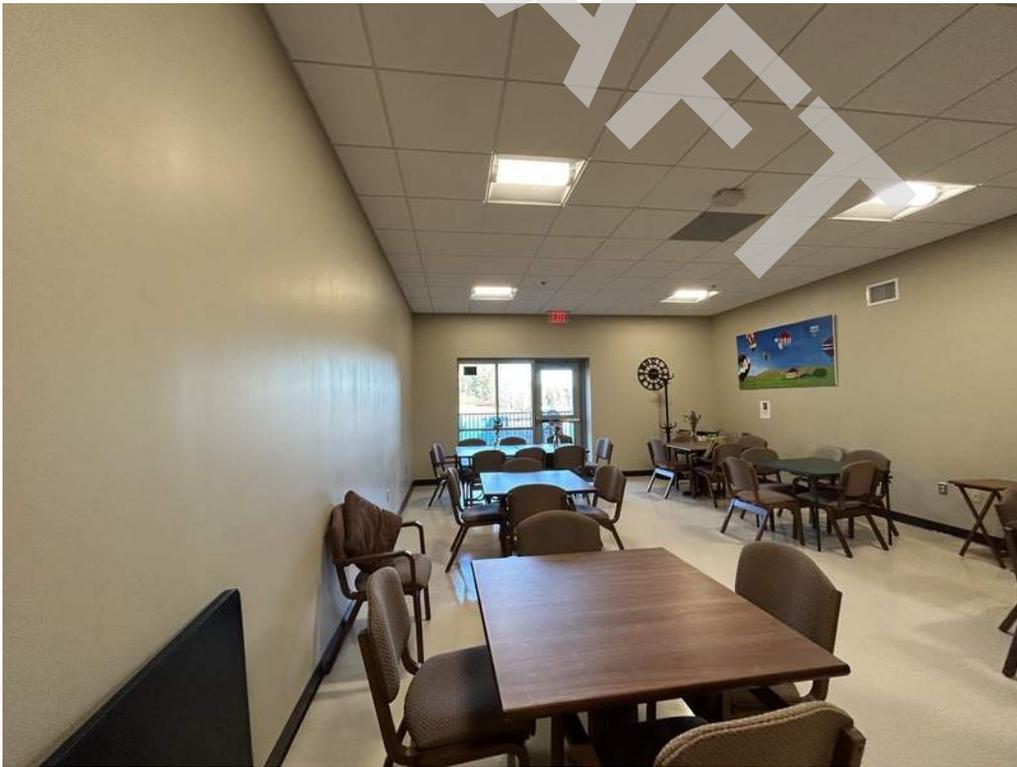
32 - Tables do not provided knee and toe clearance and inadequate clear floor space to the patio was observed at the Senior Center Café.

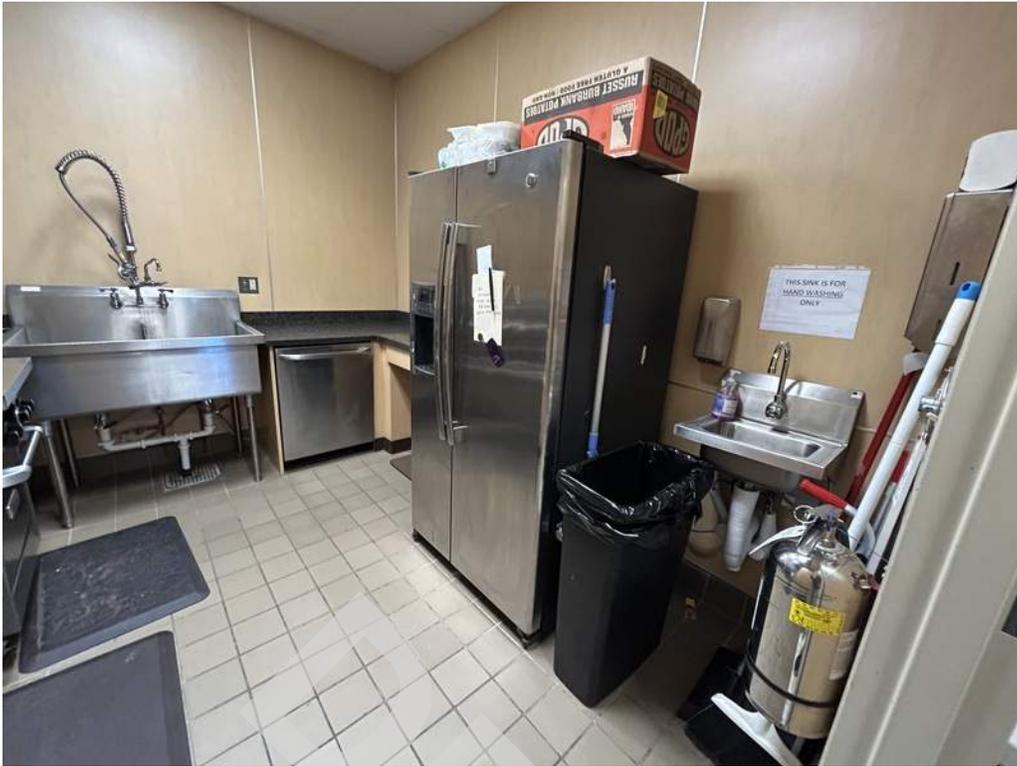
33 - Adequate clear floor space is not provided at the kitchen sink in the Senior Center Café.

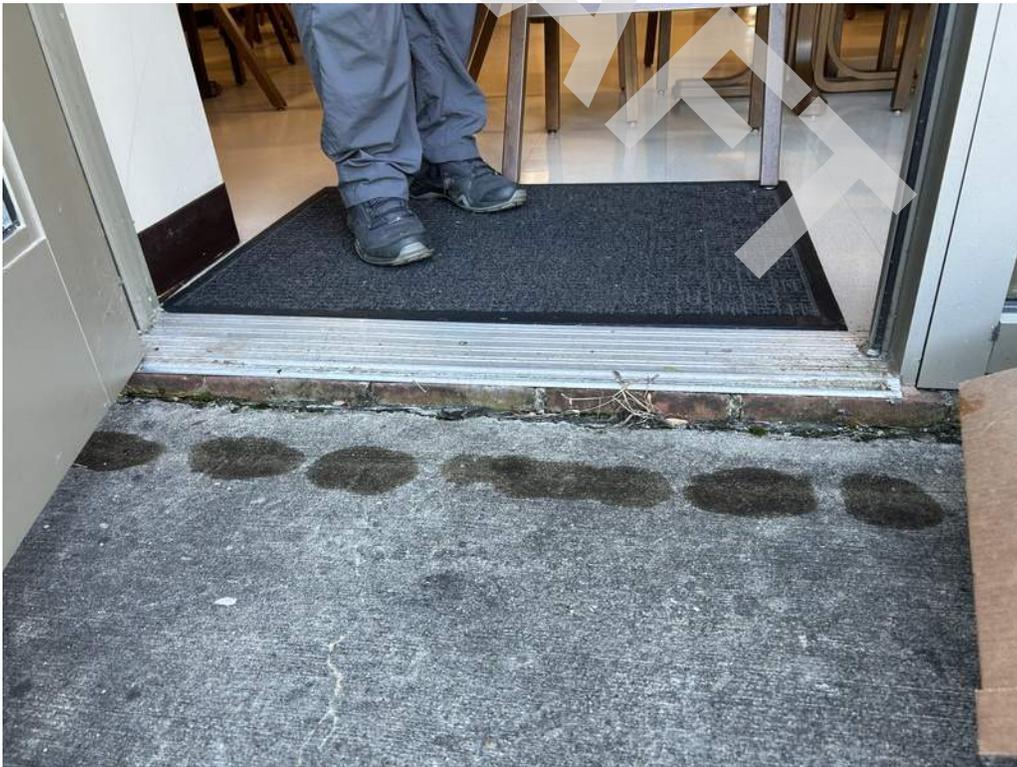
34 - The door threshold at the Senior Center Café exceeds the allowable height.

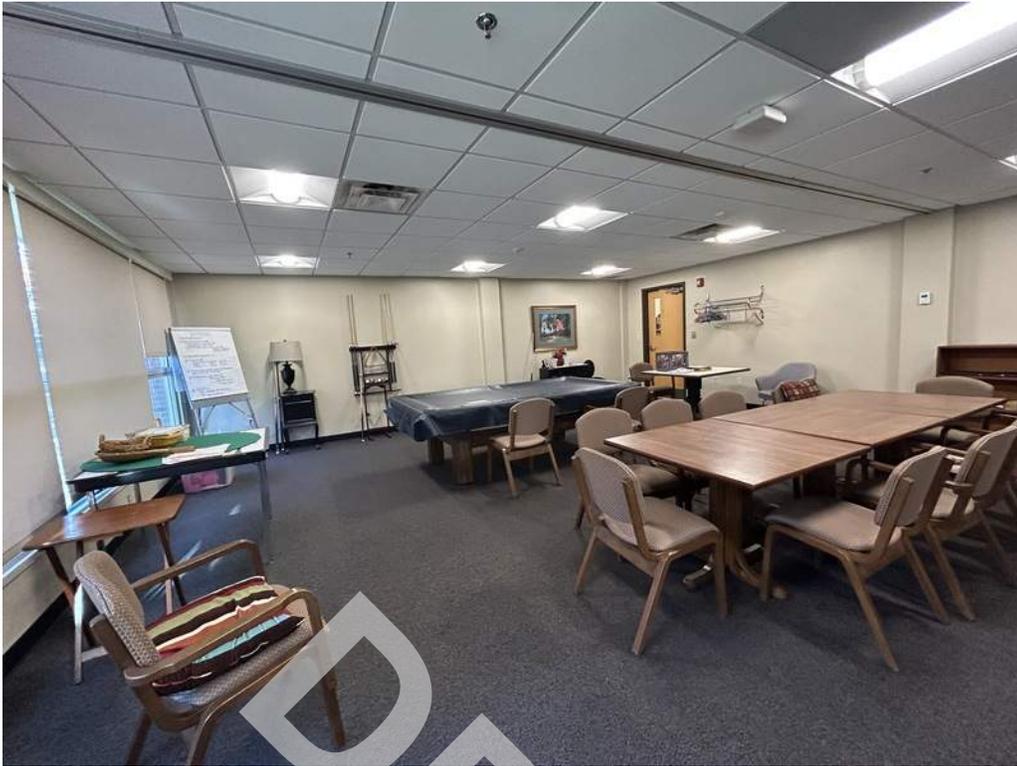
35 - At the Senior Center Game Room, the pool table and seating tables do not provide knee and toe clearance.

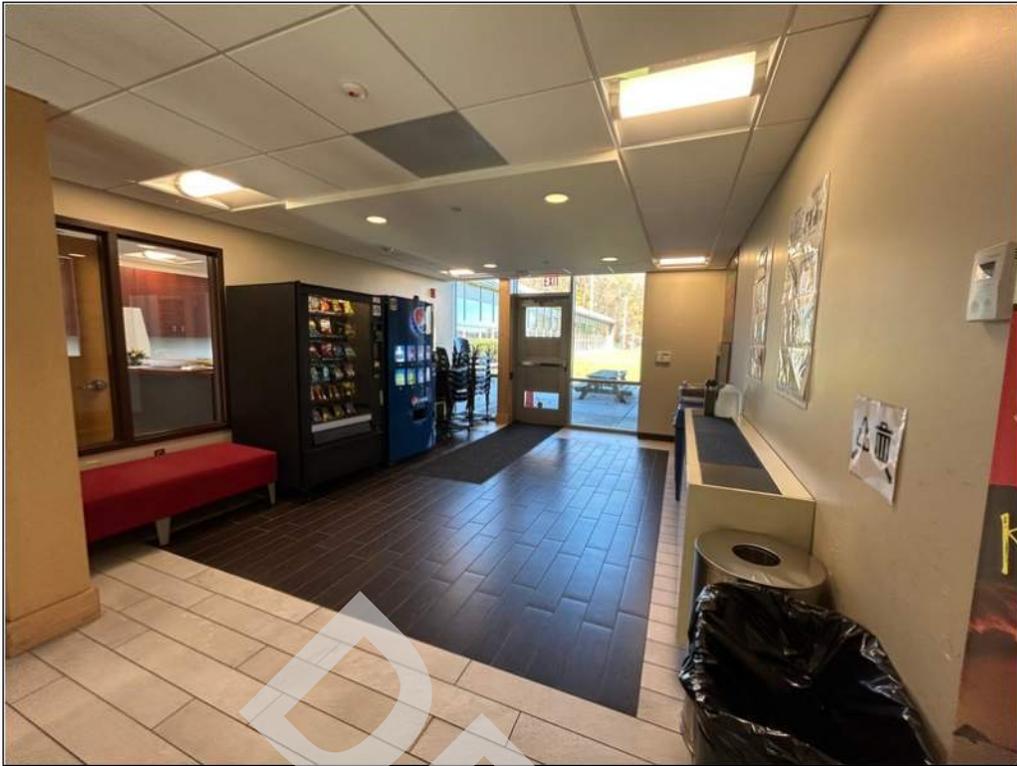
37 - The snack vending machine provided is not complaint as the operable parts are above the reach range.

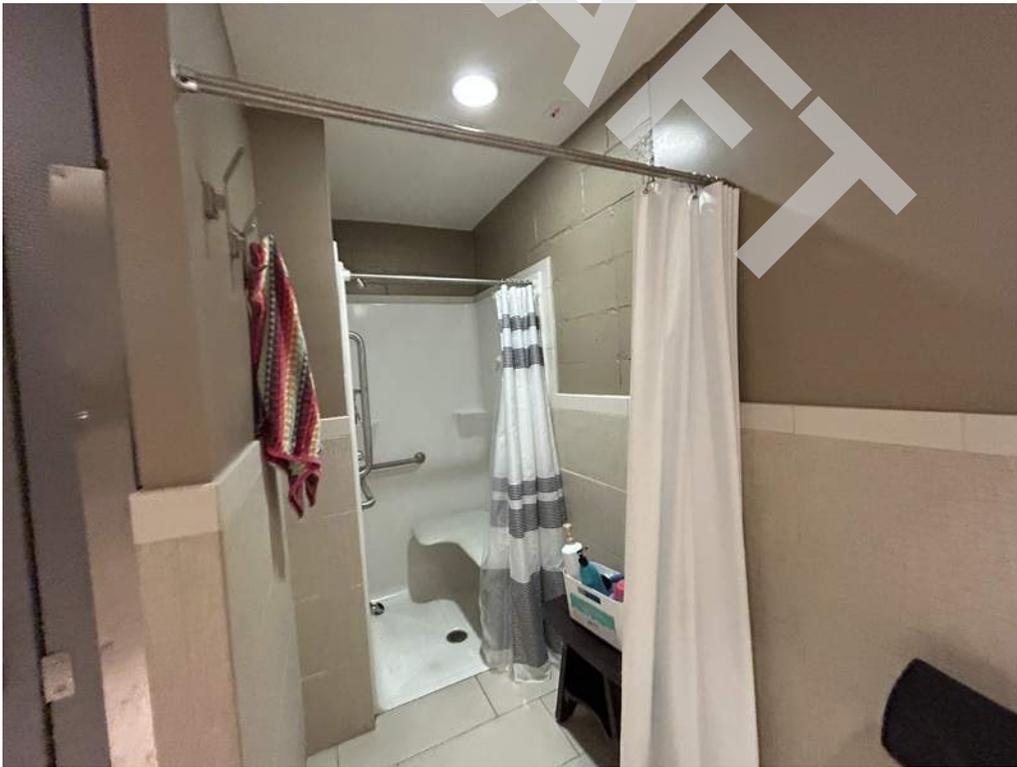
38 - The minimum required clearance measured from the transfer shower control wall is not provided.

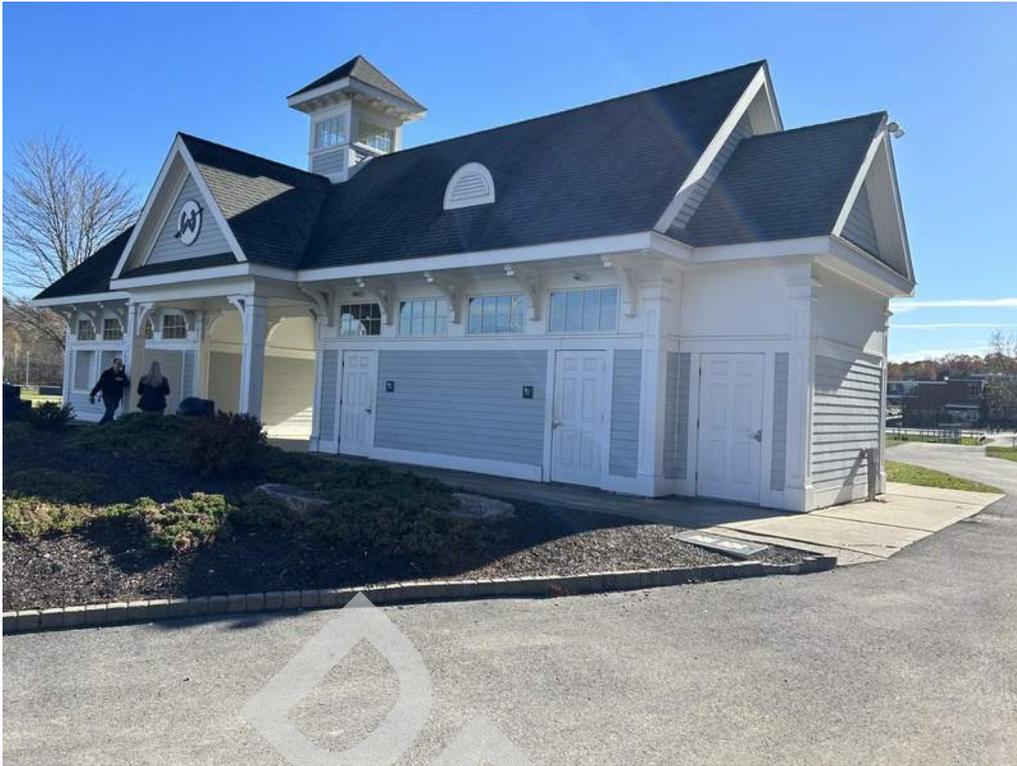
1 - Paving and landscape area along the north side of the building.

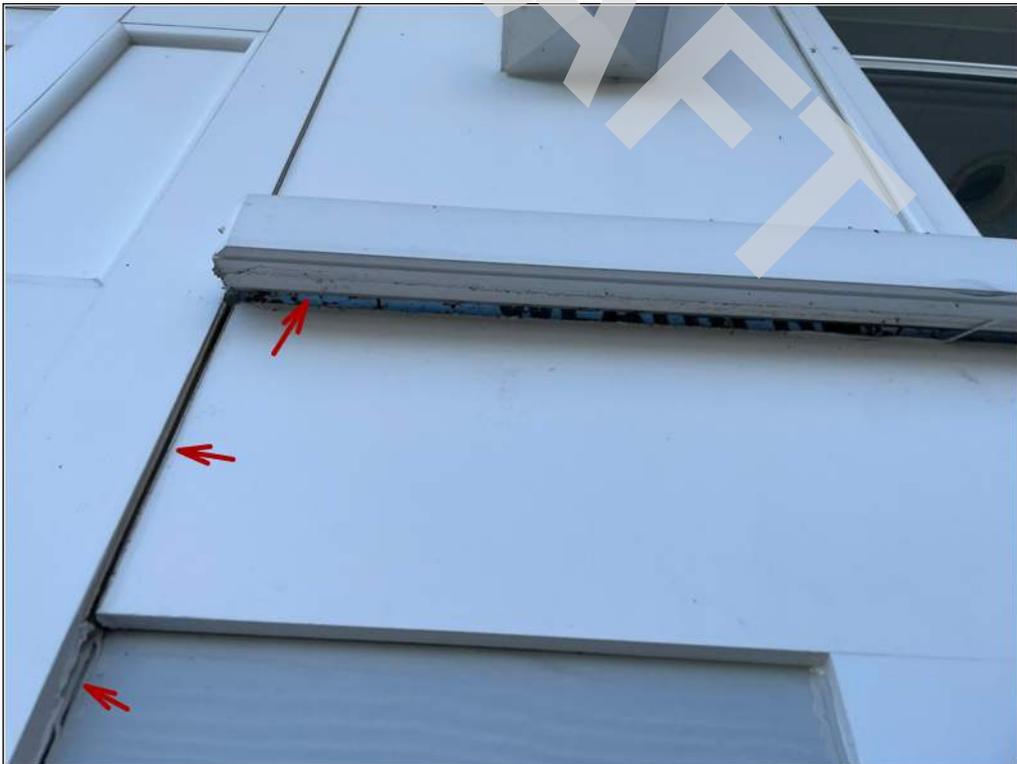
4 - Differential movement noted between fiber cement trim and panels throughout the building enclosure.

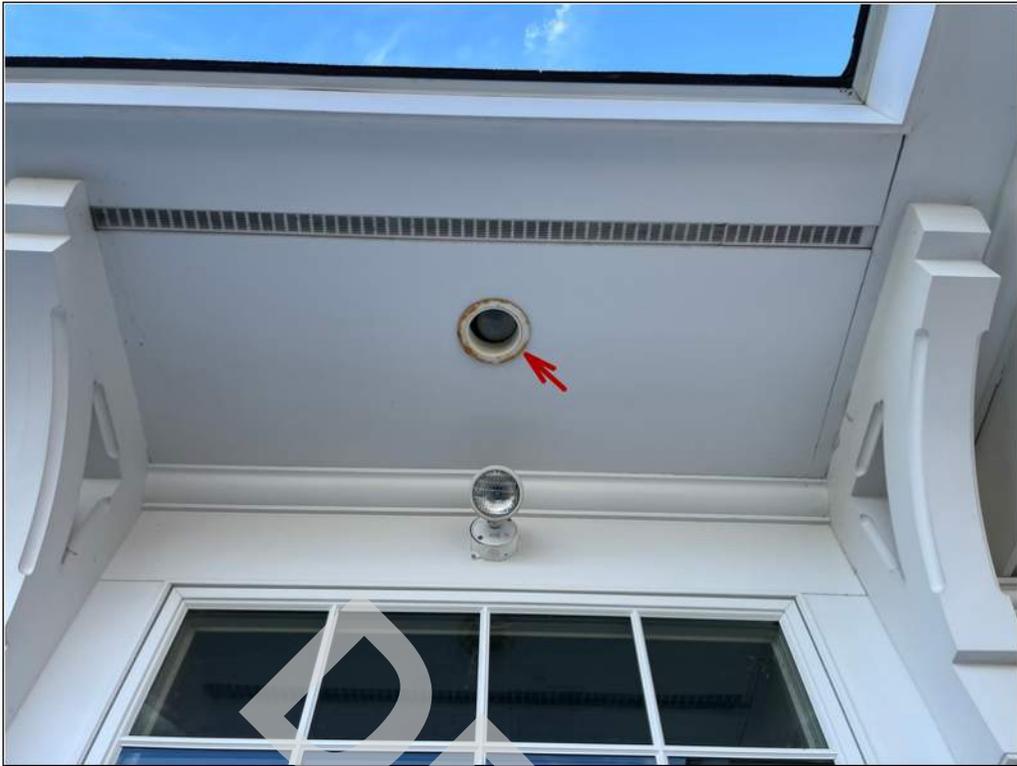
5 - Recessed lighting metal rings have corroded due to water and moisture exposure.

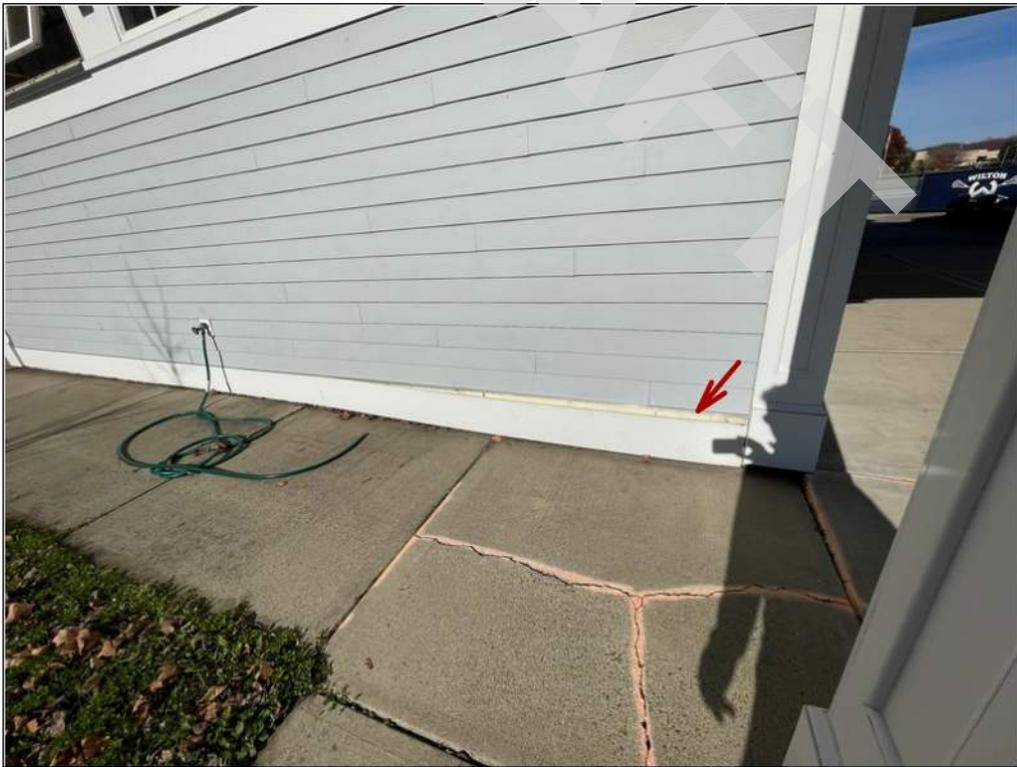
6 - Fiber cement base has displaced and detached from the facade.

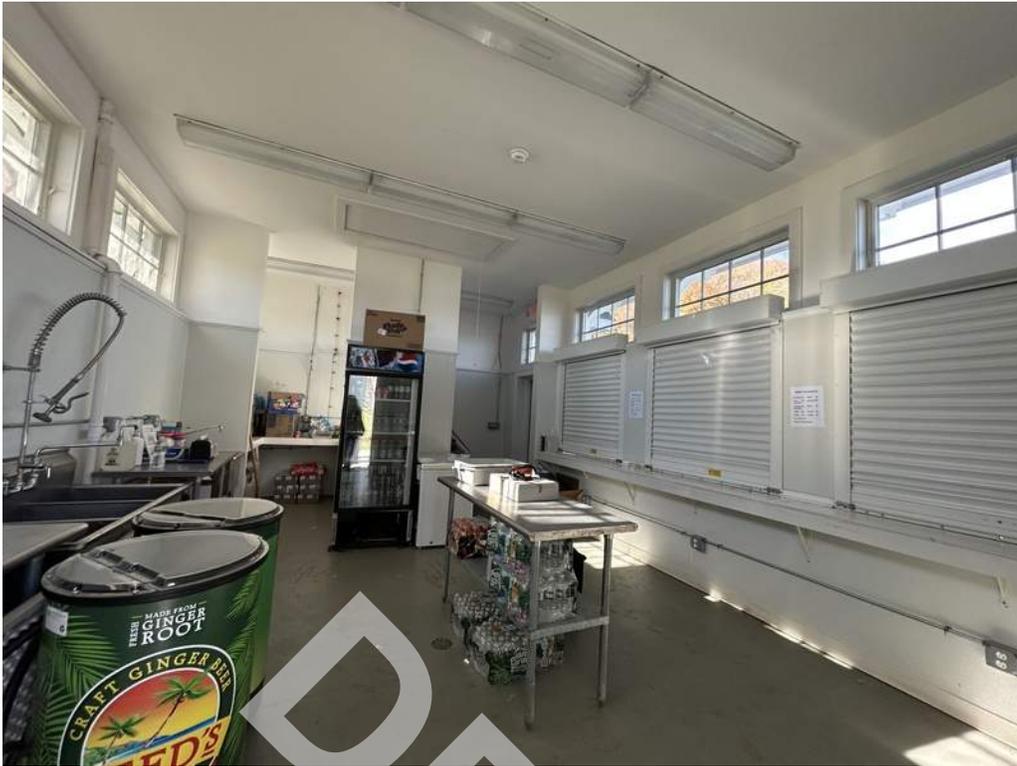
7 - Interior kitchen finishes consist of painted gypsum board ceiling and boards and painted concrete slabs.

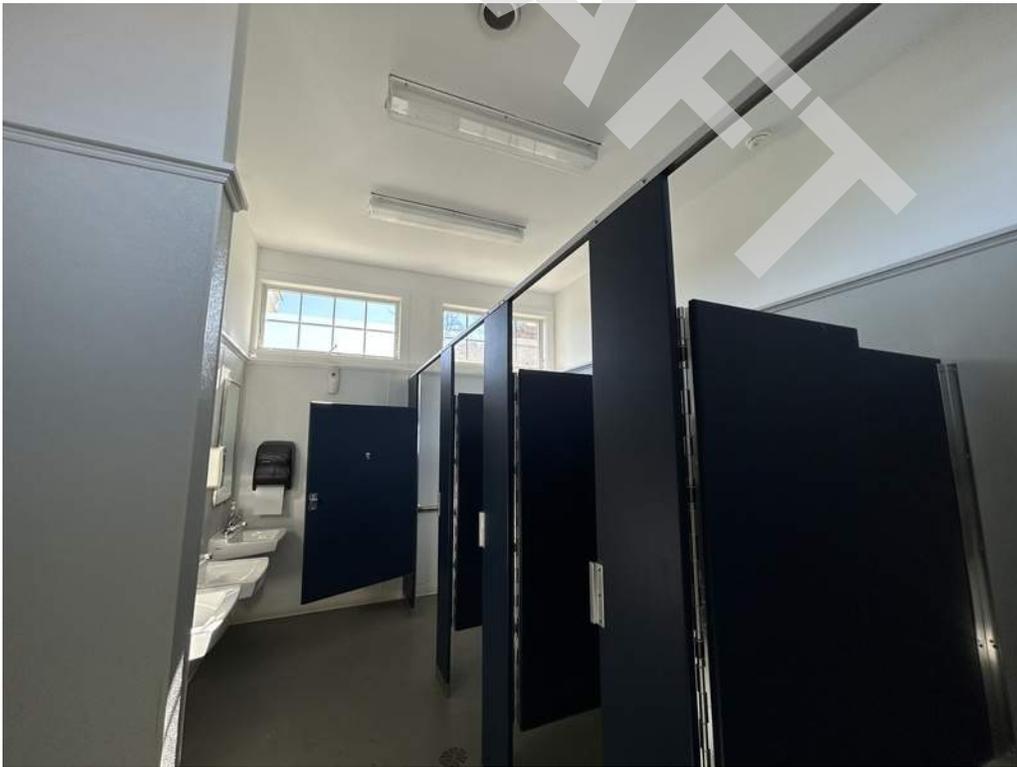
8 - Interior restroom finishes consist of painted gypsum board ceiling and boards and painted concrete slabs.

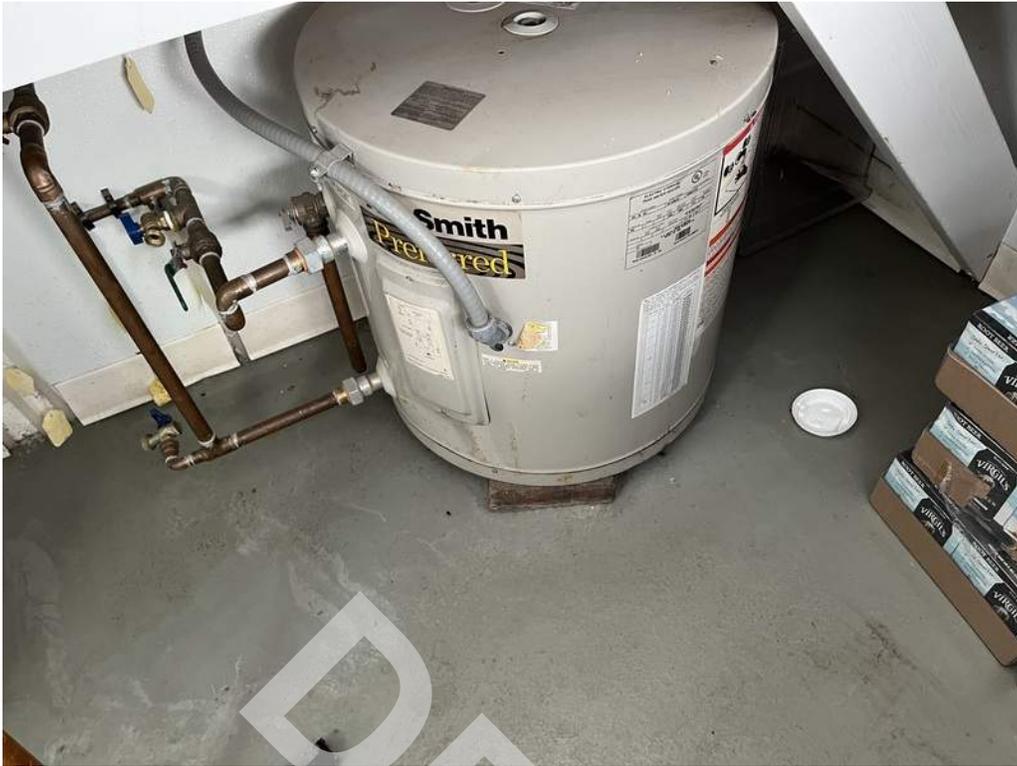
9 - Two electric storage-type water heaters provide hot water to the building.

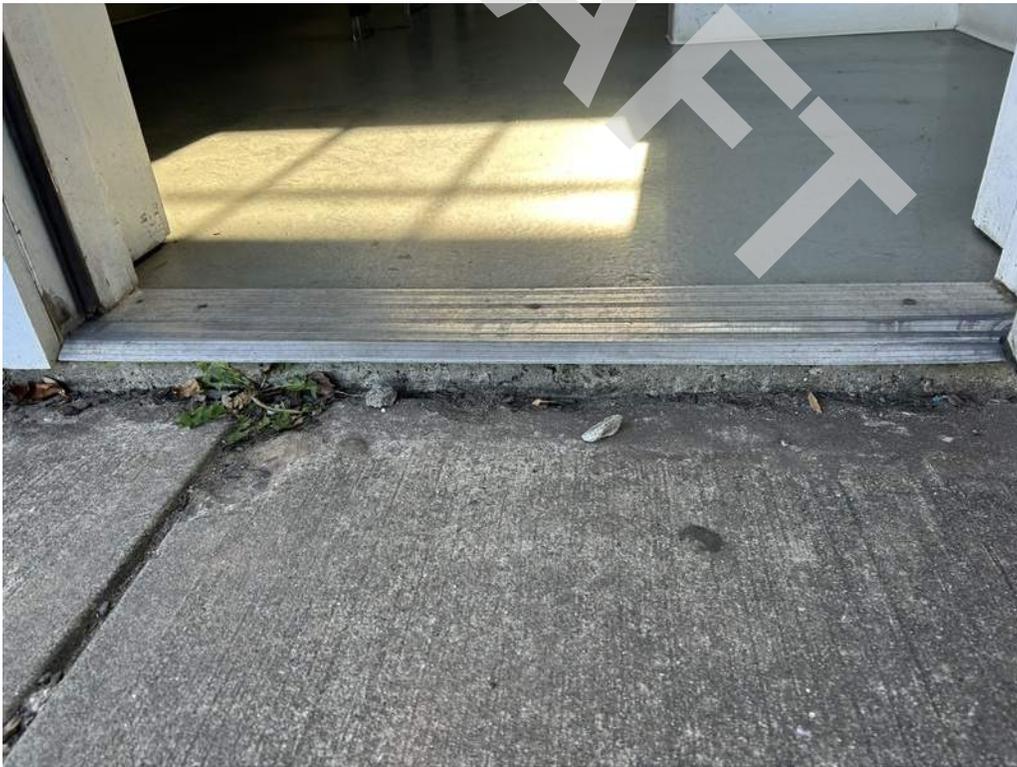
10 - The restroom door threshold exceeds the allowable height.

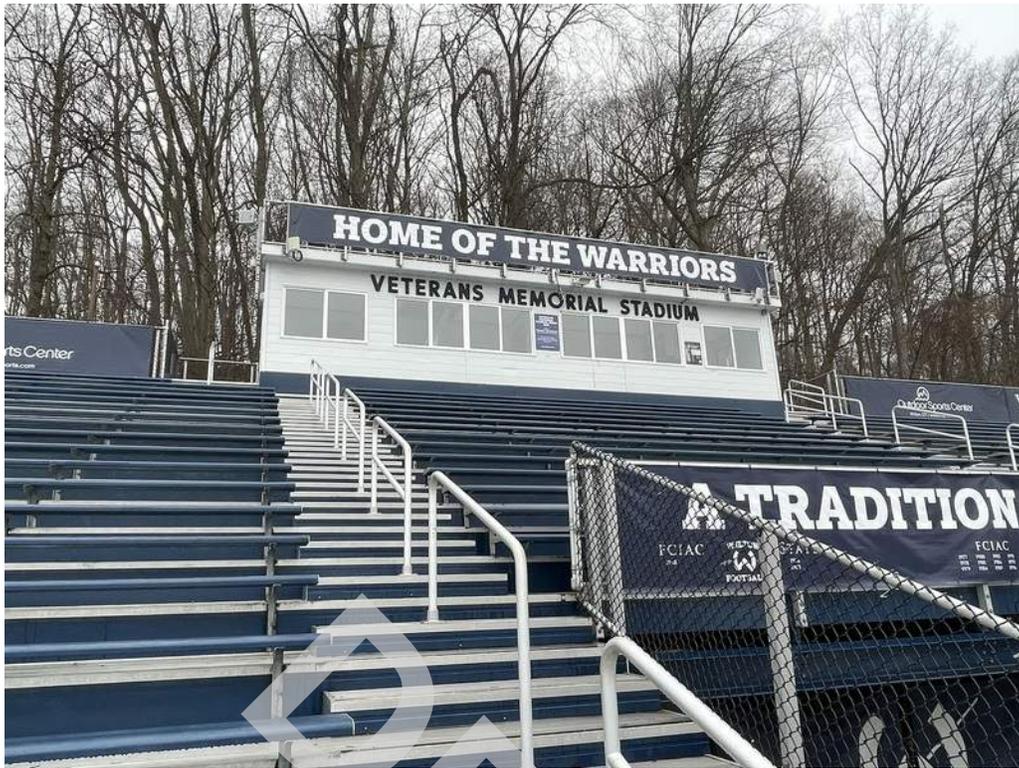
1 - Press box over the grandstand.

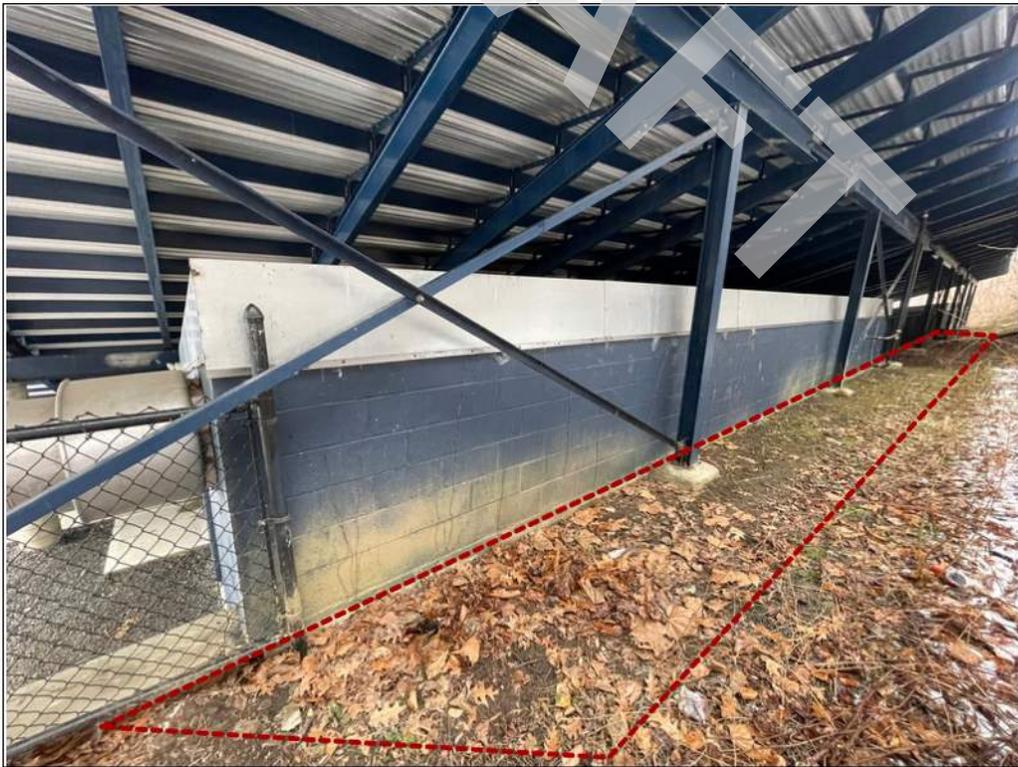
2 - Area adjacent to the building does not slope away from the retaining wall.

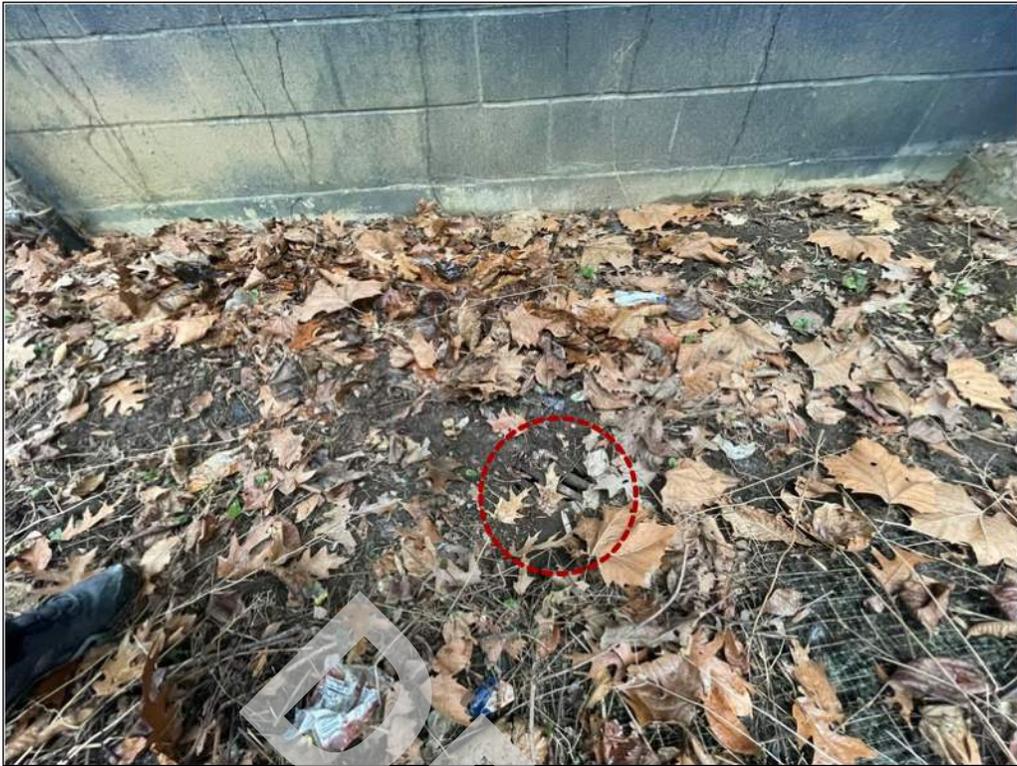
3 - Yard drains along the west wall of the team rooms are not readily accessible, obstructed by soil and debris.

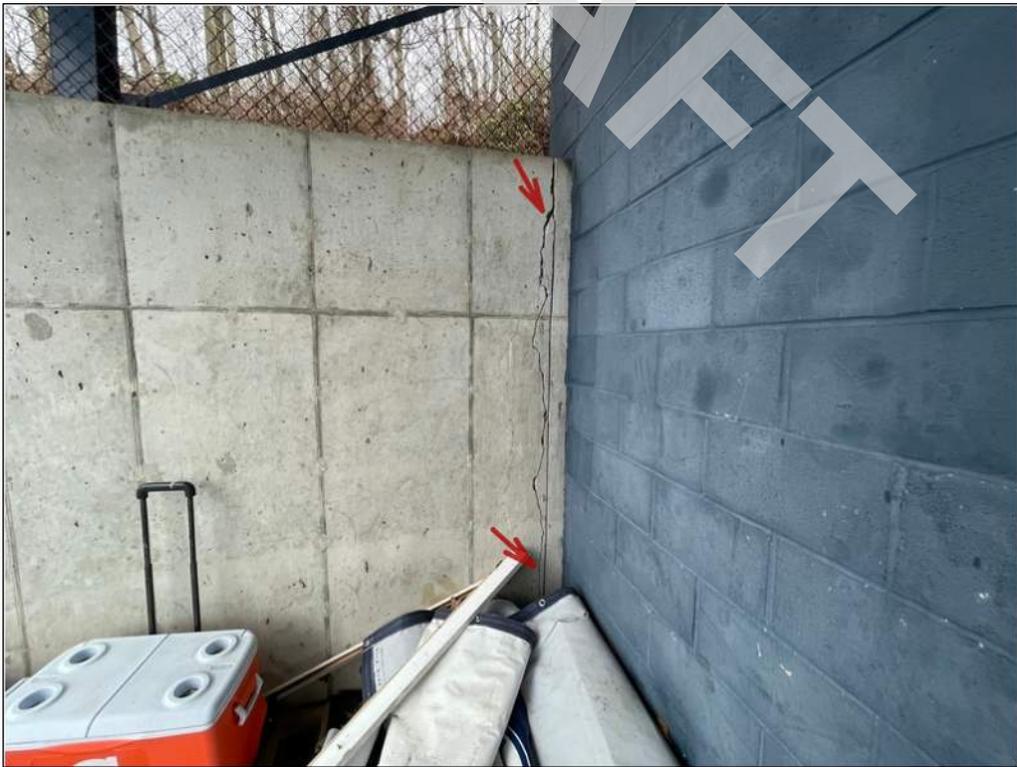
4 - A crack was noted along the entire height of the retaining wall next to the south team room enclosure.

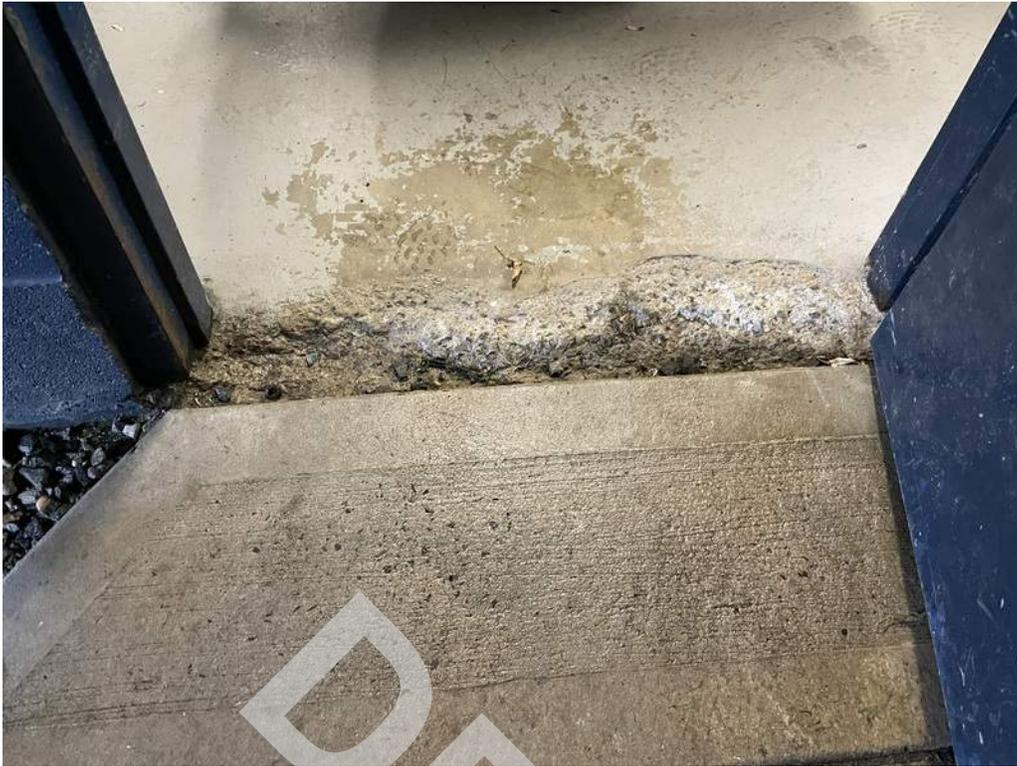
5 - Concrete floor is spalling along one of the entrances.

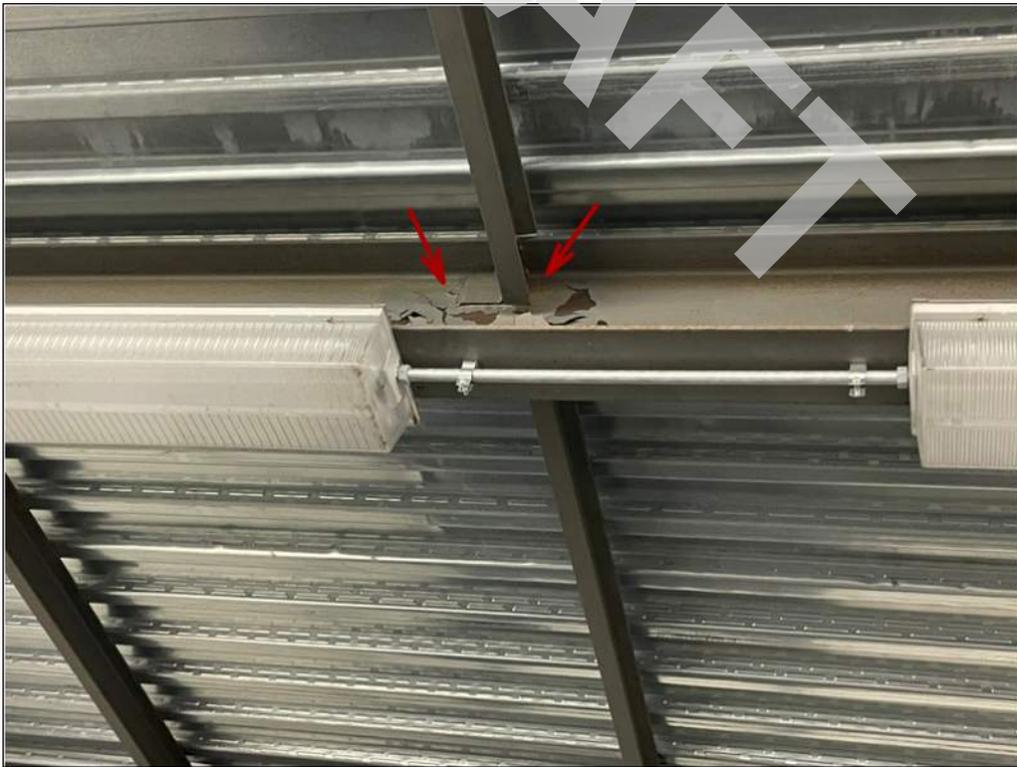
6 - Surface corrosion and peeling coating at the team rooms roof steel framing.

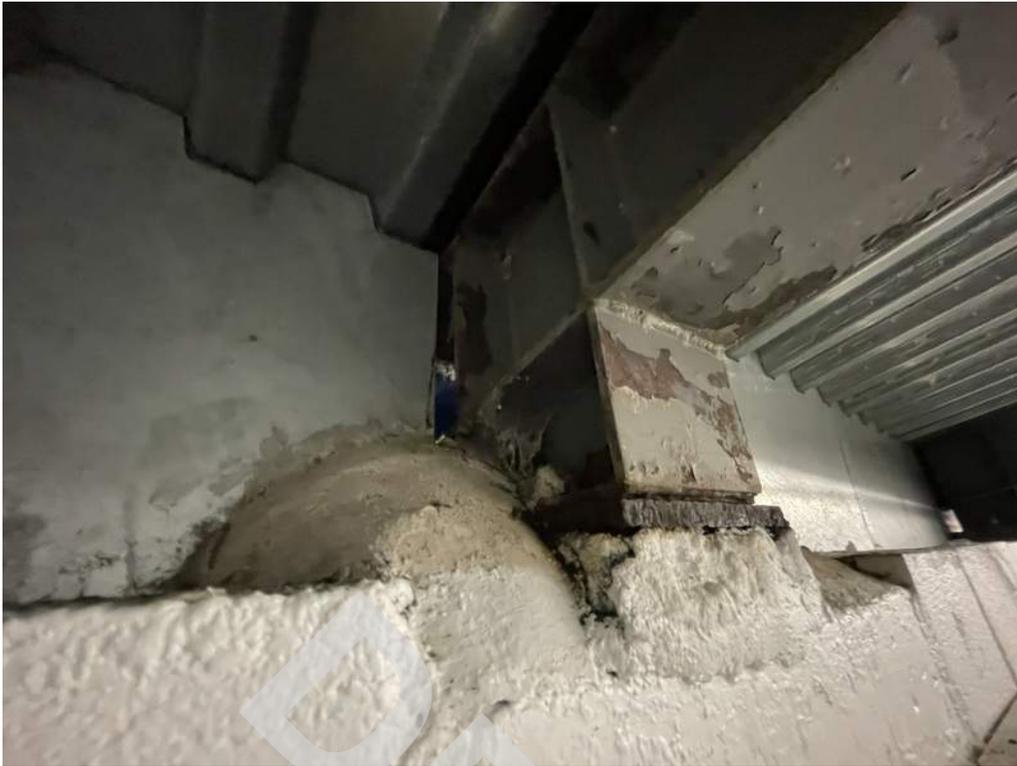
7 - Surface corrosion and peeling coating at the team rooms roof steel framing.

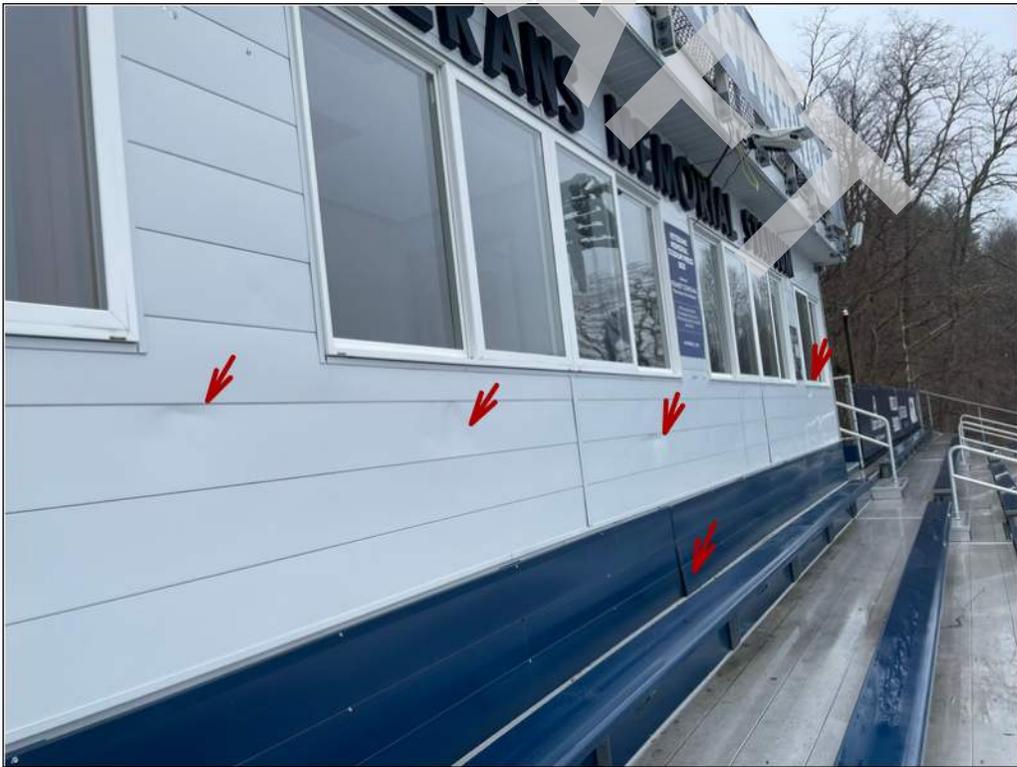
8 - Various metal panels along the Press Box enclosure have dents or have displaced.

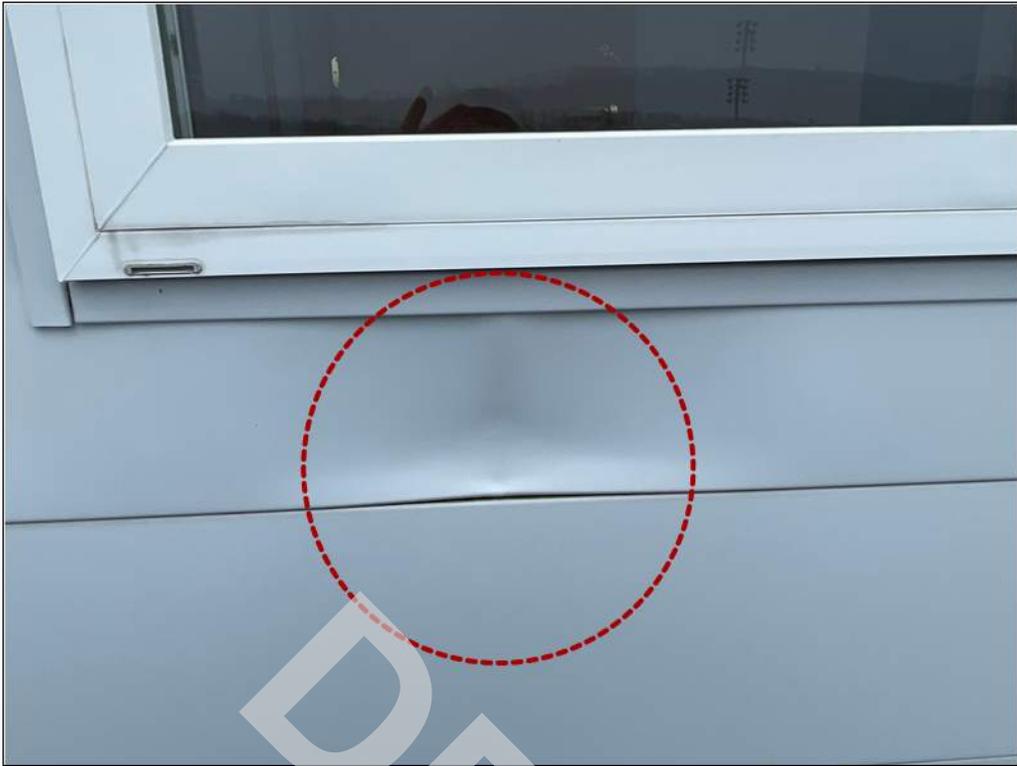
9 - Metal panel dent has opened the joint between panels.
