# FACILITY CONDITION ASSESSMENT

## TOWN OF WILTON – TOWN BUILDINGS

Wilton, Connecticut

Draft: February 2, 2024

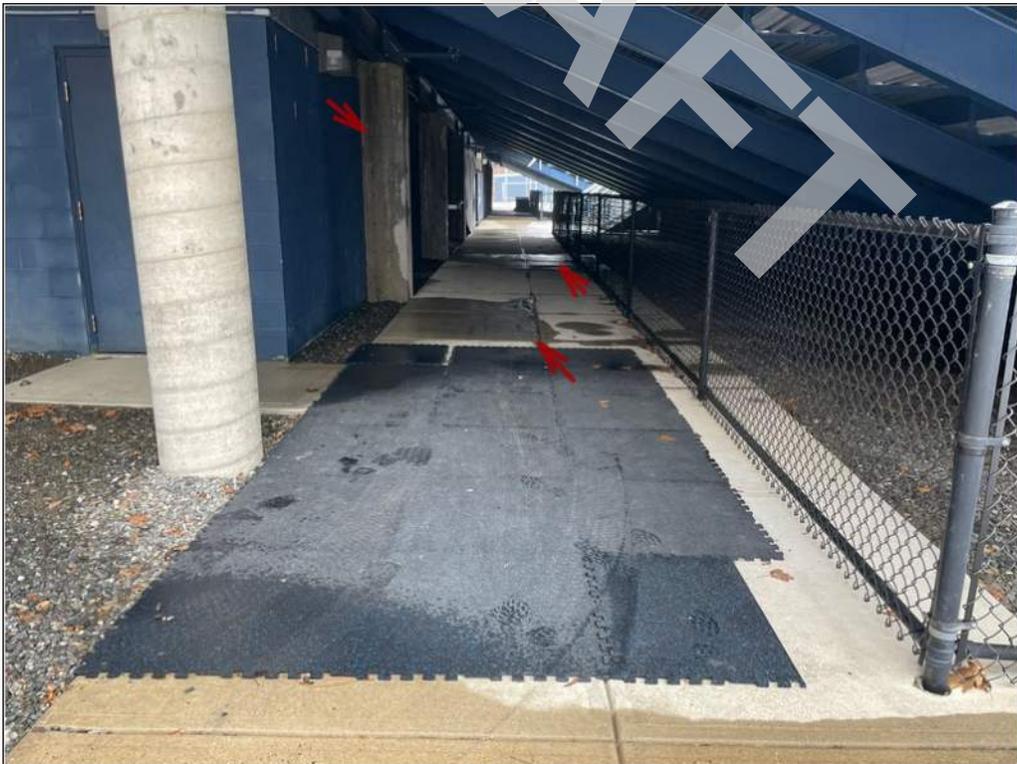
10 - Water from the grandstand is dripping along the team room CMU (Concrete Masonry Walls) and adjacent reinforced concrete walkway.

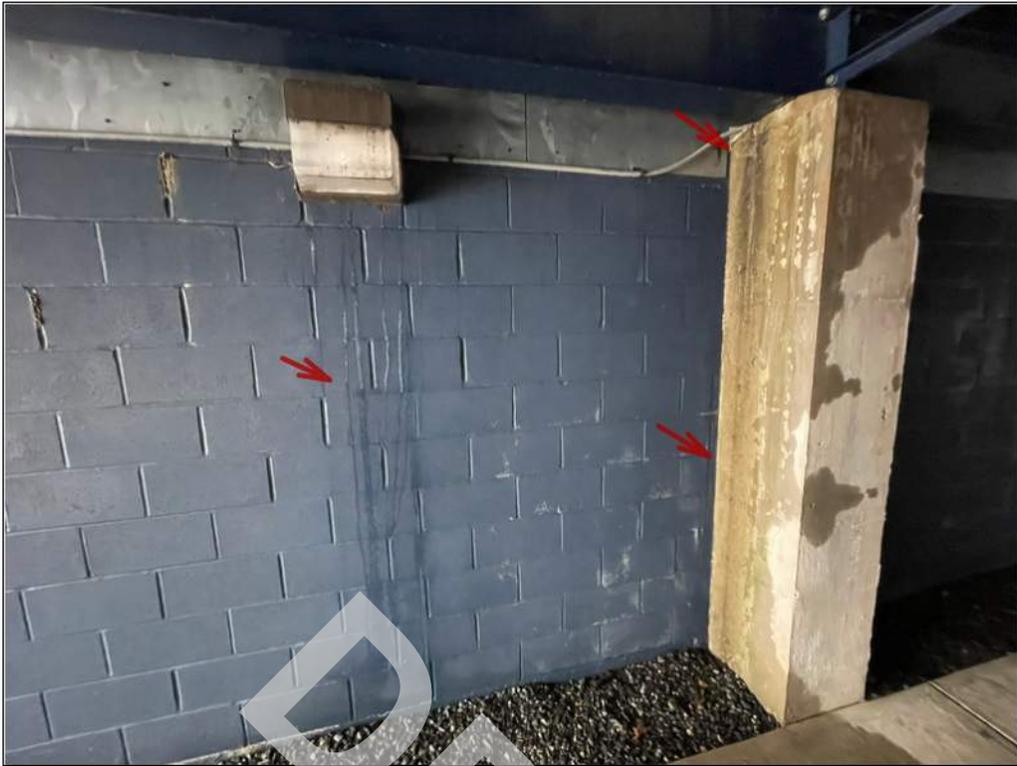
11 - Water from the grandstand is dripping along the team room CMU (Concrete Masonry Walls) and reinforced concrete structure.

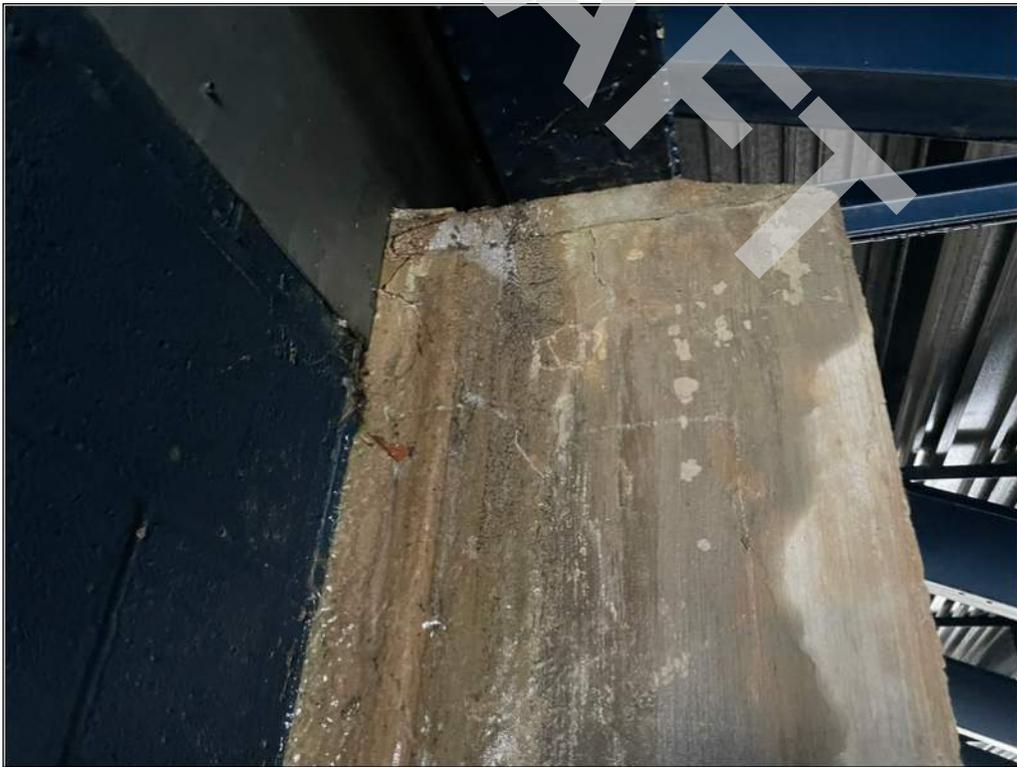
12 - Water dripping from the grandstand is freezing along the concrete column surfaces.

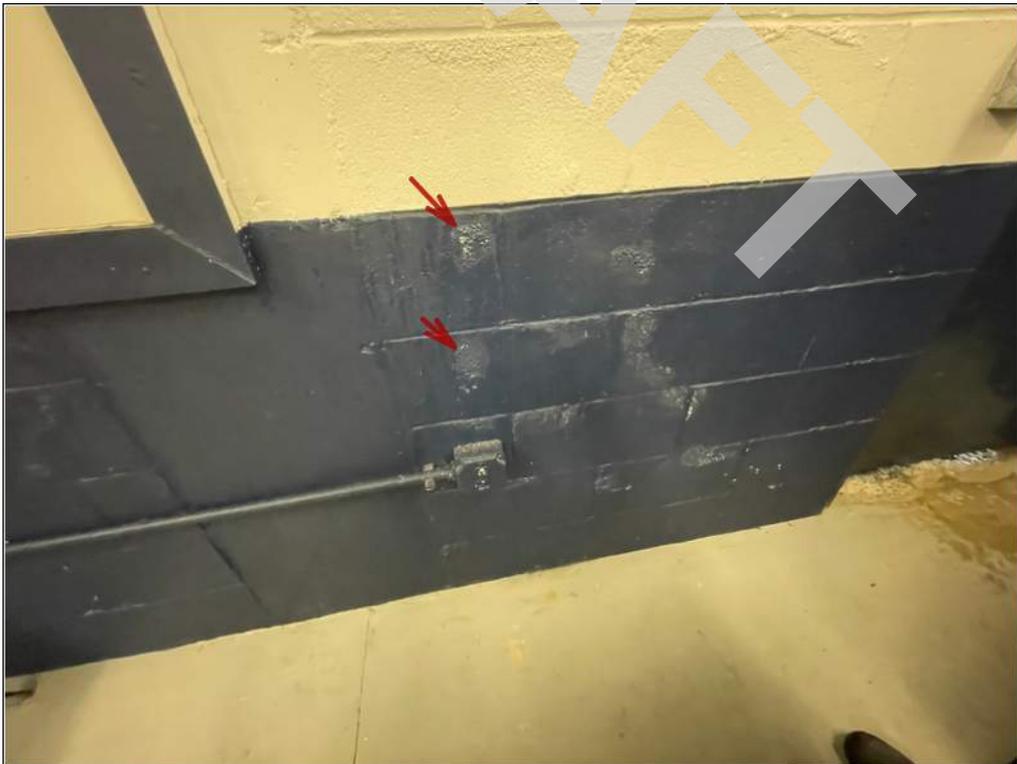
14 - Visible signs of moisture and efflorescence are spreading along the interior surface of the CMU enclosure.

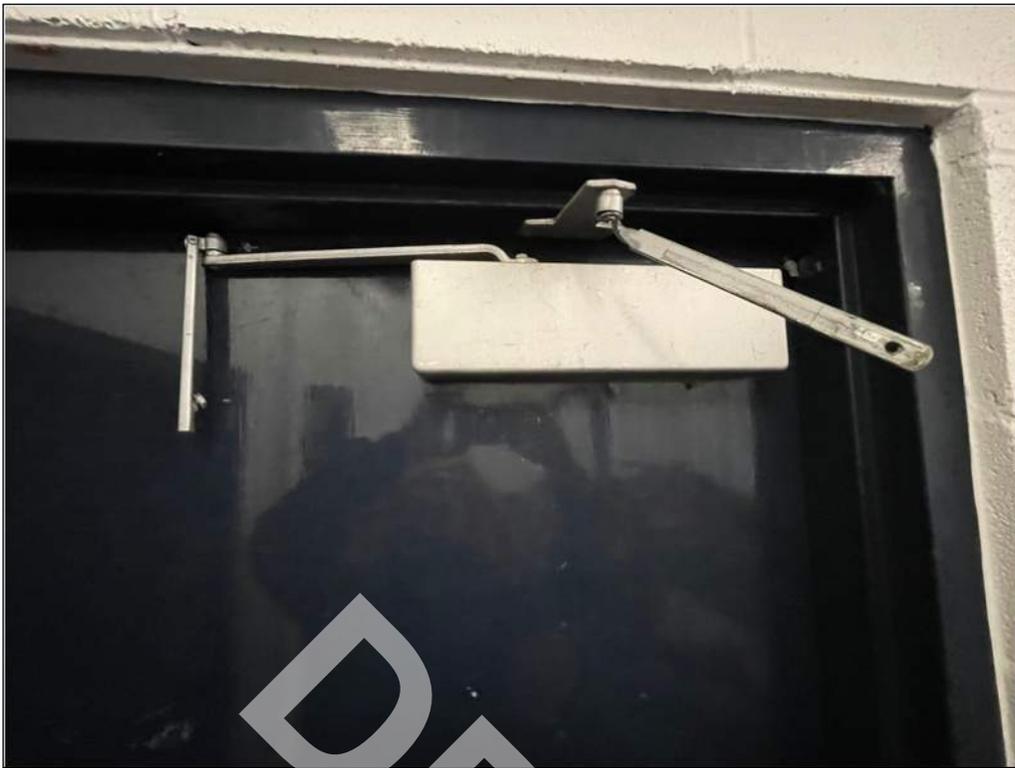
15 - Team Rooms: Door closer arm is bent.

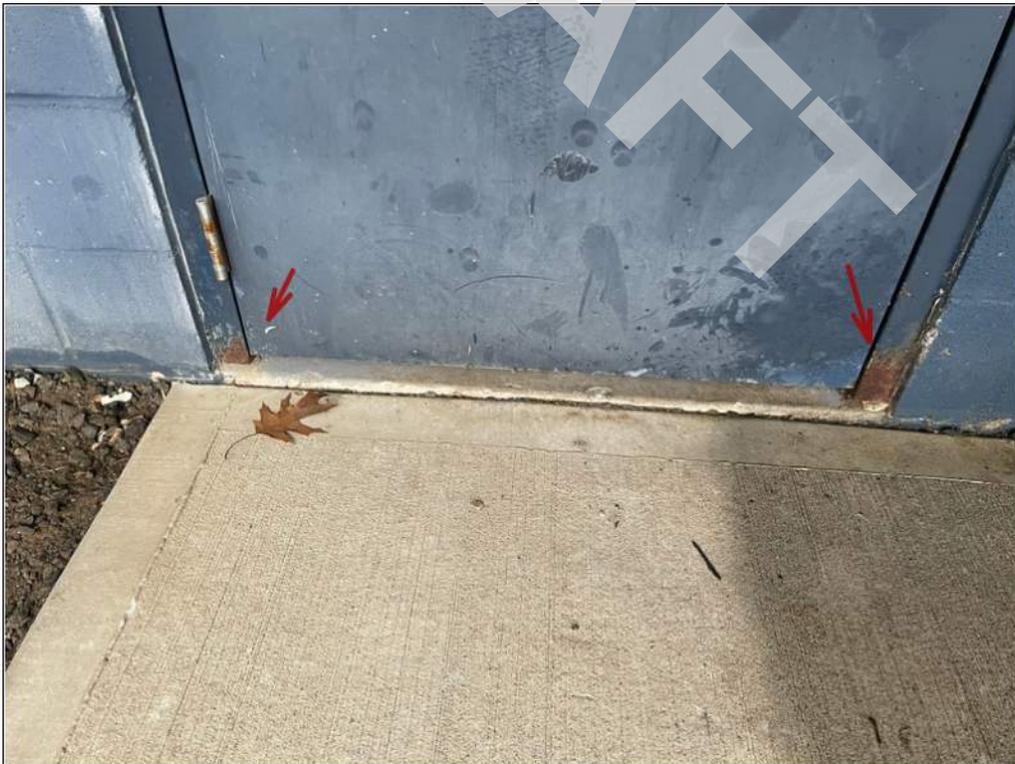
16 - Metal surfaces along the frame and doors at the team rooms are starting to corrode.

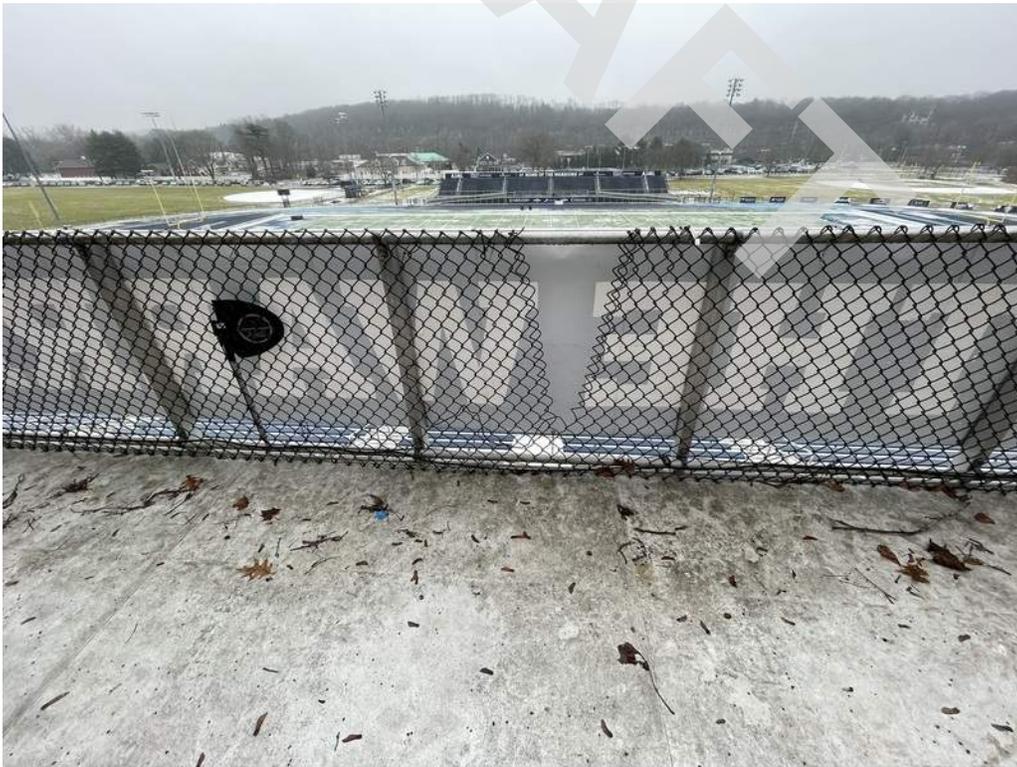
18 - A section of the chain link fence at the press room roof guardrail is broken.

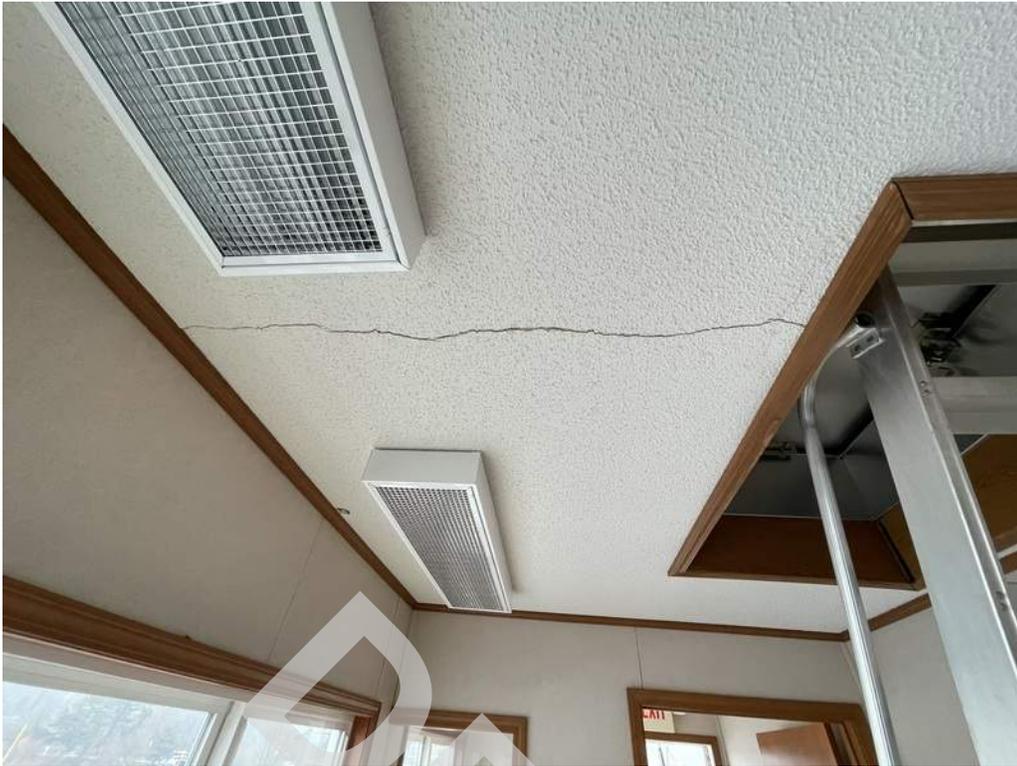
19 - Localized cracks along the press box ceiling have occurred.

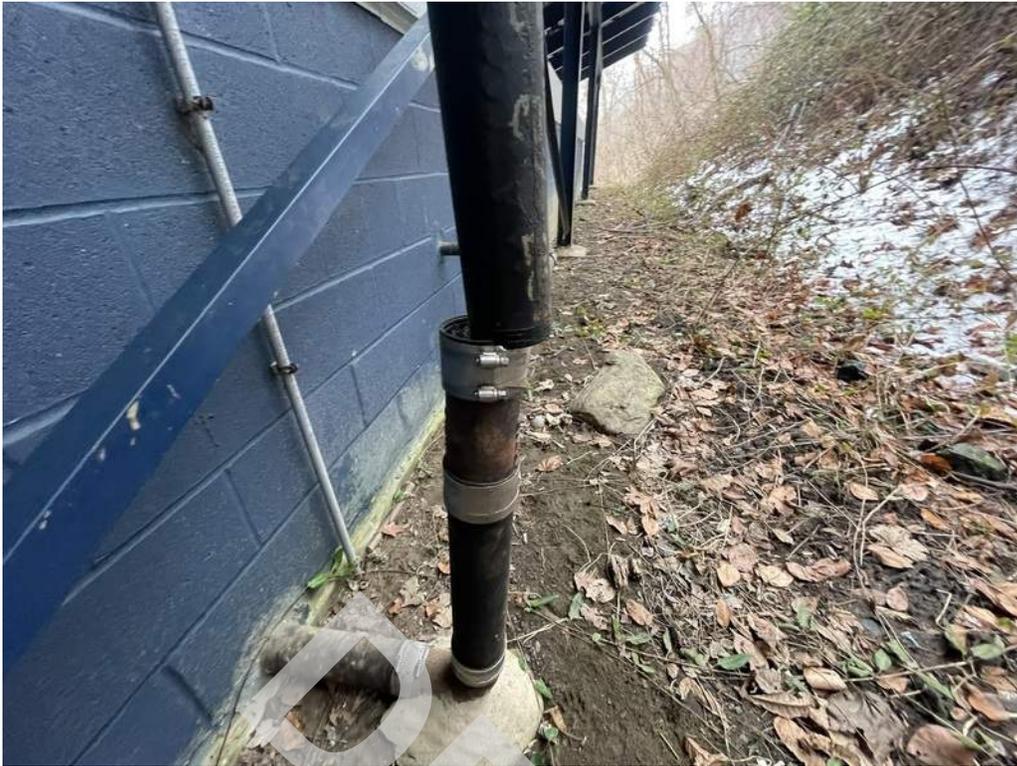
23 - A vent pipe on the exterior of one team room has broken and is currently disconnected.

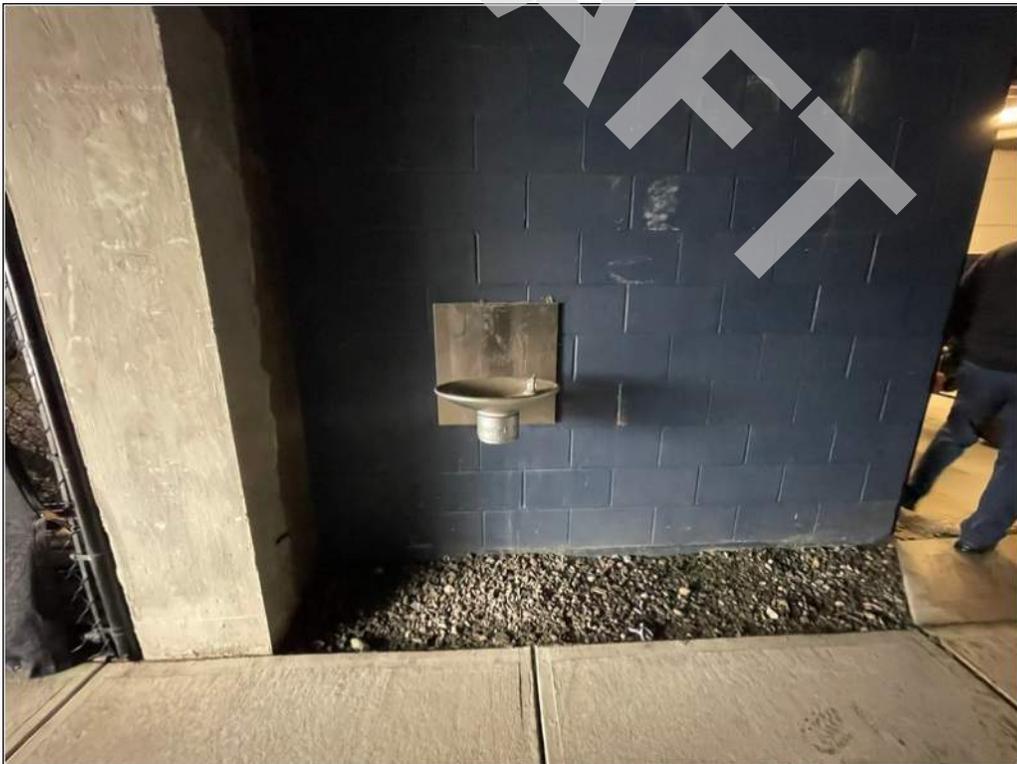
24 - Water fountains are not provided with a firm surface for front approach.

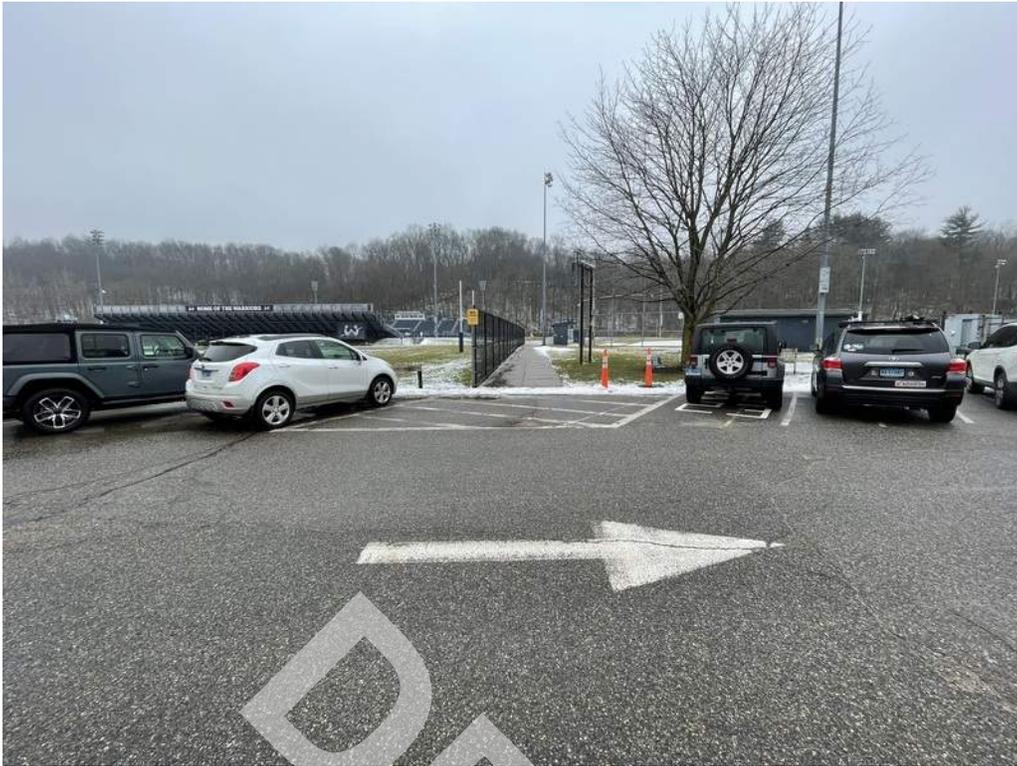
25 - Accessible spaces are not provided adjacent to the accessible route leading to the stadium.

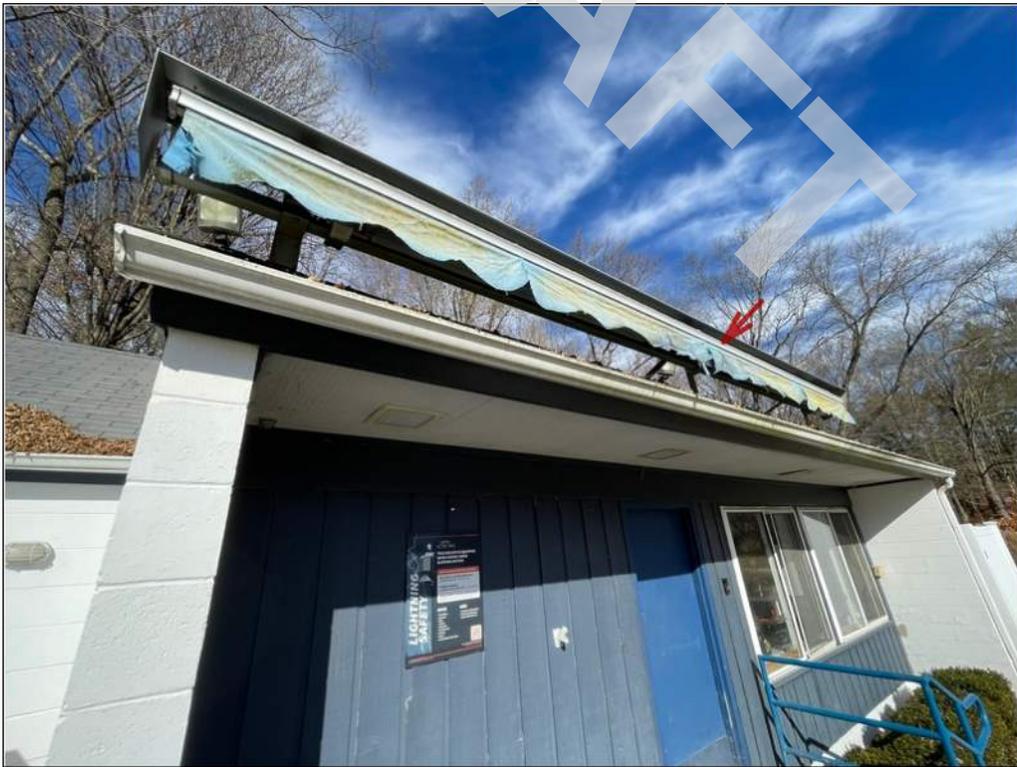
6 - Restrooms: A retractable fabric awning sits atop the asphalt shingles. Fabric is ripped.

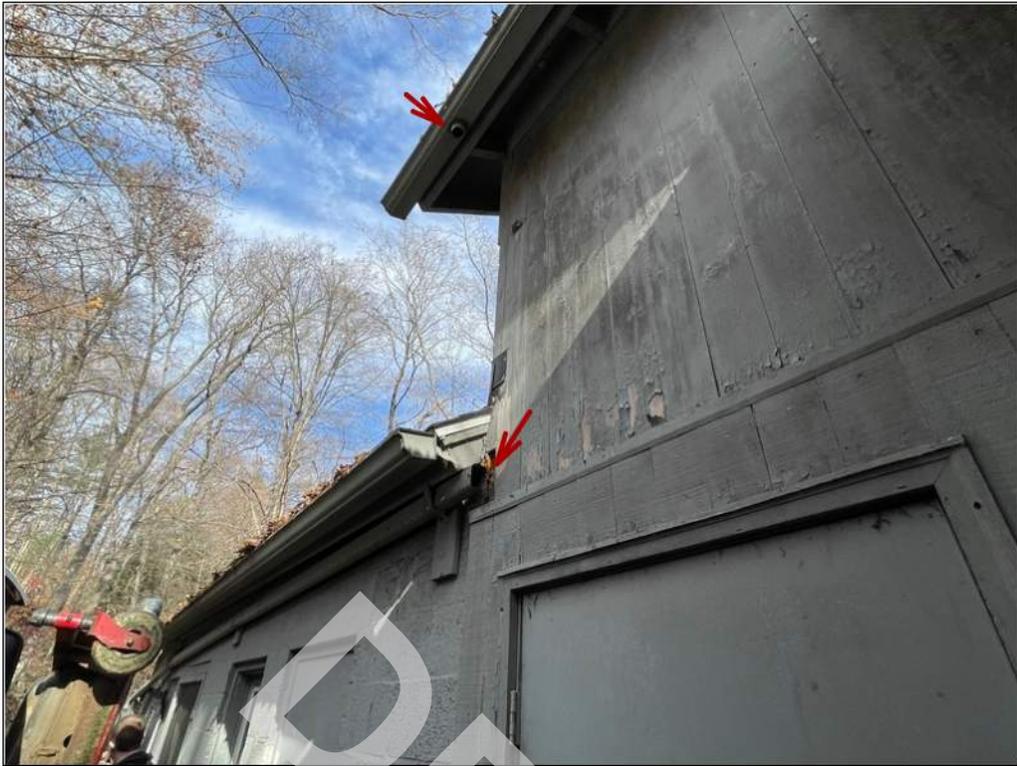
7 - Barn: A roof leader is missing along the west side of the barn.

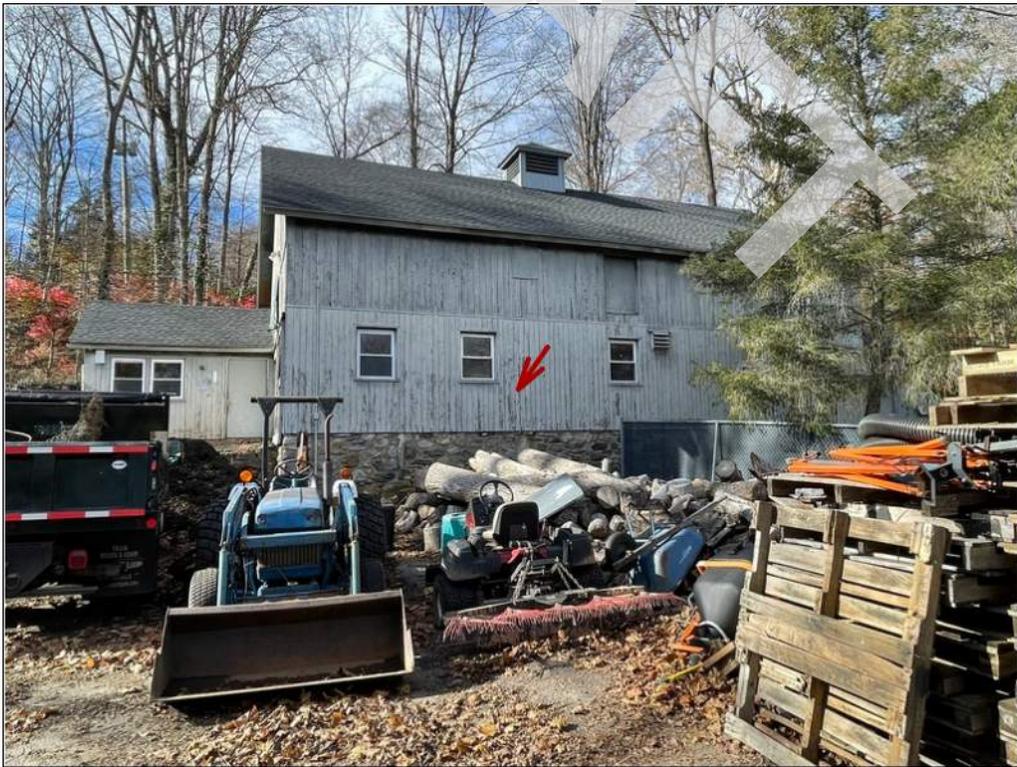
8 - Barn: Paint over, the wood cladding is peeling.

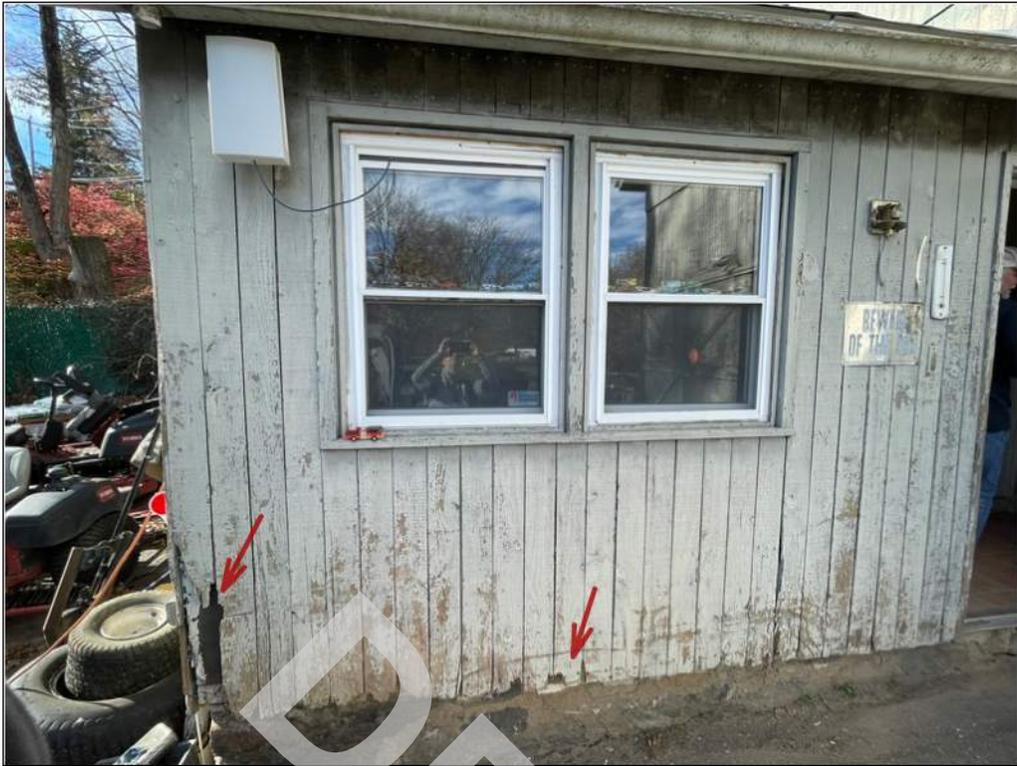
9 - Barn: Wood plank facade is in poor condition, including broken wood planks.

#	Item	QTY	Unit	Unit Cost	EUL	EFF Age	Year 1	Year 2	Year 3	Year 4	Year 5	Year 6	Year 7	Year 8	Year 9	Year 10	Total Cost	Comments
9	Ⓟ Building Integrity - Barn: The barn exterior cladding consists of painted wood planks. Localized areas are in poor condition. Damages include missing and broken wood plank. Perform localized repairs.	500	SF	\$15.00			\$7,500										\$7,500	Priority 3 - Necessary - Not Yet Critical.
10	Ⓟ Appearance - Barn: After localized repairs to the exterior cladding have been completed, prepare all surfaces and paint throughout. Scope includes installing temporary scaffolding to complete all surfaces.	4,500	SF	\$8.00	10	9	\$36,000										\$36,000	Priority 4 - Recommended.
11	A budget is provided for general contractor overhead, profit, general conditions associated to the envelope and exterior.	1	LS	\$19,000.00			\$19,000										\$19,000	
12	A budget is provided for architectural/engineering fees associated to the envelope and exterior.	1	LS	\$12,000.00			\$12,000										\$12,000

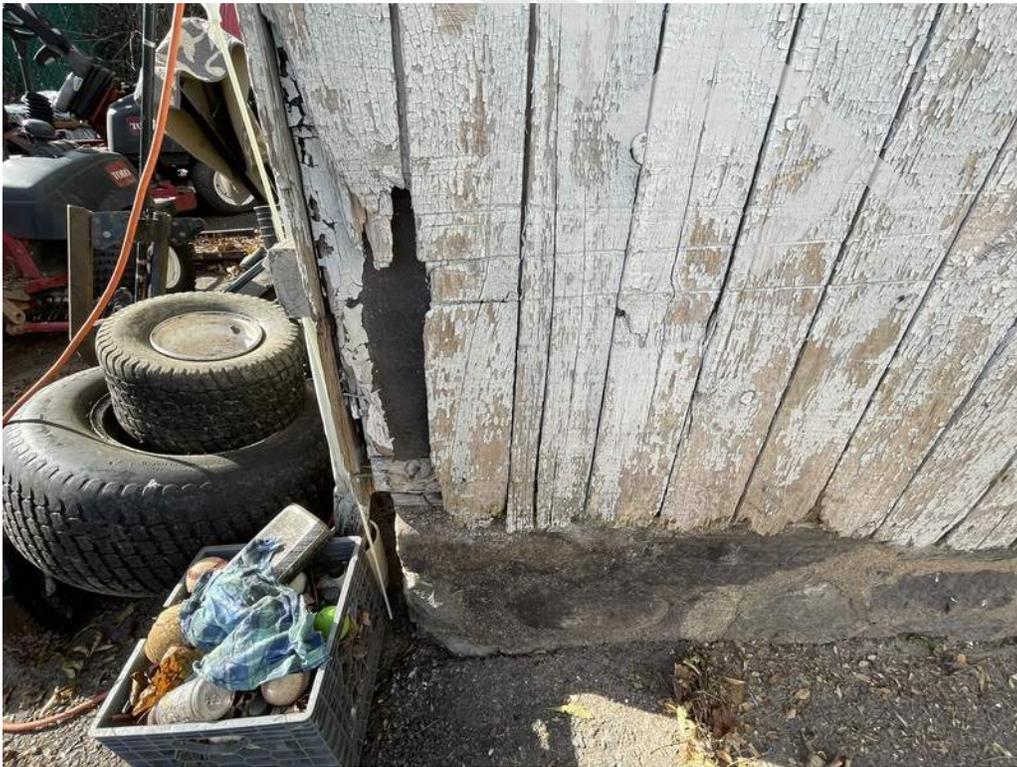
10 - Barn: Close up view of damaged wood and paint finish.

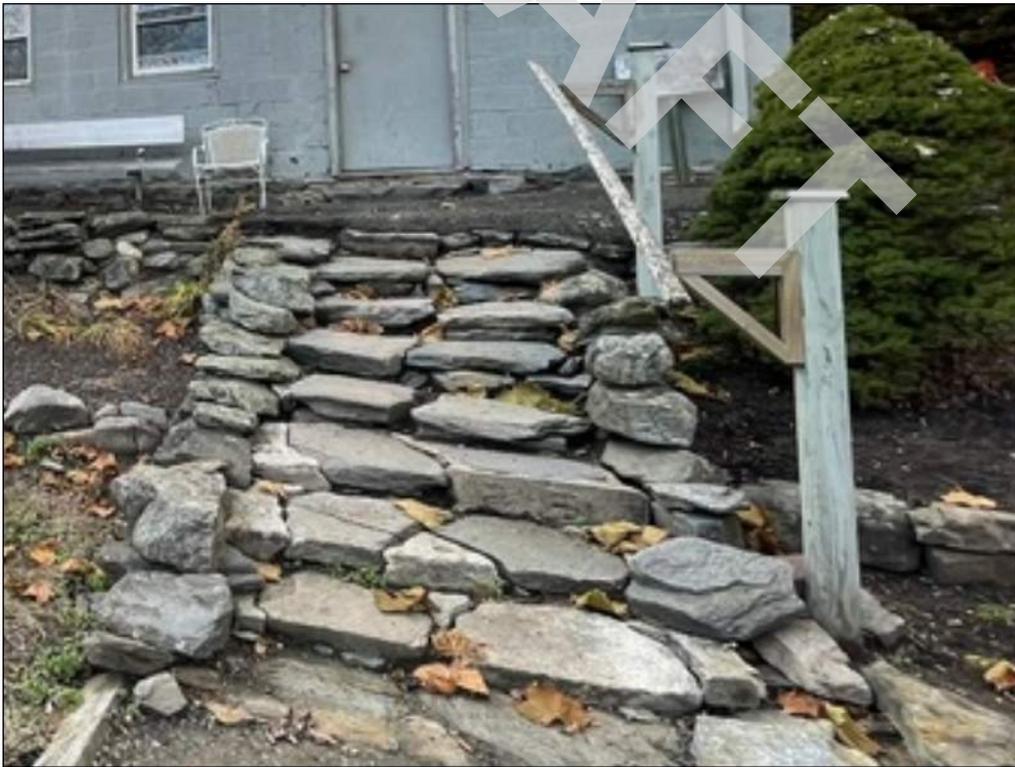
12 - Barn: Rock stair and landing are in poor condition; surfaces are uneven and a second handrail is not provided.

#	Item	QTY	Unit	Unit Cost	Replacement Percent	Immediate Total	Comments
<b>ENVELOPE AND EXTERIOR</b>							
1	Ⓢ Building Integrity - Barn: Stone stairs, landing, and wood handrails along the east side of the barn are uneven and in poor condition. Repair steps, landings, and provide handrails and support on both sides of the stairs.	1	LS	\$15,000.00	100%	\$15,000	Priority 1 - Current Critical.
<b>MECHANICAL/ELECTRICAL/PLUMBING</b>							
2	Life Safety Code Compliance - Barn: Battery powered emergency lighting is provided throughout the building. Each light observed was tested to confirm it was functional. One of the emergency lights in the barn did not turn on when tested. Replace the non-functioning light with new. It is recommended to regularly test all emergency lights.	1	EA	\$1,000.00	100%	\$1,000	Priority 1 - Current Critical
3	Life Safety Code Compliance - Barn: Advisory - At the time of the site visit the fire alarm panel light reading "Trouble" was on. It is recommended to regularly check all fire alarm panels to ensure there are no problems within buildings or to systems.	0	EA	\$0.00	0%	\$0	Priority 1 - Current Critical.

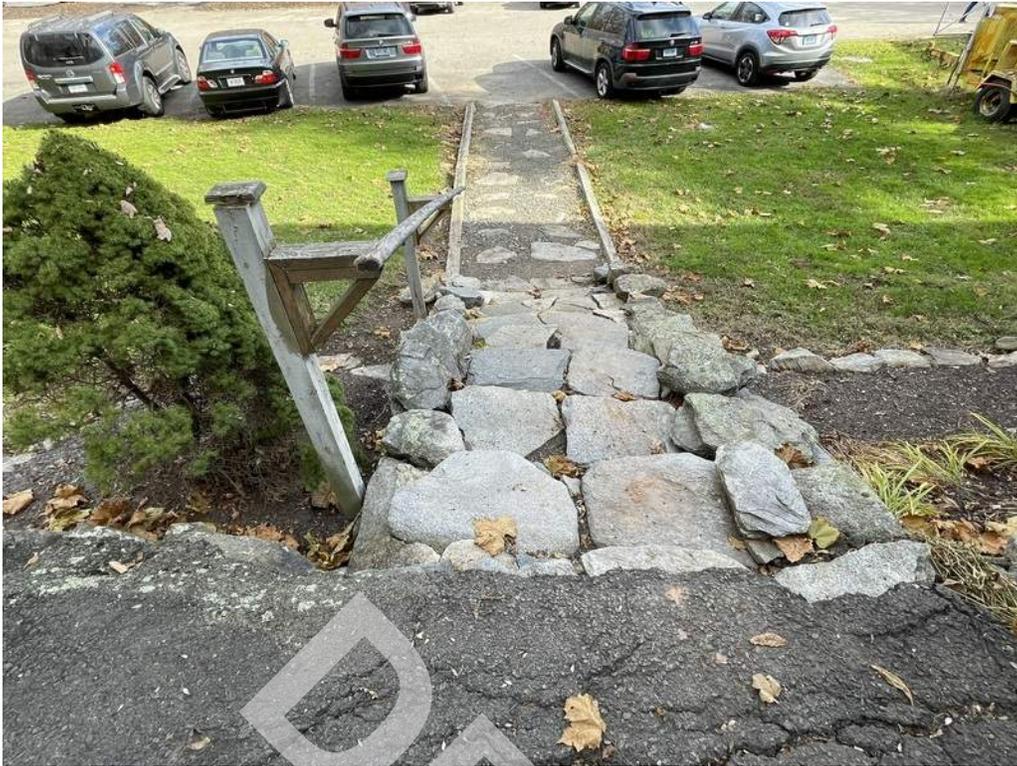
13 - Barn: Rock stair is uneven, and does not have a second handrail.

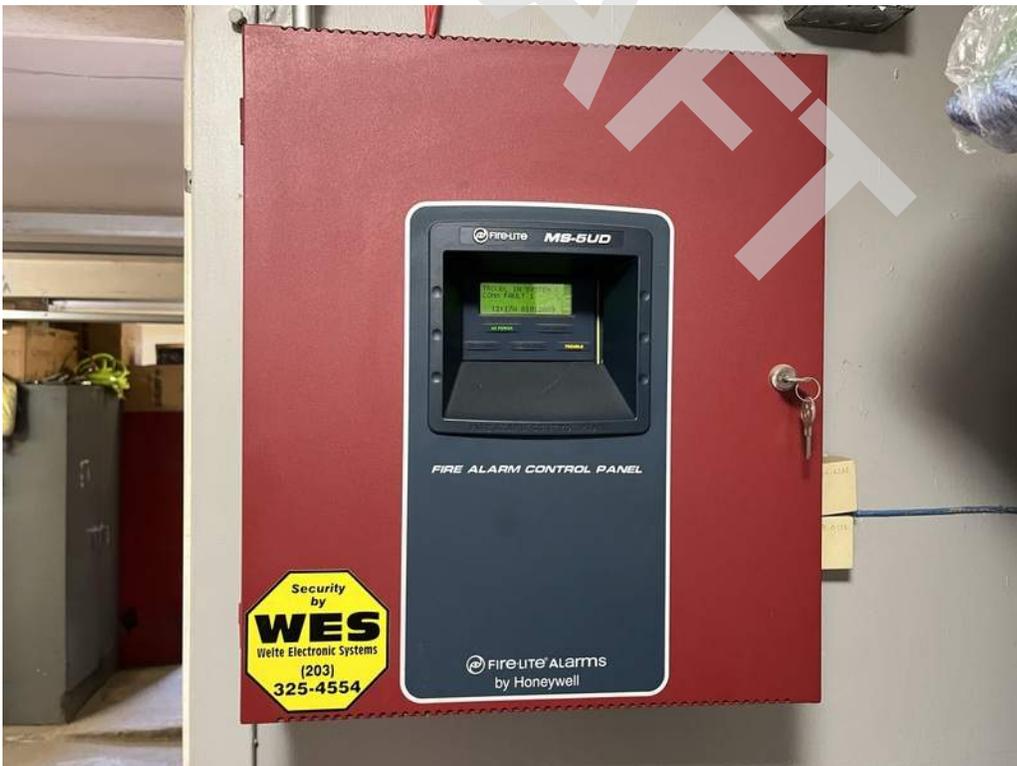
18 - Barn: The building is provided with a Fire-Lite MS-5UD fire alarm panel located in the main room of the building. The panel's "Trouble" light was on at the time of the site visit.

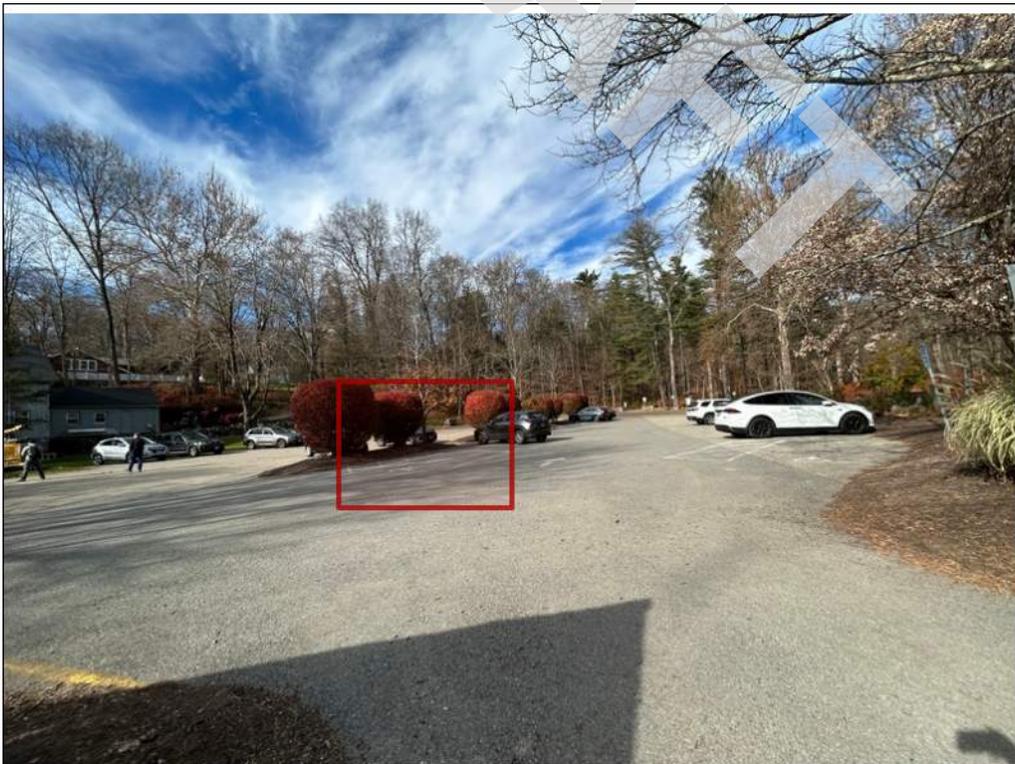
20 - Missing signage was observed at the accessible parking space.

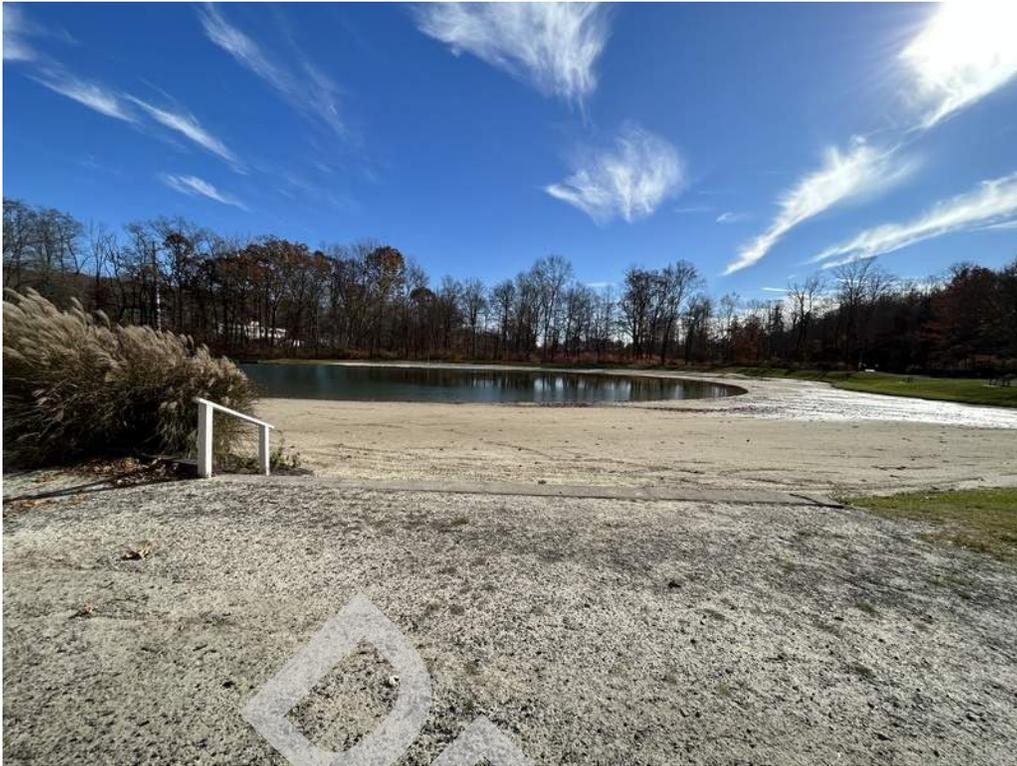
21 - An accessible route is not provided to the lake.

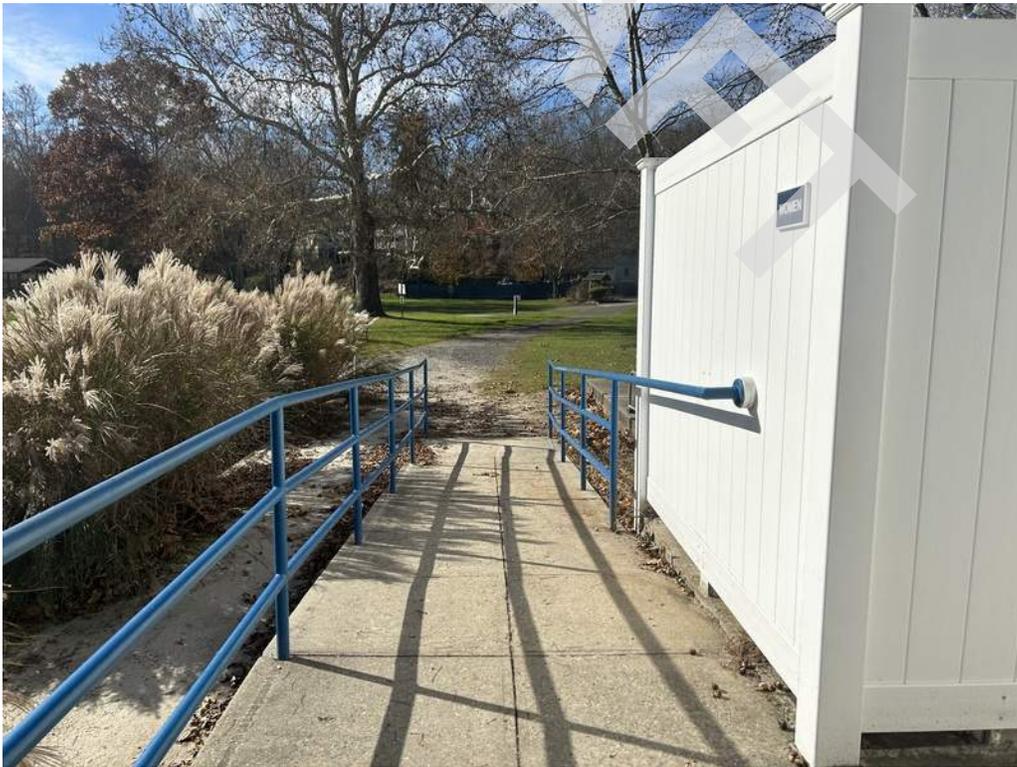
22 - Restrooms: The ramp at the Merwin Meadows Restroom does not provide edge protection on both sides, handrail extension at the bottom of the ramp, and a compliant bottom landing.

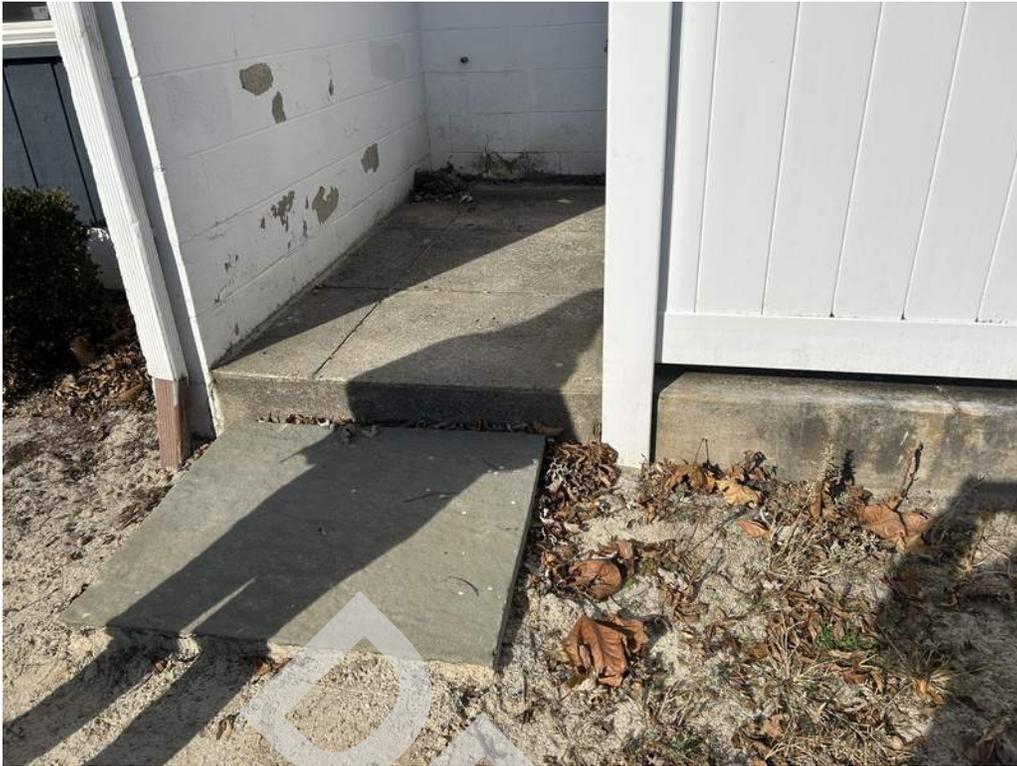
23 - Restrooms: An accessible route to the men's restroom is not provided.

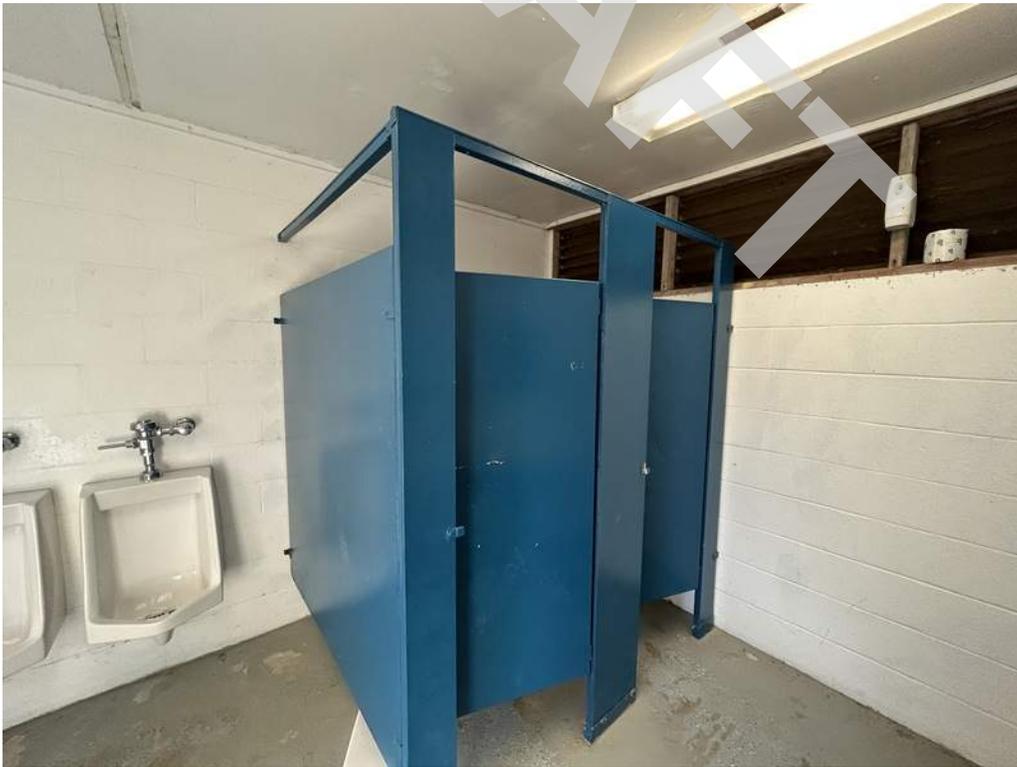
24 - Restrooms: Accessible stalls and urinals are not provided.

#	Item	QTY	Unit	Unit Cost	Replacement Percent	Immediate Total	Comments
9	ADA: The Merwin Meadows Restrooms provide a women and men's multi-user restroom, which were noted to have various non compliant items. Items include missing scald guard protection under the sinks, accessible stalls and urinals not provided, and mirrors mounted above complaint height. Perform alterations to meet compliance.	2	EA	\$10,000.00	100%	\$20,000	Priority 1 - Current Critical.
Total Repair Cost						\$170,300

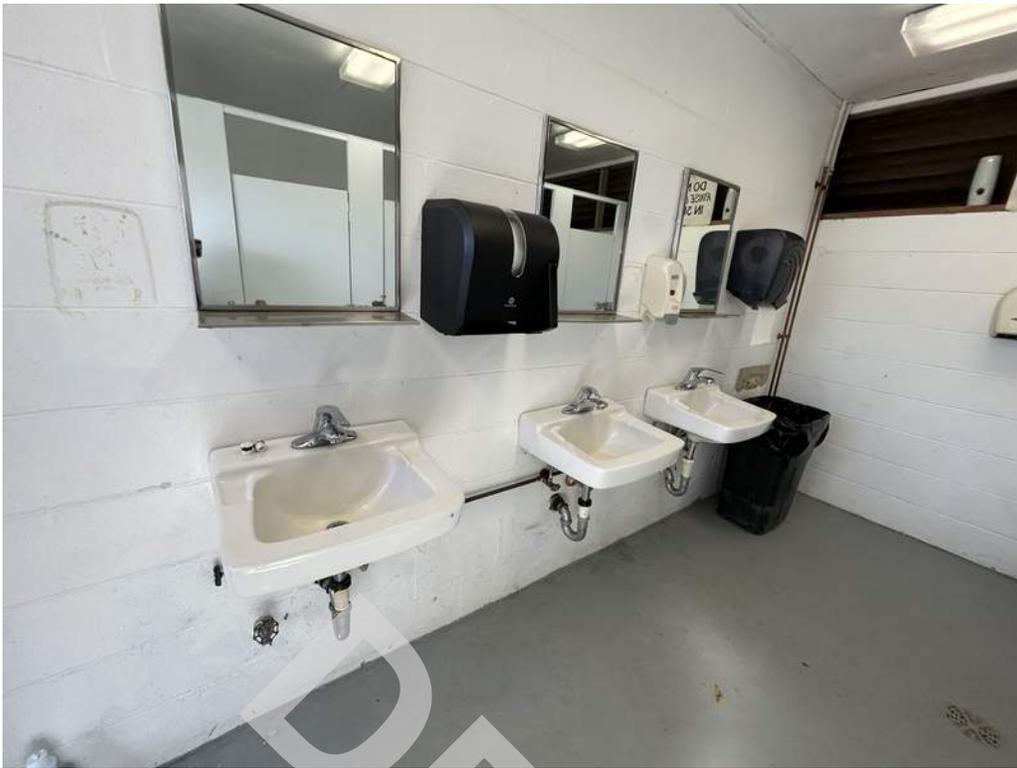
25 - Restrooms: Scald guard protection is not provided under the sinks.

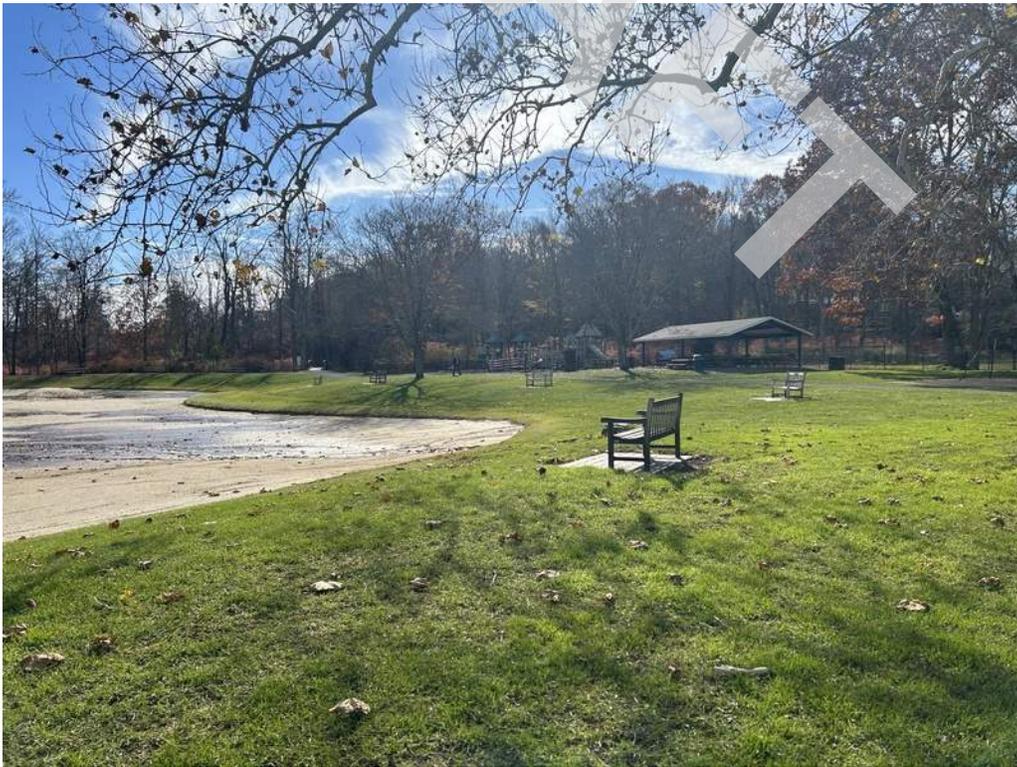
26 - A firm surface route from the parking lot to the Merwin Meadow playgrounds and picnic pavilion are not provided.

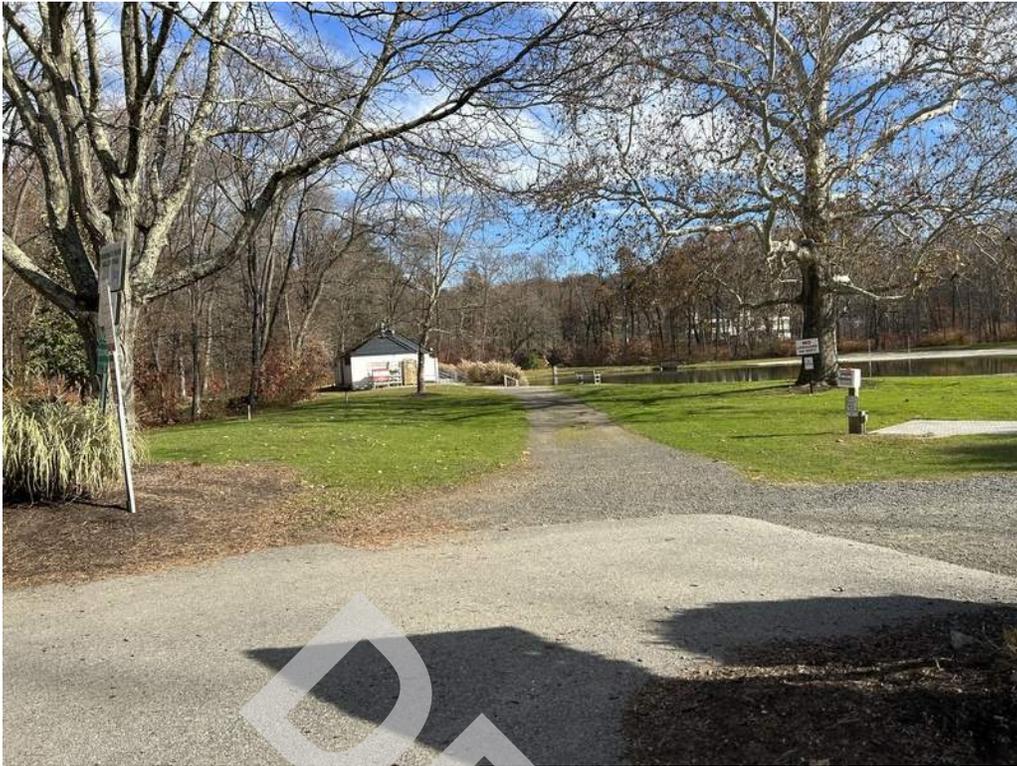
27 - A firm surface route from the parking lot to the Merwin Meadow Restrooms facility is not provided.

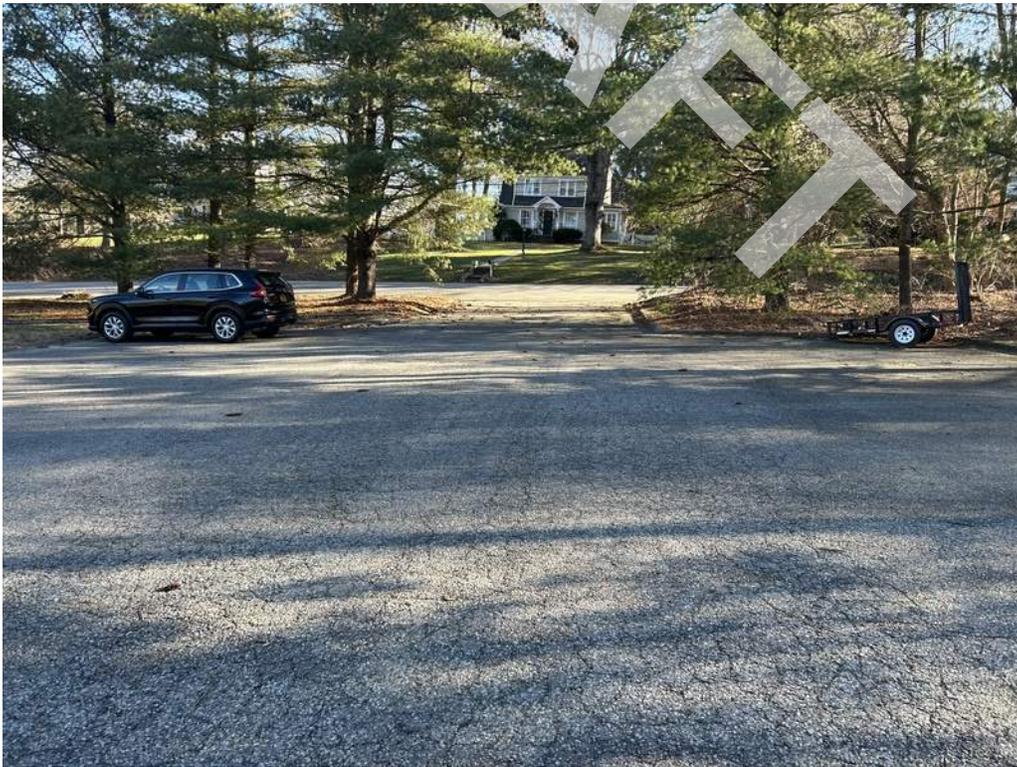
2 - The side asphalt paved parking area, along New Street, exhibits alligator cracking throughout.
