# FACILITY CONDITION ASSESSMENT

## TOWN OF WILTON – TOWN BUILDINGS

Wilton, Connecticut

Draft: February 2, 2024

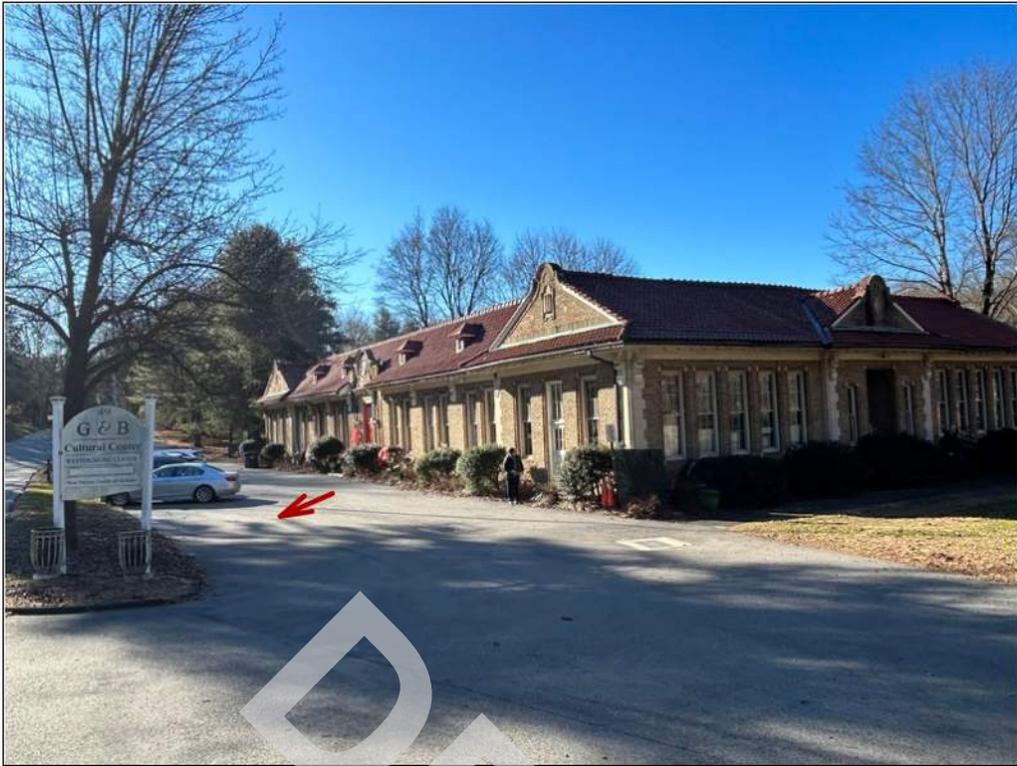
3 - Parking spaces in front of the building are not striped.

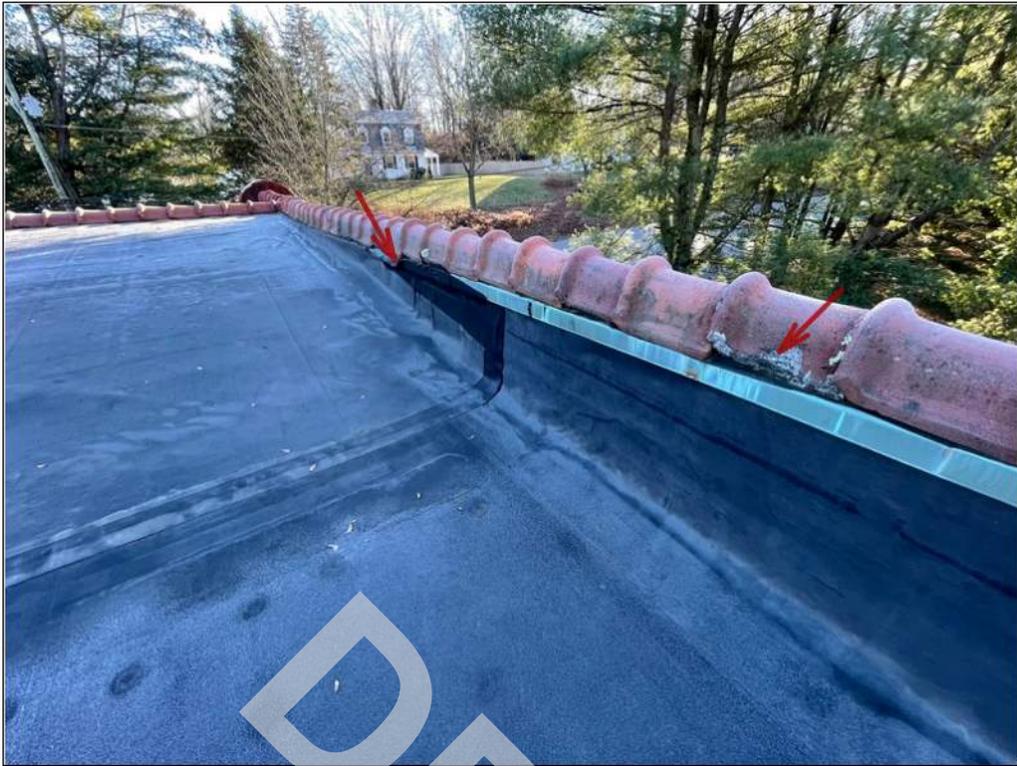
5 - Parapet coping consists of clay roof tiles with EPDM flashing and metal counterflashing. Clay roof tiles are in poor condition, some units are displaced and the EPDM parapet flashing is poorly installed.

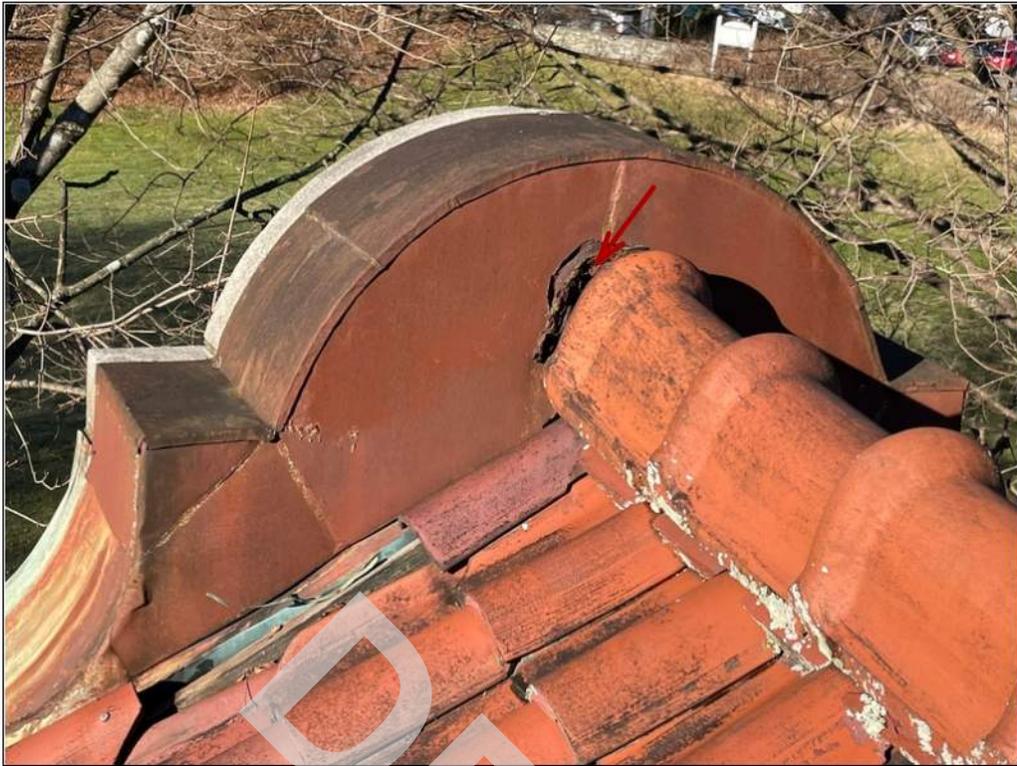
7 - Metal surfaces along the roof have corroded and have openings.

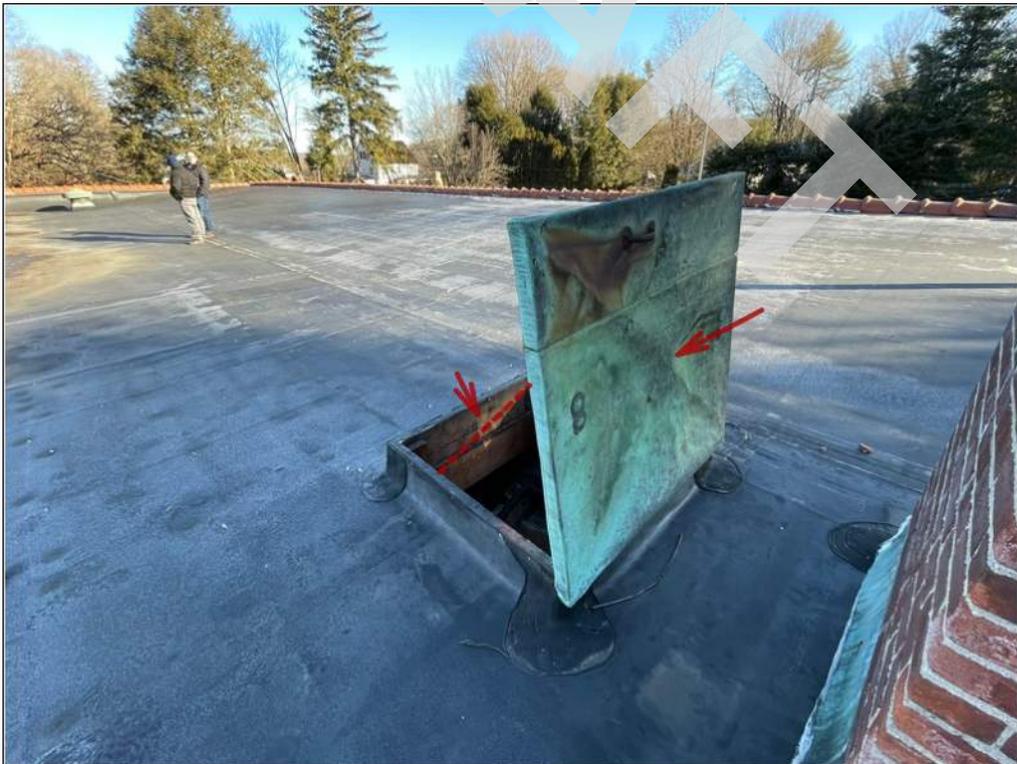
8 - Roof hatch is missing one hold open hardware and is in poor condition.

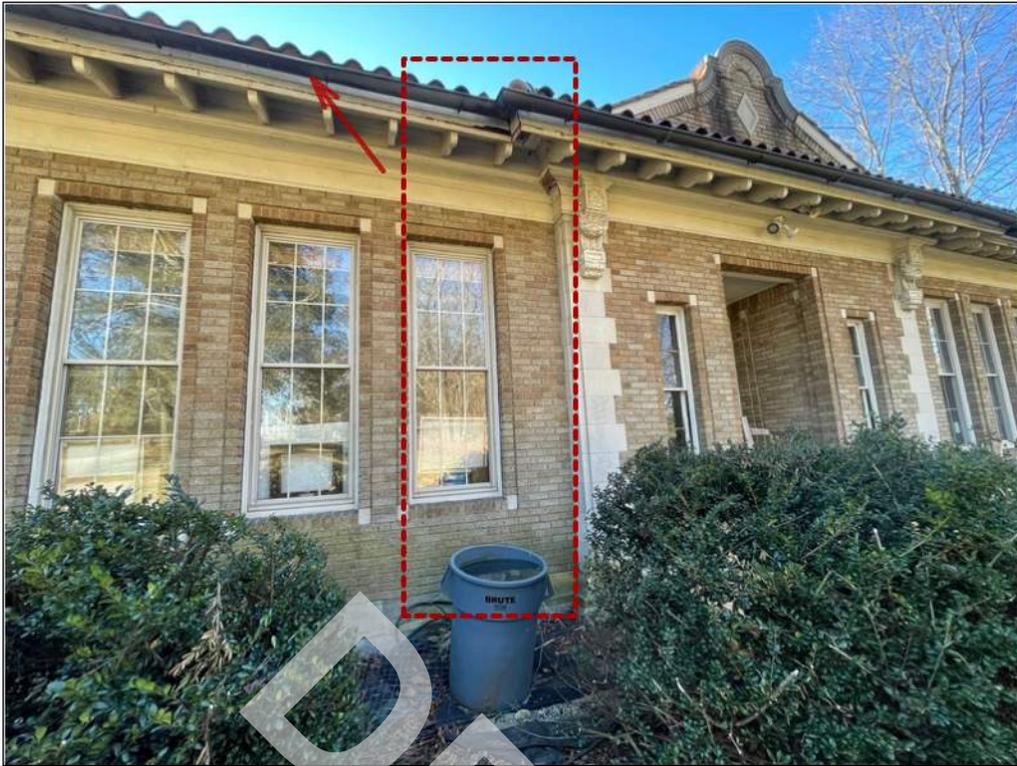
8	<b>P</b> Building Integrity: Metal roof gutters and leaders are provided around the perimeter of the roof. The age of the gutters and leaders was not provided, however, it was reported that the gutters overflow during high rain events, and sections of the system were noted to be in poor condition with various bent portions. Perform a roof gutter and leader rehabilitation program including debris removal, rectifying proper slope at the roof gutters and replacing any damaged sections of the system. The budget represents replacing approximately 50% of roof gutters.	250	LS	\$40.00			\$10,000										\$10,000	Priority 2 - Potentially Critical.
9	Energy: Portions of the low slope roof could be considered for the addition of photovoltaic (PV) solar panels. Engage the services of a registered Structural Engineer to perform an analysis to determine if the structure can support the added loads of a PV system as well as a qualified party to perform a feasibility study, including a solar analysis. Based on the results of a preliminary structural and solar analysis, consideration could be given to the addition of PV panels on the roof. The results of the analysis will determine the system's limitations and requirements. PV solar panels can provide the building with a renewable, clean source of energy.	1	LS	\$10,000.00			\$10,000										\$10,000	Priority 4 - Recommended.

9 - Sections of the roof gutters are in poor condition and appear to be overflowing.

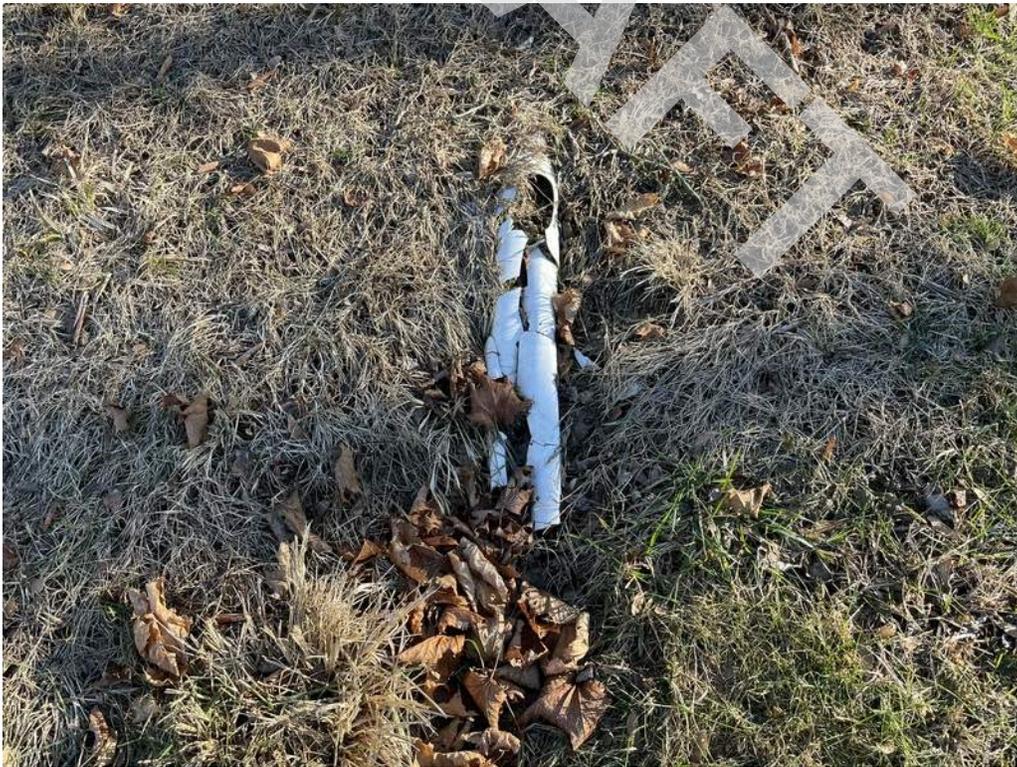
10 - Roof leader drain pipe extensions have failed.

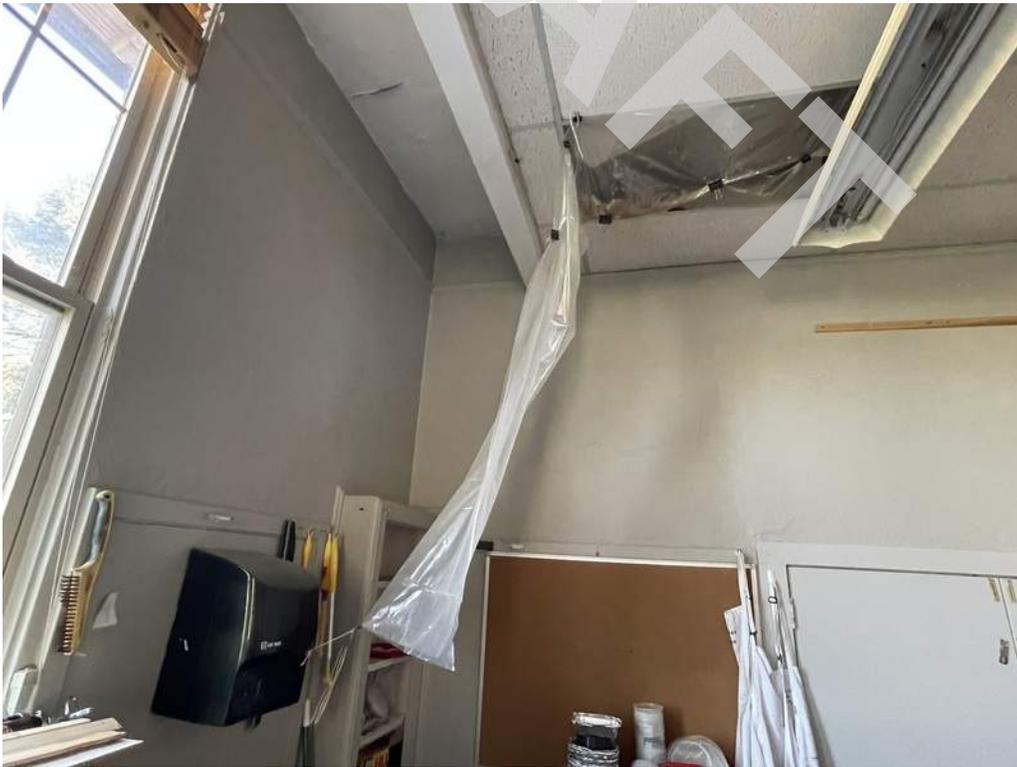
12 - Signs of active roof leaks coming down from the ceiling at one of the art studios.

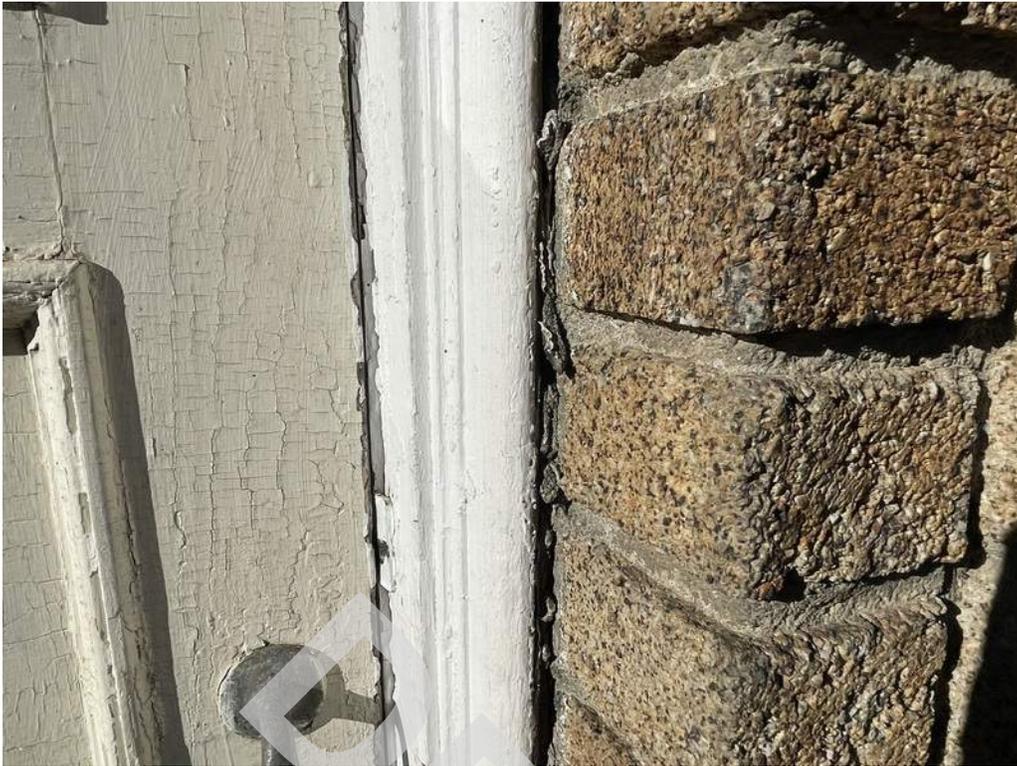
13 - Joint sealant along brick masonry openings has failed.

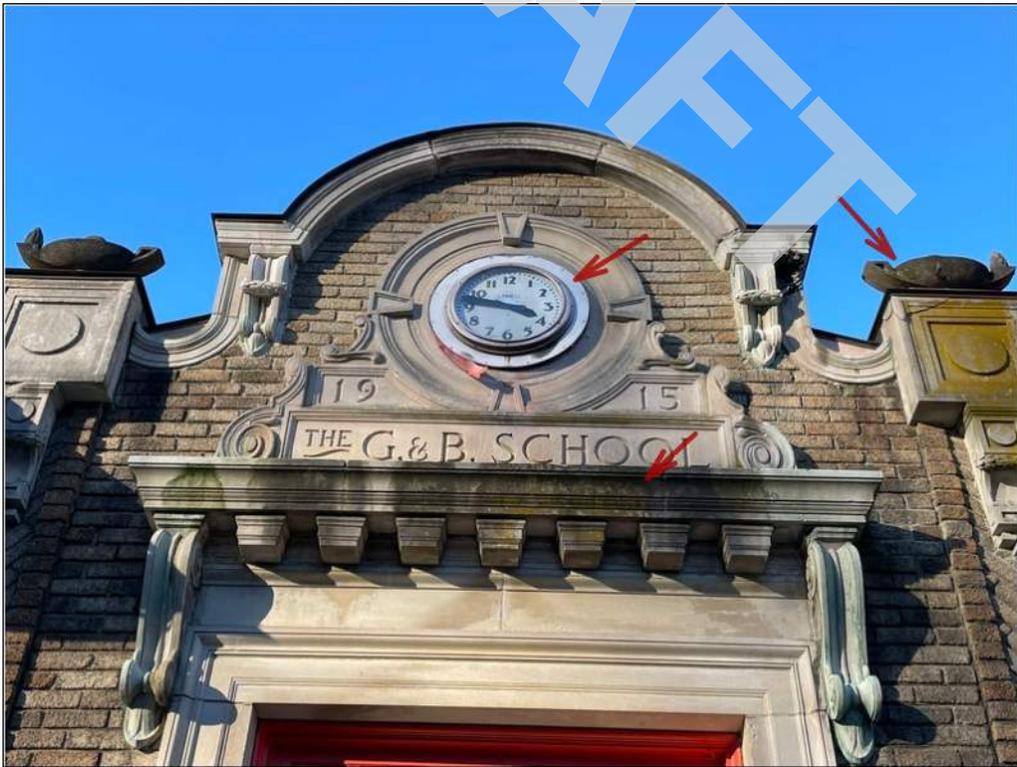
14 - Building clock is not working properly and appear to be in poor condition. Organic growth and build up stains are in the front facade stone.

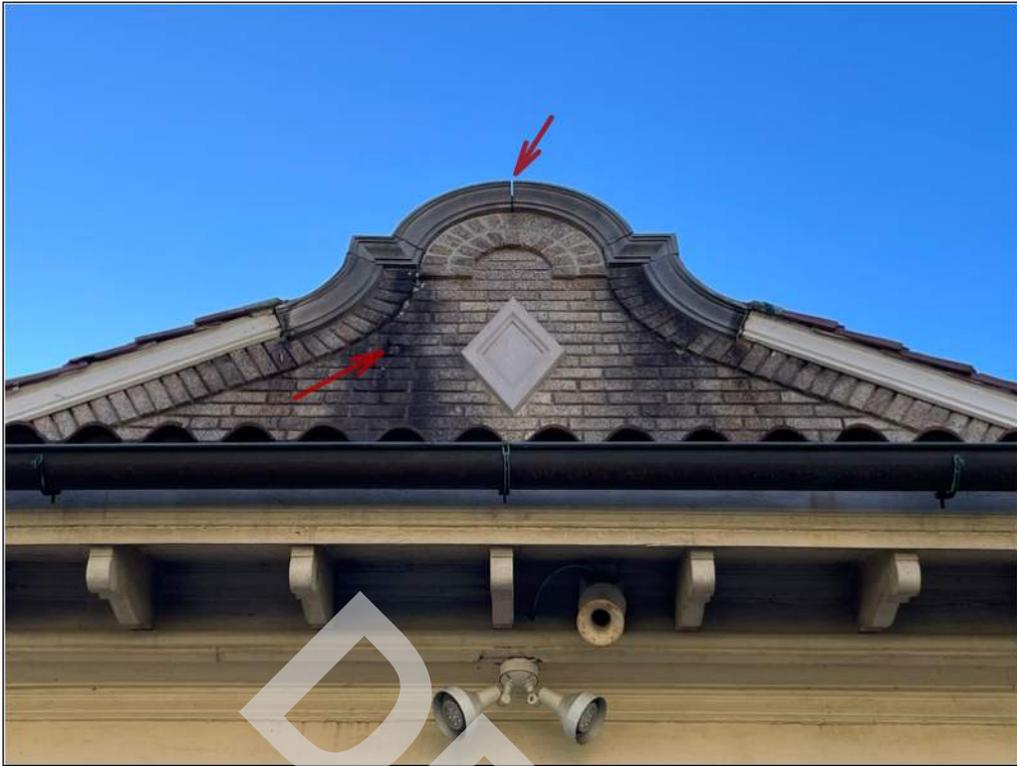
12	<b>P</b> Building Integrity: Joint mortar at localized areas of the brick masonry and stone walls are deteriorating. Perform a brick and stone repointing program through the building. The budget represents repointing approximately 10% of the brick and stone. Budget includes using the use appropriate methods that are adequate for the age and type of brick and stone, and includes power-washing organic growth and debris, with non abrasive methods.	350	SF	\$30.00			\$10,500										\$10,500	Priority 2 - Potentially Critical.
13	<b>P</b> Building Integrity: It was noted and reported that multiple instances of water intrusion occur at the basement during rain events. Engage the services of a qualified architect/engineer to perform an investigation throughout the basement enclosure to determine the cause of the water intrusions and provide recommendations and repair documents.	1	LS	\$10,000.00			\$10,000										\$10,000	Priority 2 - Potentially Critical.

15 - Localized areas of mortar joints are missing or are in poor condition along the masonry brick and stone facades. Areas of the stone and brick masonry have organic growth and debris accumulation.

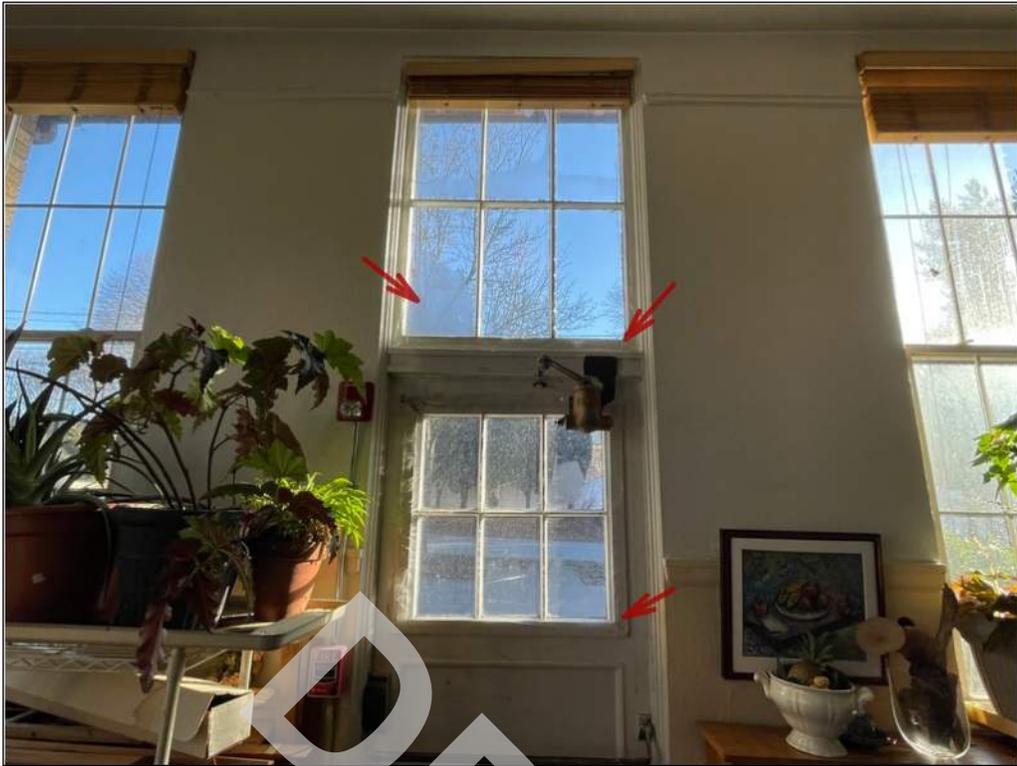
17 - Single pane glass window unit above the door and on the door leaf have condensation and have been covered with window films to reduce draft.

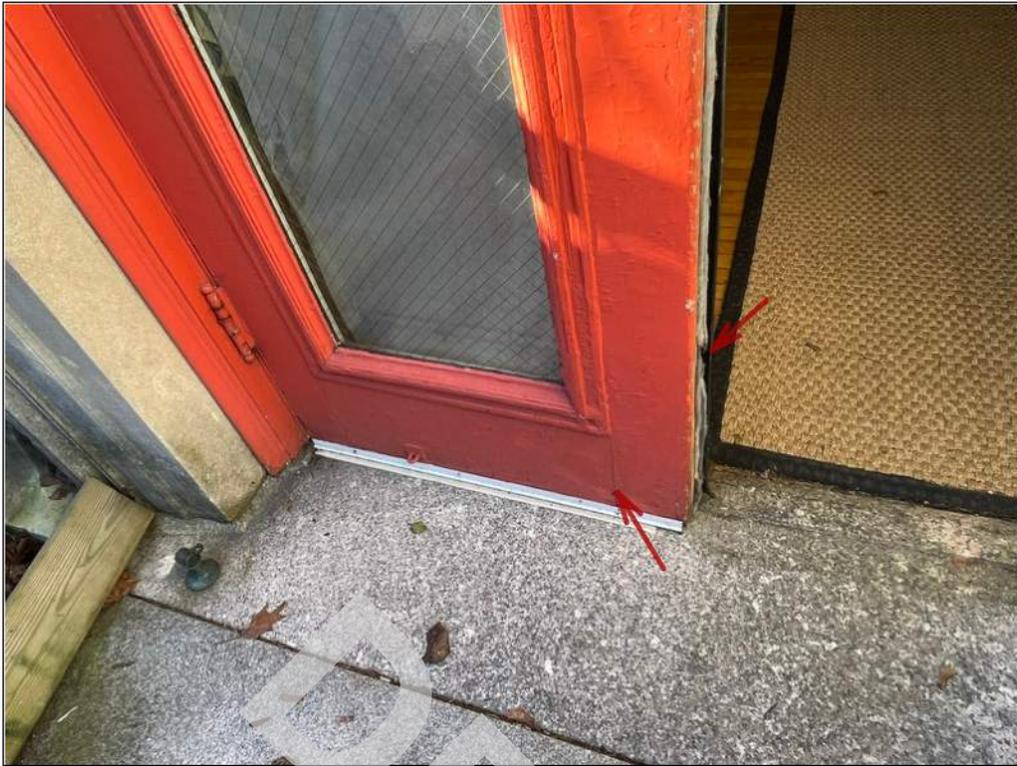
19 - Wood surface and weatherstripping are in poor condition.

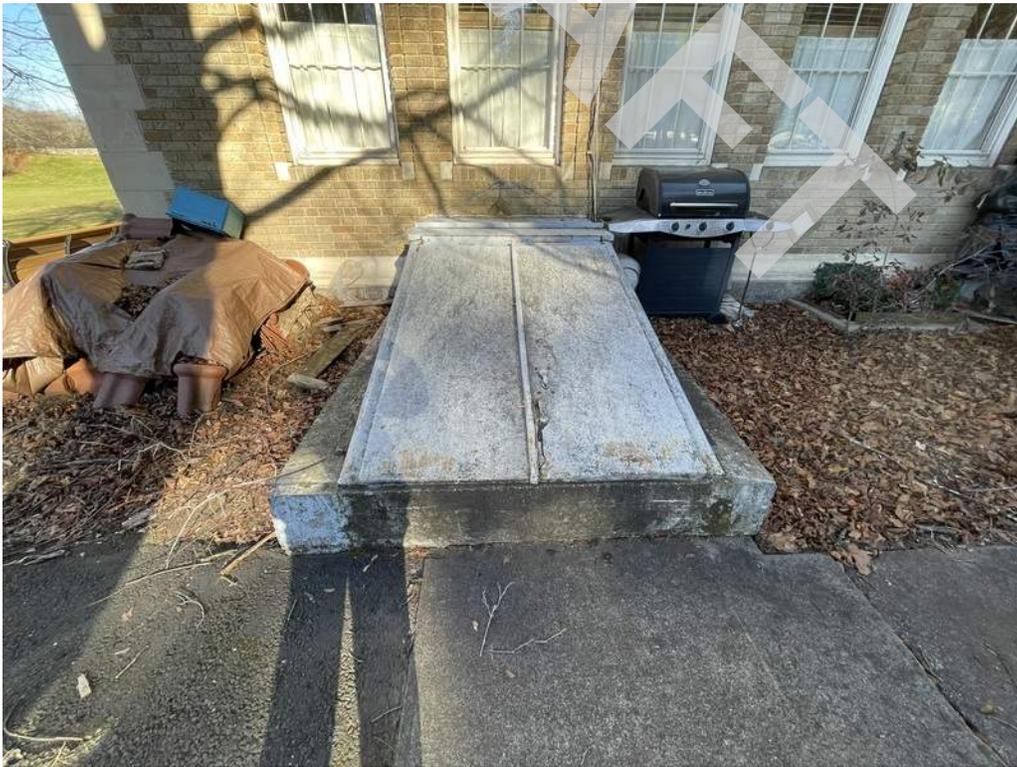
20 - Metal basement hatch door is in poor condition.

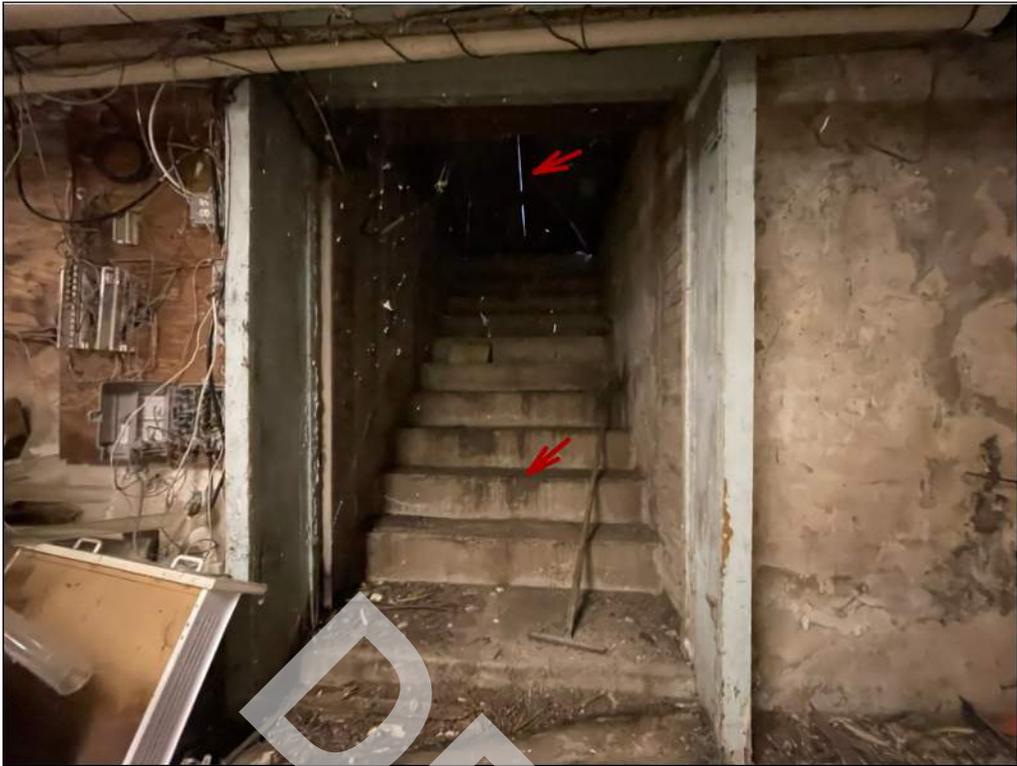
21 - Basement hatch door doesn't close properly and steps have signs of water intrusion.

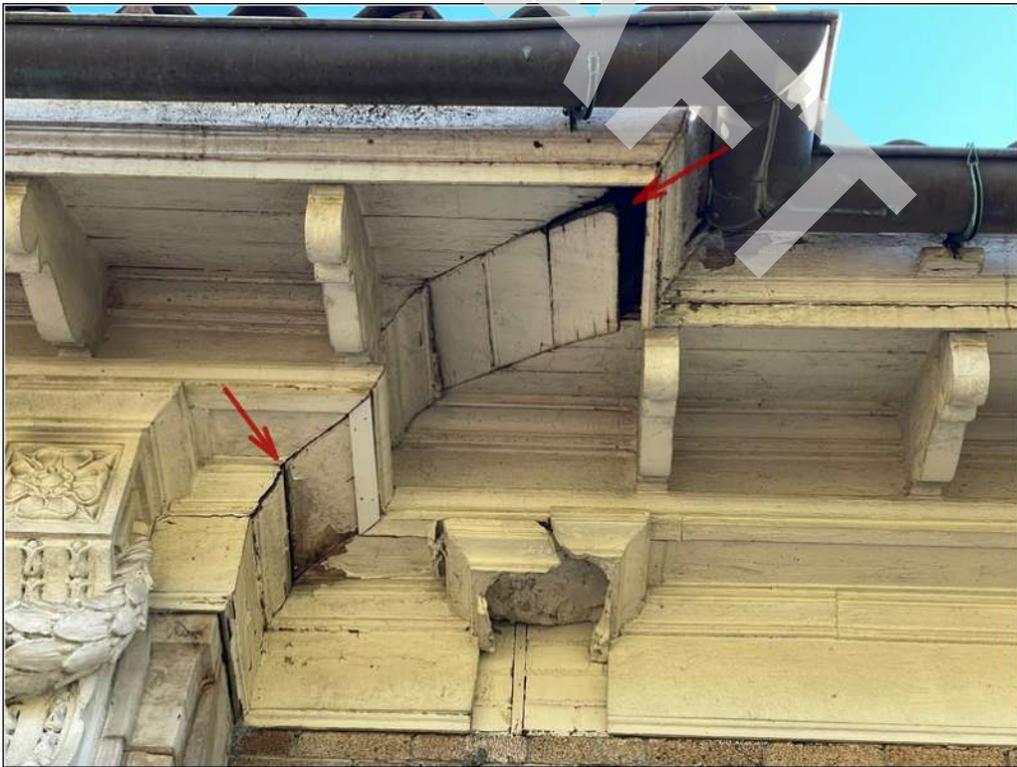
22 - Wood soffits and trim around the roof have displaced and open joints; paint finishes are peeling; wood surfaces are rotting and have missing pieces.

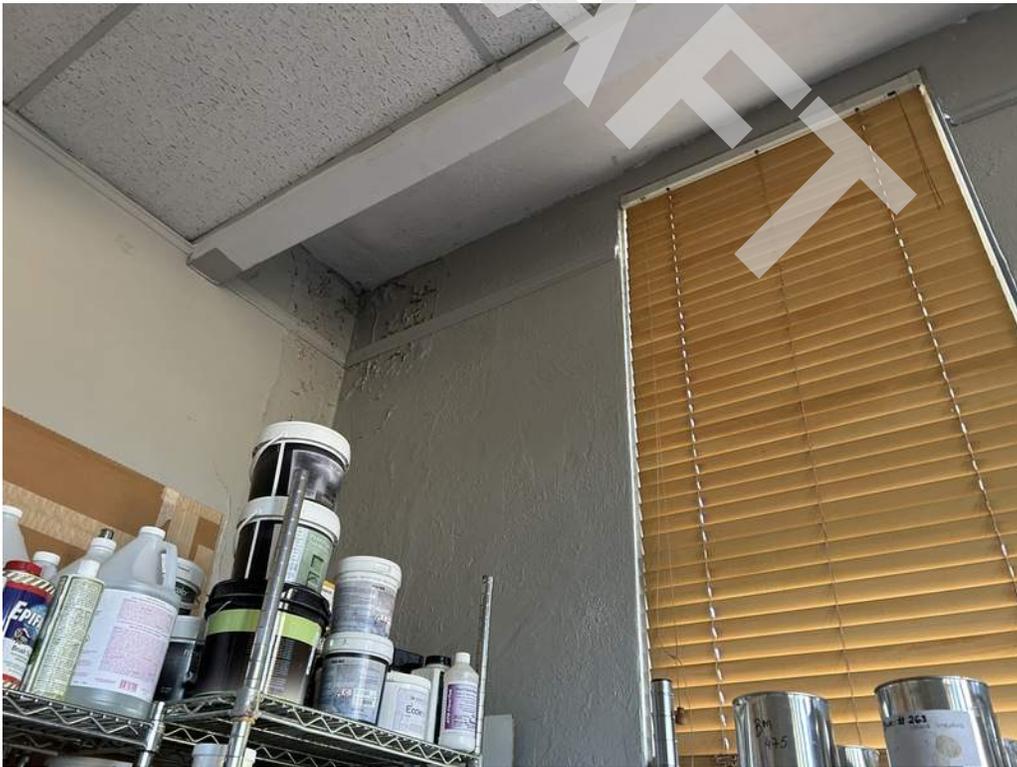
24 - Deteriorated paint was observed at the corner of Classroom 1AA.

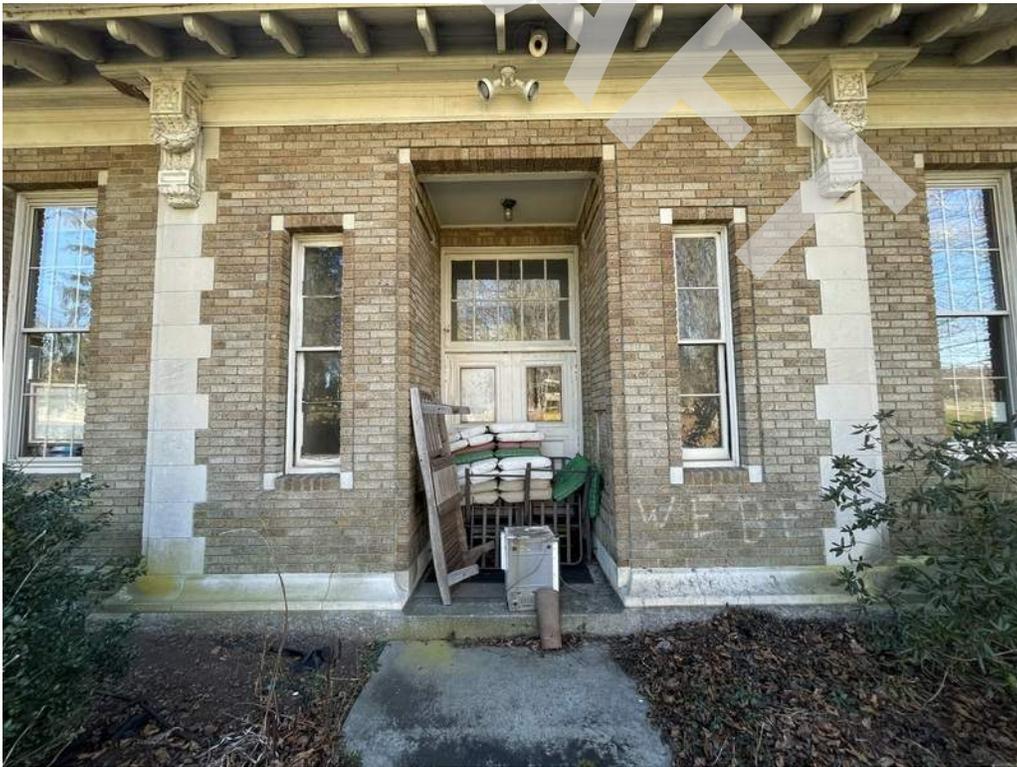
28 - Stored chairs and cushions are blocking the egress.

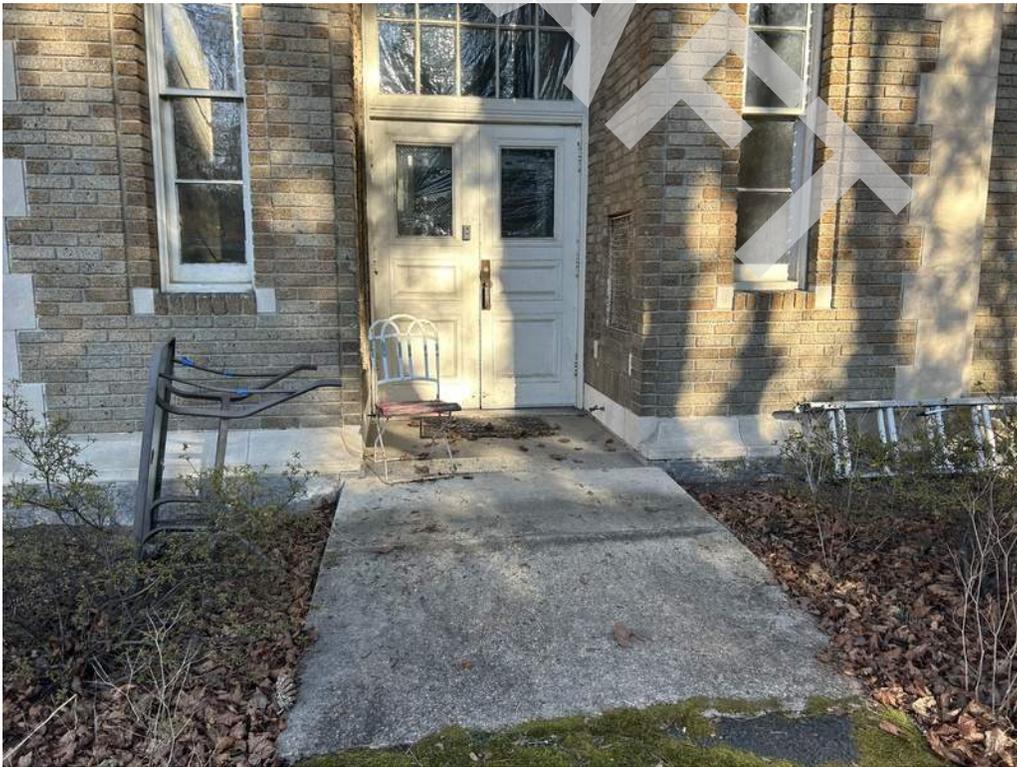
#	Item	QTY	Unit	Unit Cost	Replacement Percent	Immediate Total	Comments
8	ADA: The minimum clear width required is not provided at the accessible entrance door. Remove the existing door leaves and install new door and leaf to meet compliance.	1	LS	\$6,000.00	100%	\$6,000	Priority 1 - Current Critical.
9	ADA: Light switches were observed to be mounted above reach range at approximately 10 locations. Remount light switches to compliant height.	10	EA	\$600.00	100%	\$6,000	Priority 1 - Current Critical.
Total Repair Cost						\$63,000

30 - The minimum clear width is not provided at the accessible entrance door.

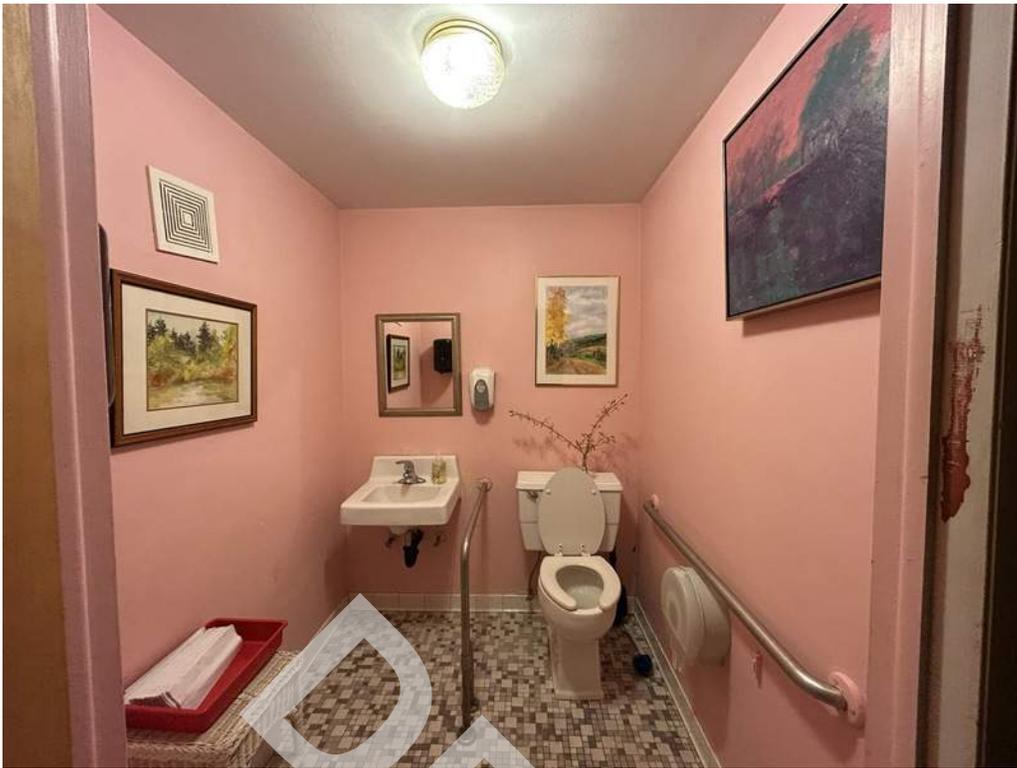
31 - The designated accessible single-user restroom is non compliant.

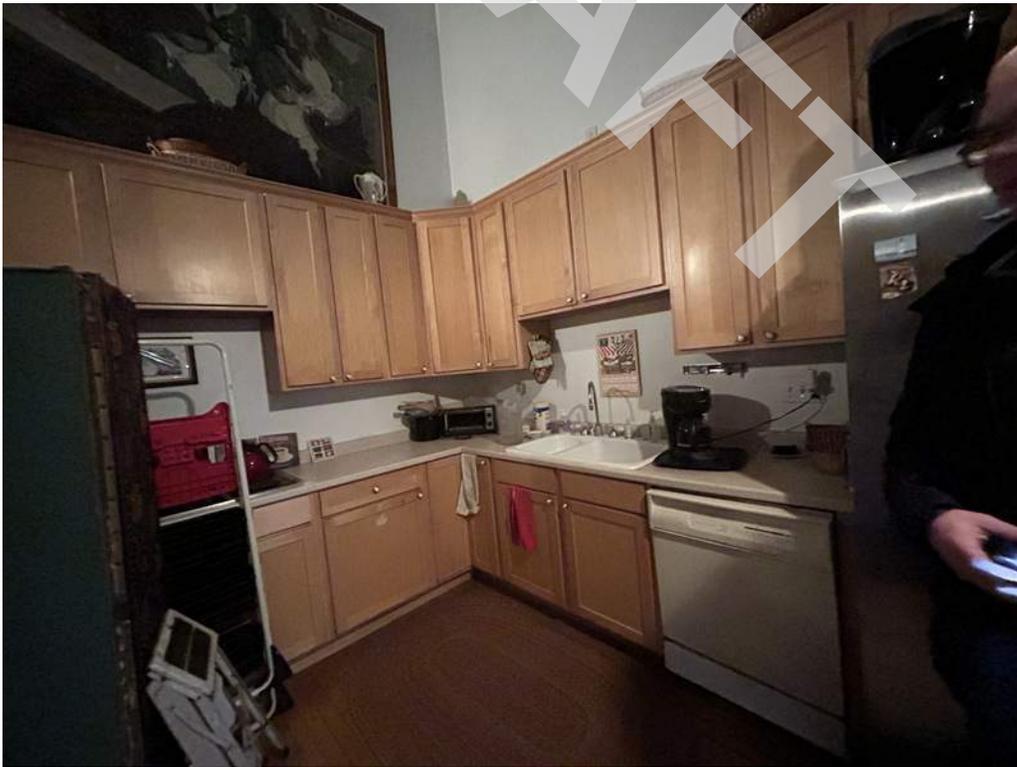
7	ADA: The kitchen was noted to have various non-compliant items. Items include knee and toe clearance at the sink, non-complaint stove top, and a work station at the required height is not provided. Perform alterations to meet compliance. Budget to include replacing the existing double ovens which reportedly have not been operable for several years.	1	LS	\$8,000.00	100%	\$8,000	Priority 1 - Current Critical.

32 - A compliant work space, cook top, and knee and toe clearance at the sink is not provided at the kitchen.
